10 Year Facility Master Plan  
3 School Pilot Study for:

## *Boston Public Schools*

Boston, Massachusetts

### Evaluation of Existing Conditions: Mario Umana Academy

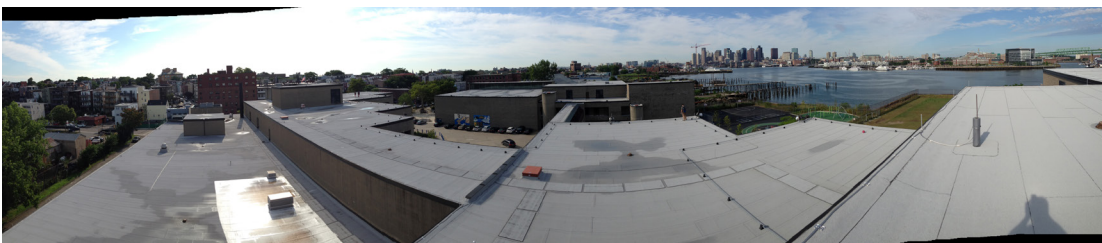
A new rolled on asphalt and bitumen built-up roofing system was installed in 2014. The roofs are minimally pitched and drained internally. The new tapered insulation appears not to have enough pitch causing ponding in many locations.

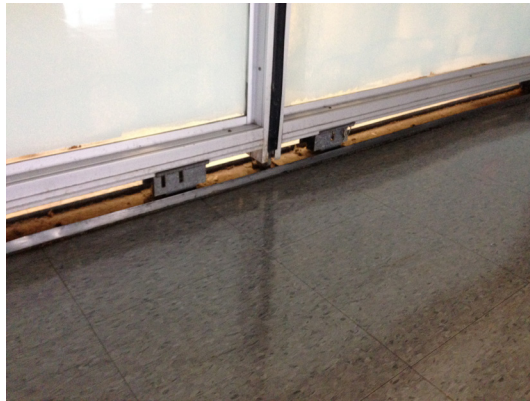
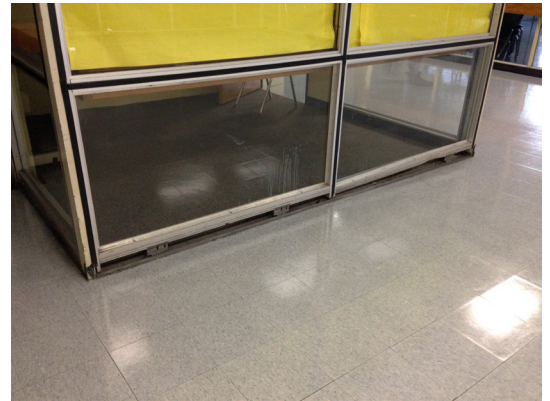
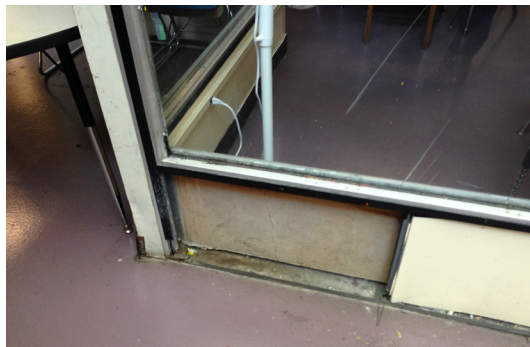
The interior unitized panel system partitions are generally in good condition at all corridors. The glass and panel units separating the classrooms from the common areas are missing most of their bottom covers.

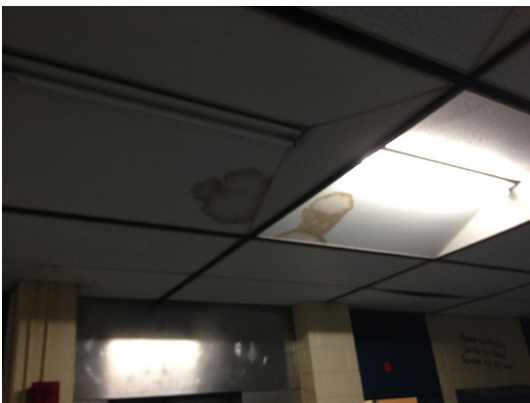
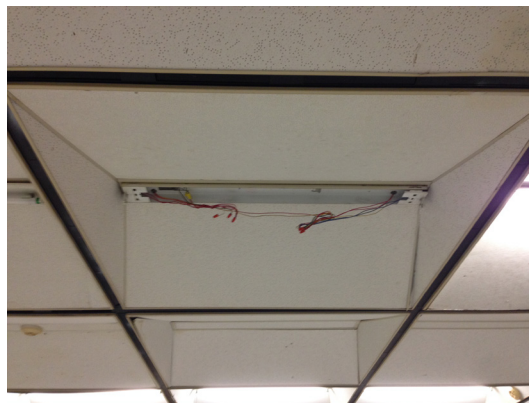
Most classrooms and corridors have 2'x2' - 2'x4' ACT tiles with exposed grid. Many tiles need replacement due to sustained water damage. Light fixtures are surface-mounted within an coffered 2'x4' unit. The existing fluorescent reflected lighting units in the ceiling grid do not meet the lumen requirements and repetition frequency discharge above 100 Hz recommended in educational facilities.

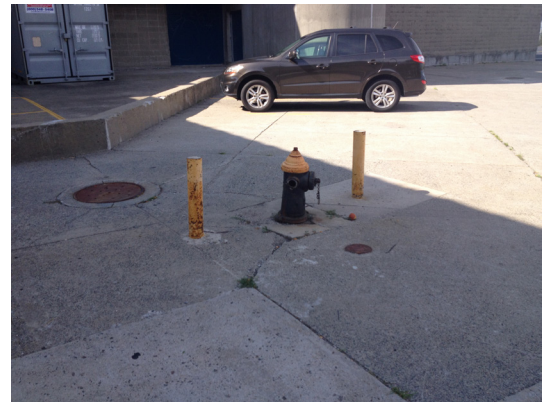
Some of the fire hydrants appear to be damaged and inoperable.

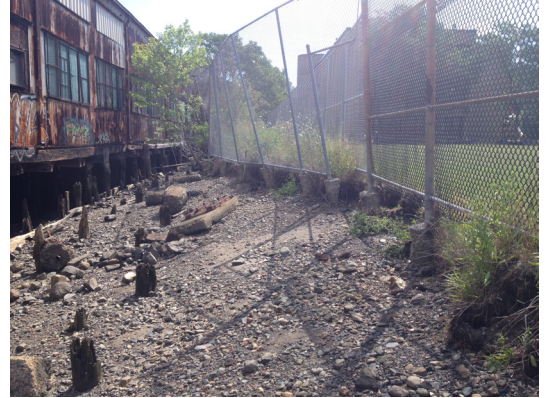
A softball field is located between the school and the harbor. It appears to have a sinkhole in the center of the field, and is often saturated. The field is unusable for softball and the backstop has rusted and collapsed. The outfield is usable as a small play field. The saturated conditions are likely due to poorly drained soils over a high water table. The sinkhole may be caused by one or two site conditions. First, the sinkhole is partially located atop an old shipway that may not have been filled correctly when the school was constructed. Second, the north side of the field is an un-reinforced and eroding slope that falls into the harbor beneath the adjacent pile-supported building.

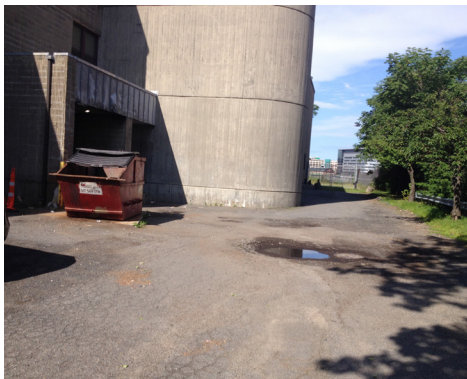
The site drainage is in poor condition. Most of the catch basin grates have been replaced with steel plates that limit flow, causing ponding. The ponding water has infiltrated around the catchbasins, undermining the subsoils, which cause the pavement to settle and crack. The catchbasins also appear to be settling, and should be inspected. No water quality structures were found on site. No stormwater systems to reduce runoff volume or rates were found on site.

*Failed catchbasin*

- Flood study of building and egress, and analysis of the risk of sea level rise and strategies to adapt.
- Install standard grates on catchbasins.
- Reconstruct sub base and repair courtyard.
- Mill and overlay north side parking lot and replace berms.
- Selective Border Street sidewalk panel repair.
- Repair basketball court crack.
- Study athletic field failures.
- TV sewer and drain systems to assess condition.

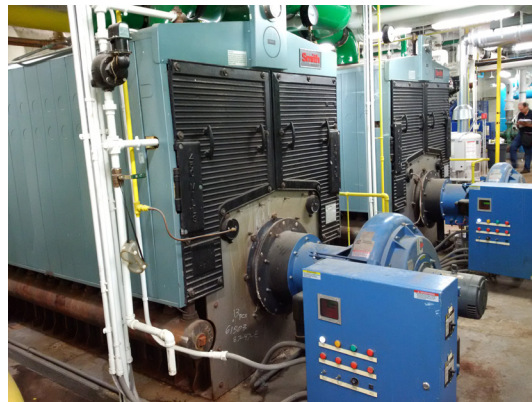
The boiler room is provided with two (2) H.B. Smith gas fired cast iron sectional boilers. Each boiler generates hot water which is distributed to hot water coils at terminal units, hot water coils at air handling units and the various heating apparatus. The boilers appear to be original to the building and generally in good condition, but boiler headers are showing signs of corrosion.

*Existing boilers*

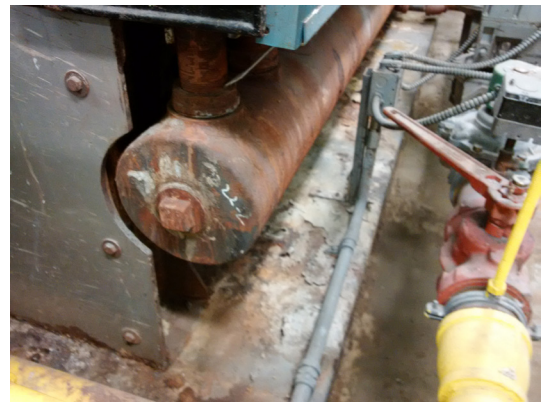
*Boiler header showing rust*

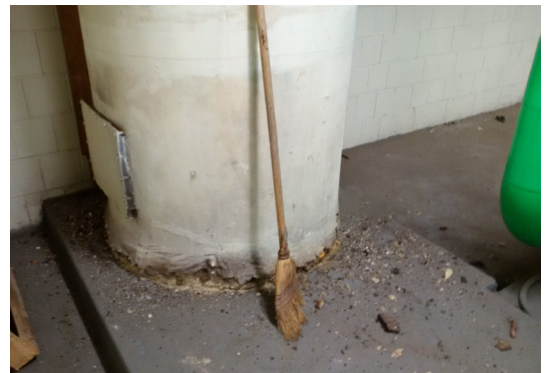
Breeching from boilers is through an insulated venting system. The breeching insulation is damaged in several places. The boilers are provided with induced draft fans. There is some interior contamination at these fans. The draft fan's insulation is missing. The breeching discharges into a metal flue which is vented vertically through the building to the exterior. The breeching connection to the masonry chimney does not appear to be sealed. The metal vertical flue insulation is damaged.

*Flue damaged insulation*

The connection between the induced draft fans & boiler vents, boilers vents & breeching and breeching connection to masonry chimney should be tested for leakage.

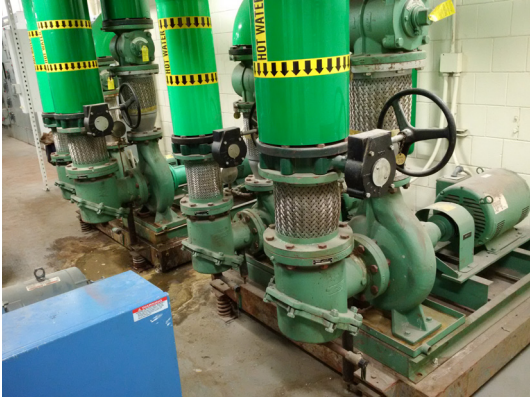
There are two (2) primary and two (2) secondary hot water pumps. All hot water pumps are leaking.

*Hot water pumps bulging flexible connections*

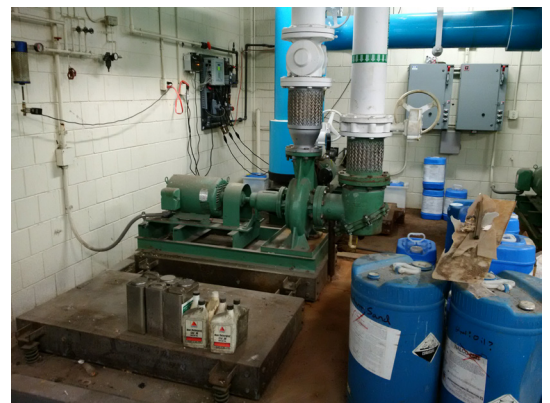
*Missing condenser water pumps*

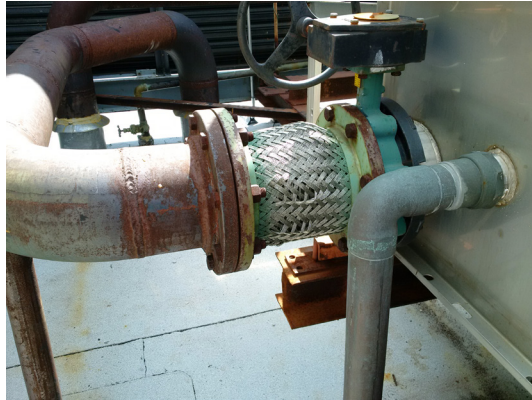
*Cooling tower damaged flexible connections*

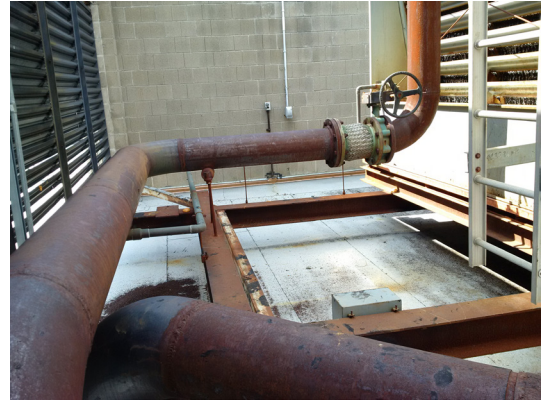
The condenser water piping on the roof requires additional supports.

*Insufficient condenser water piping support at cooling tower*

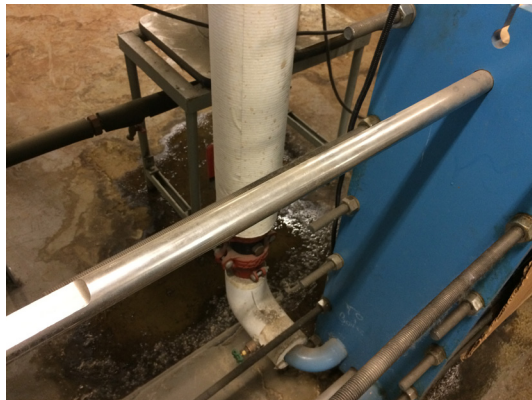
There is a plate and frame heat exchanger installed in the boiler room. The heat exchanger and an associated in-line pump are part of a cogeneration system. The plate & frame heat exchanger, associated in-line pump, piping, valves and accessories are leaking.

*Cogeneration heat exchanger leaks*

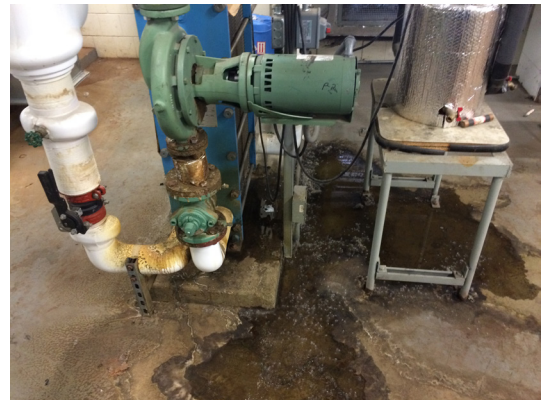
*Cogeneration in-line pump, piping, valve leaks*

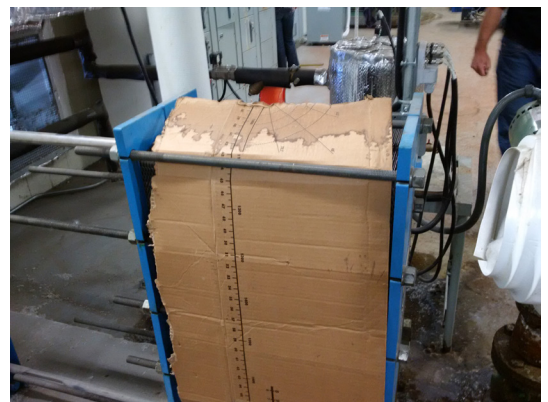
*Cogeneration heat exchanger covered by carton  
(installed by maintenance personnel trying to protect  
from overhead pipe leaks)*

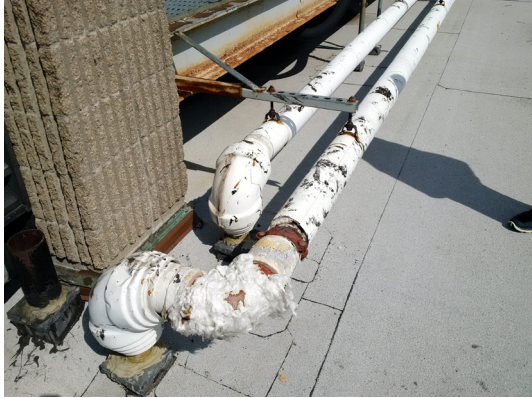
Located outside are dry coolers. Dry coolers appear to be a part of the cogeneration system. The condenser water piping appears to be also a part of the cogeneration system. The cogeneration equipment shows signs of wear and rust. The insulation on the roof mounted piping between the cogeneration outdoor cabin and the boiler room is damaged.

*Cogeneration roof-mounted piping damaged insulation and roof flashing*

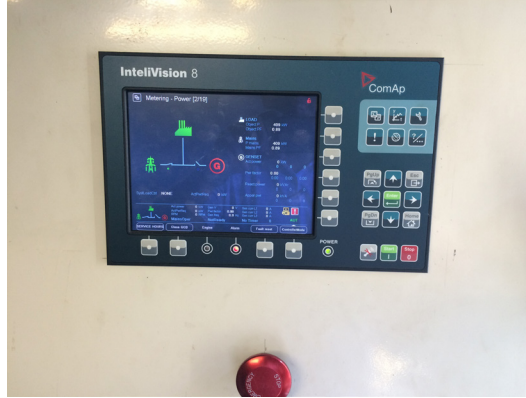
*Cogeneration control panel showing active alarm mode*

Temperature/pressure gauges are corroded and several gauges are missing. The cogeneration instruments/gauges indicated during the time of the visit the system was in active “alarm” mode.

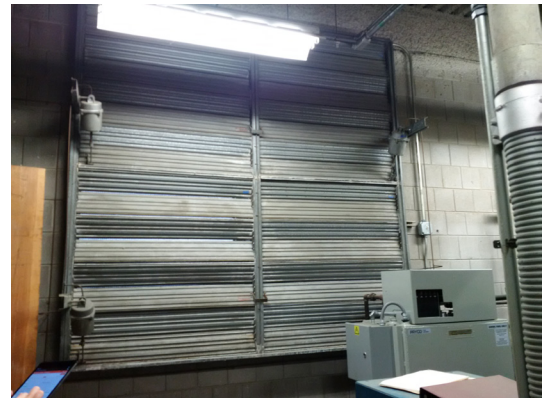
*Outside air dampers closed during air handling unit operation*

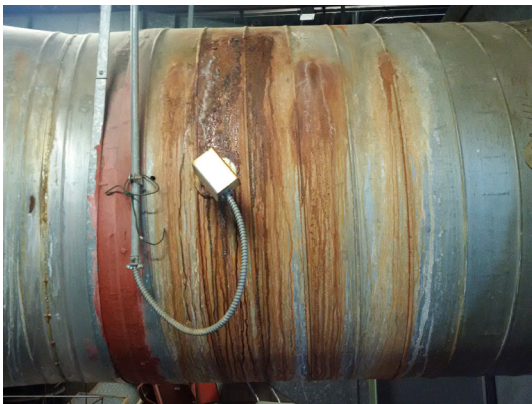
*Non-insulated ductwork leaks*

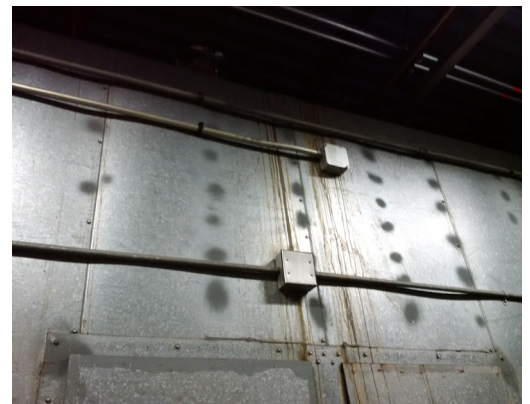
The roof drain in penthouse A is leaking directly on the ACU-3. The leak appears to be old and the air handling unit and equipment under this leak has corroded.

*Roof leak on top of air handling unit*

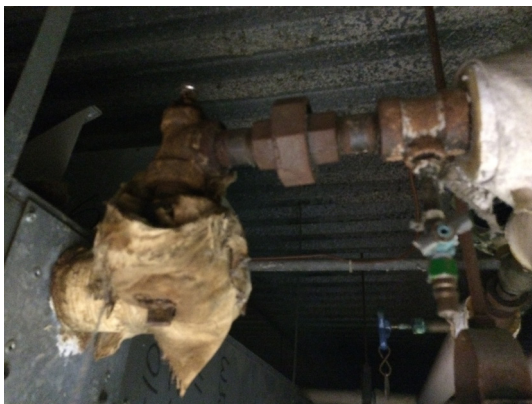
*Terminal unit HW piping*

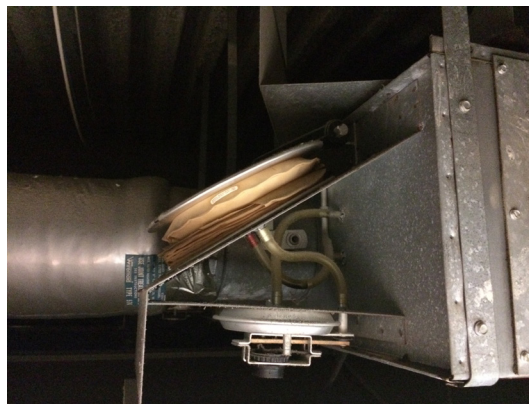
*Terminal unit damaged actuator*

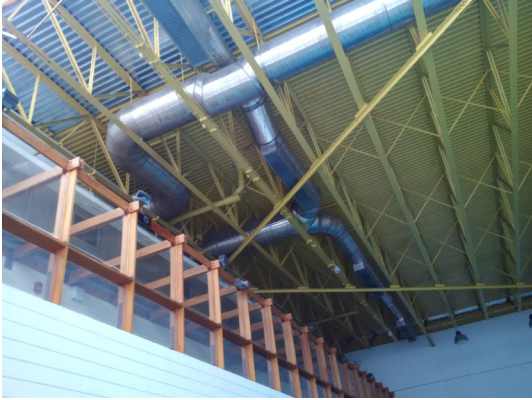
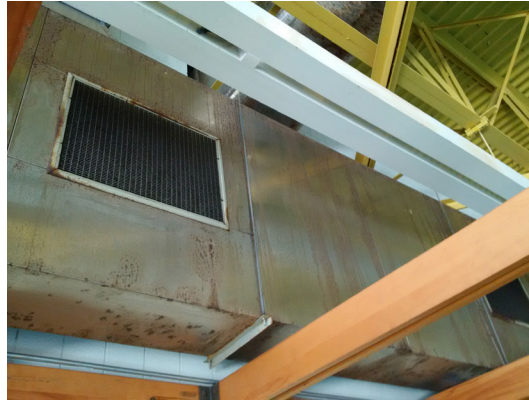
The pool is provided with heating and ventilating units. The space does not have any air conditioning and there is no humidity control. The level of humidity in the space was extremely high and the space was very uncomfortable. There was condensate on walls, windows, structural members, ductwork, diffusers, etc. Corrosion was noted on structural members. The air is distributed via exposed spiral ductwork. The ductwork and diffusers are corroding. It appears there is no space temperature control. Although the pool HVAC unit was operational, the air movement was not sensed in the space. The Pool space temperature is controlled remotely by Boston School District Energy Department.

*Pool air distribution*

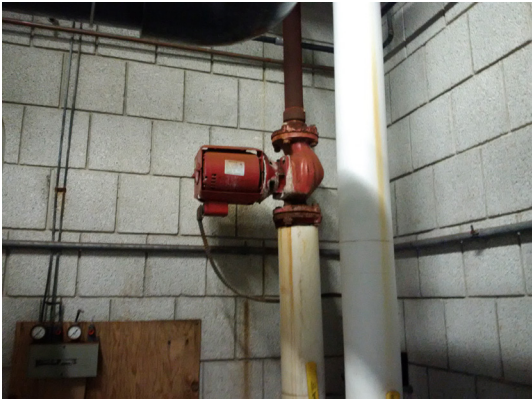
Pool equipment and piping (installed in the rooms adjacent to pool) does not appear in good working order, is leaking and corroded.

*Leaking/corroded in-line pump (pool equipment)*

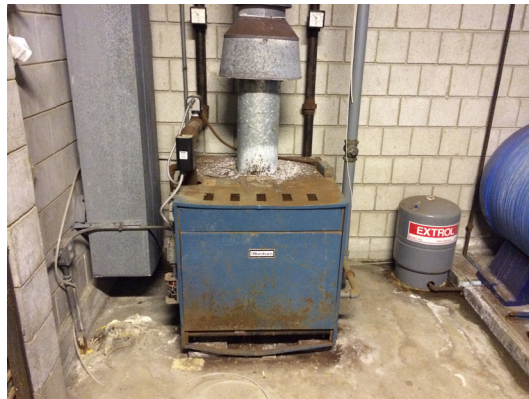
*Corroded pool heater*

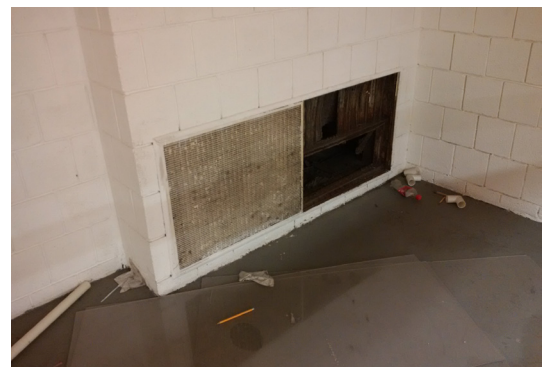
The basketball court, small gym and locker rooms are provided with heating and ventilating units. The air distribution registers are dirty and damaged and in need of replacement. Although the heating and ventilating units were operational, there was no air movement in the spaces. The indoor air quality in all these spaces is poor. There are multiple locations in the ceiling indicating leaking pipes.

*Small gym air dirty/missing register*

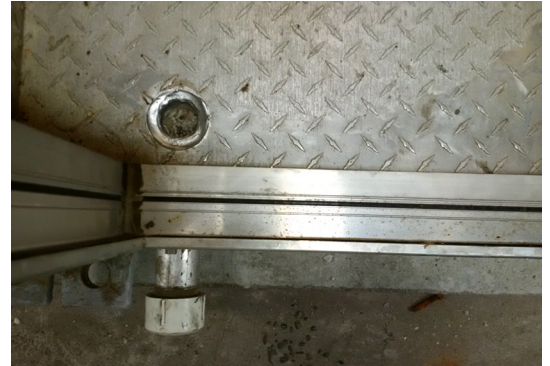
Pool and locker rooms' air handling units are located in the penthouse. The pool unit was replaced three years ago due to the condensate drain issues with the previous unit. However, at the time of survey the pool unit was operational and there was a substantial amount of condensate inside the unit cabinet at several locations. The condensate was not discharged from the unit and the drain pans appeared either sloped to the wrong direction, or the condensate drains outlets were plugged.

*Pool air handling unit floor condensate drain plugged*

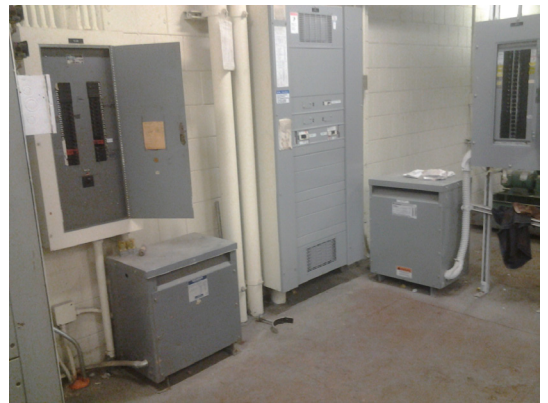
*Example of "emergency power" equipment installation (no ATS found)*

Examine and trace the existing emergency power distribution system wiring to identify/confirm Code violations and upgrade/reinstall accordingly.

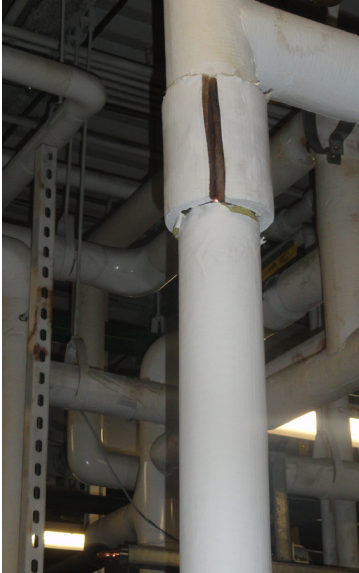
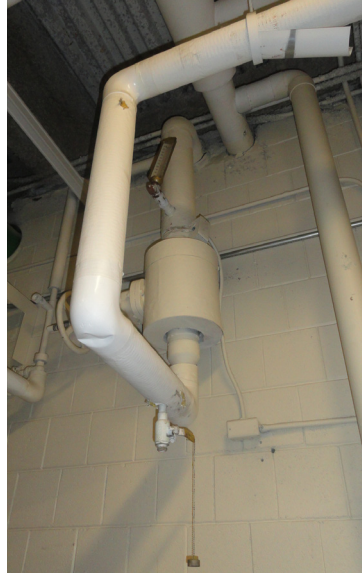
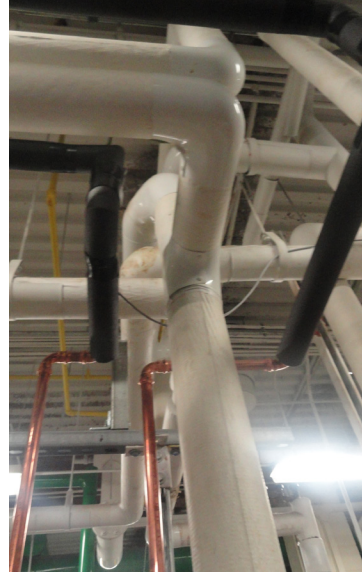
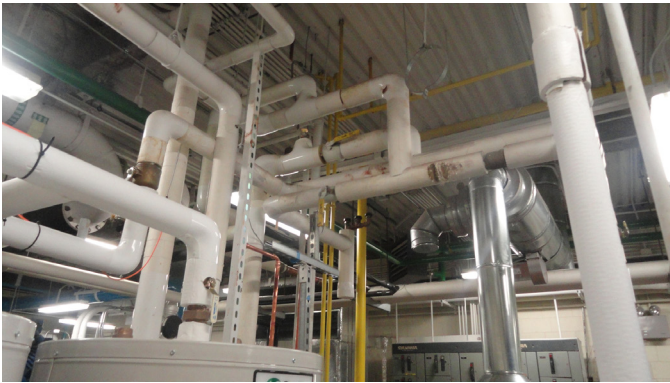
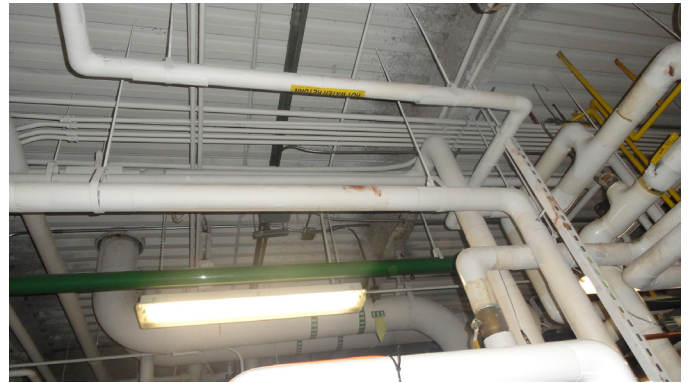
*Photo 3: Damaged PVC jackets and pipe insulation*

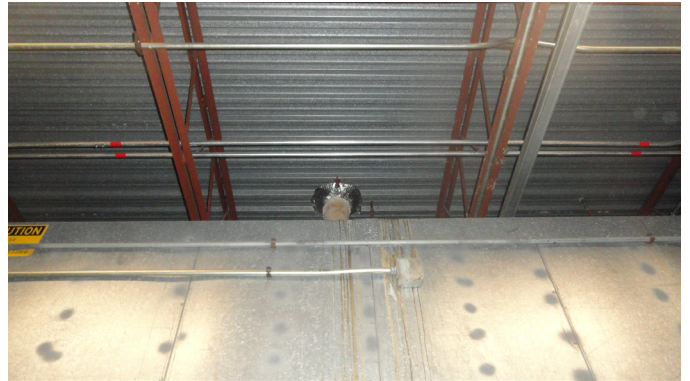
Photo 11: Leaking Roof Drain

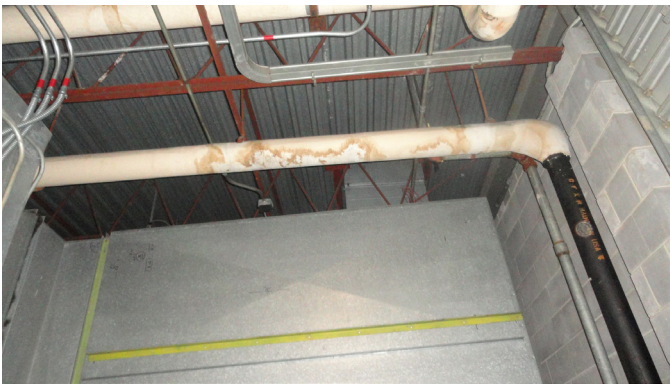
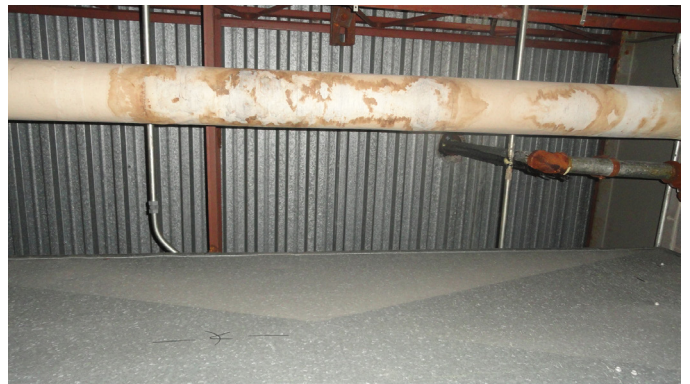
Photo 12: Pipe Insulation in poor condition

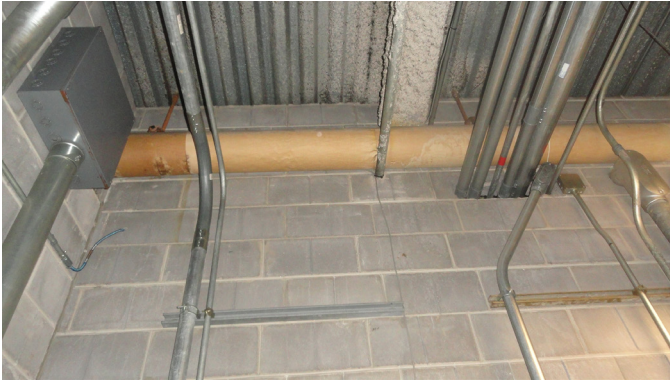
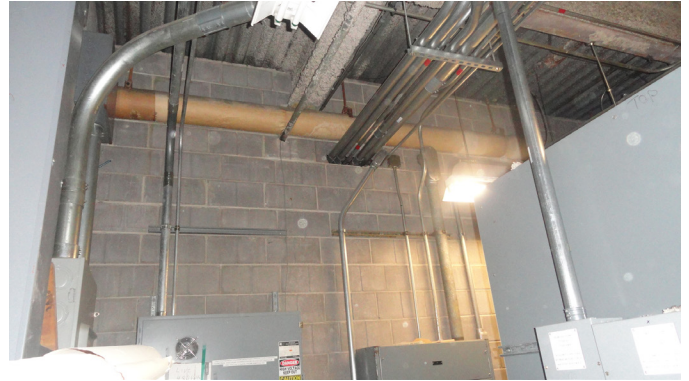
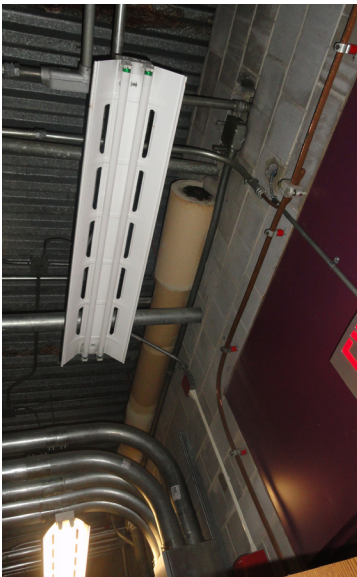
*Photo 13: Wet pipe  
installed above  
Electrical Panels*

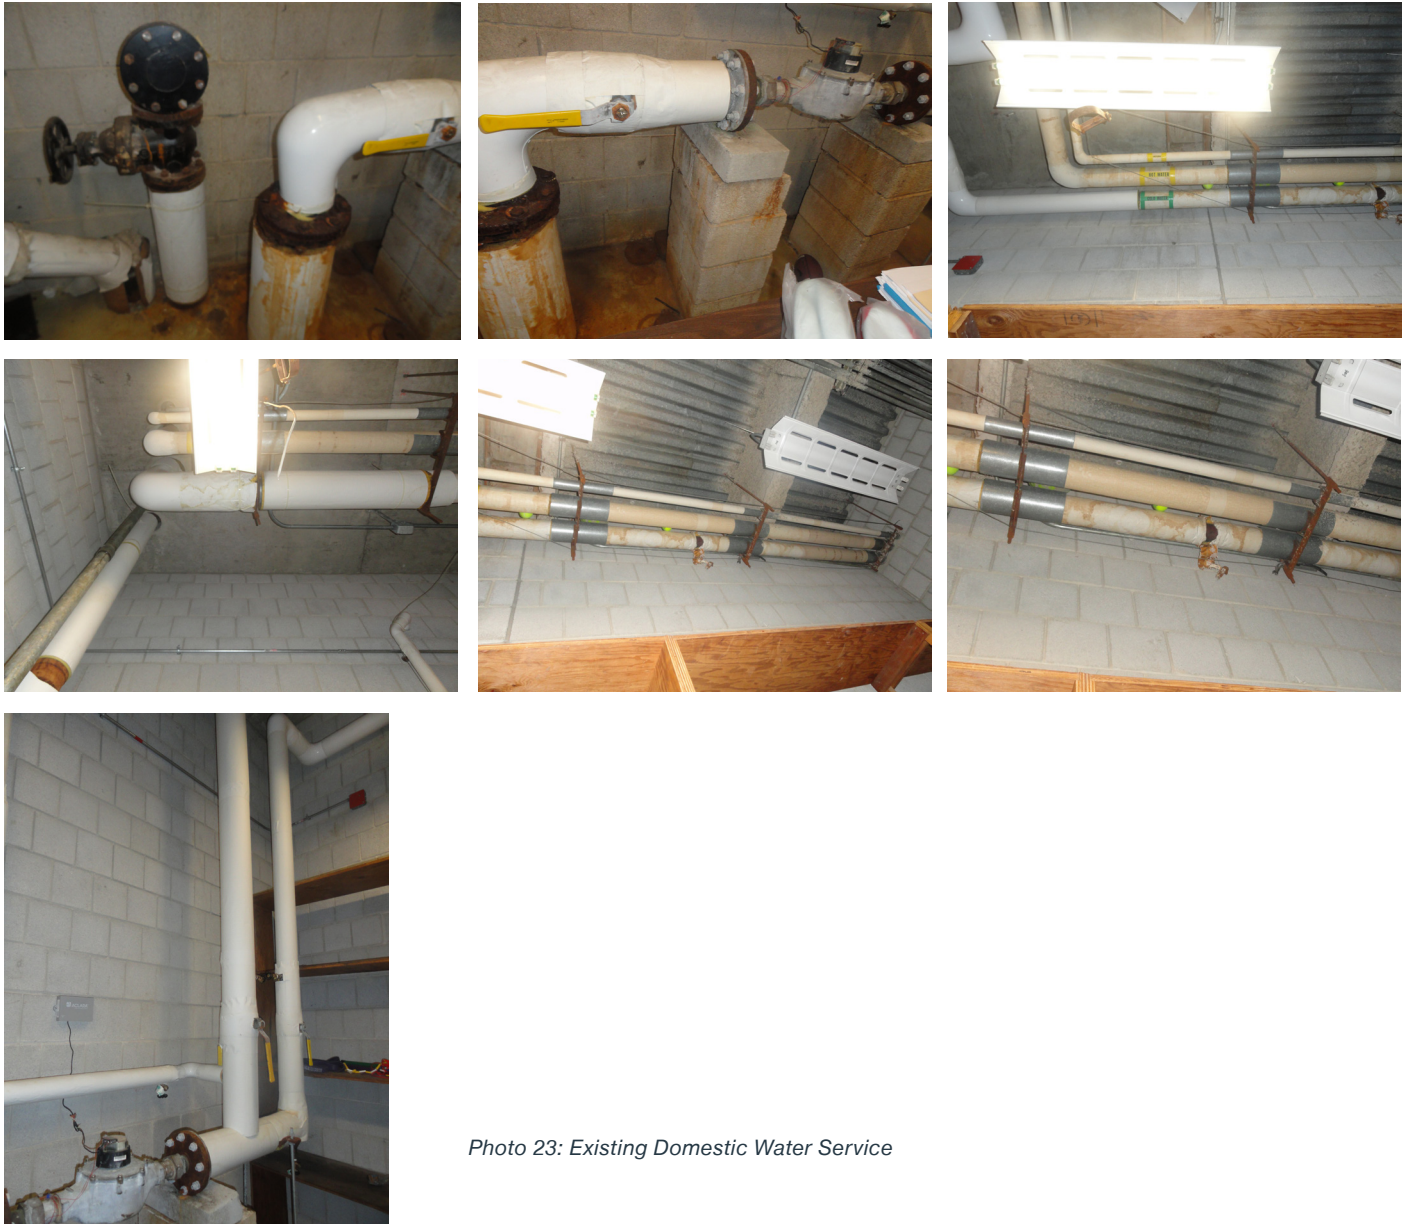
The existing water service does not include a backflow preventer assembly.

Photo 23: Existing Domestic Water Service

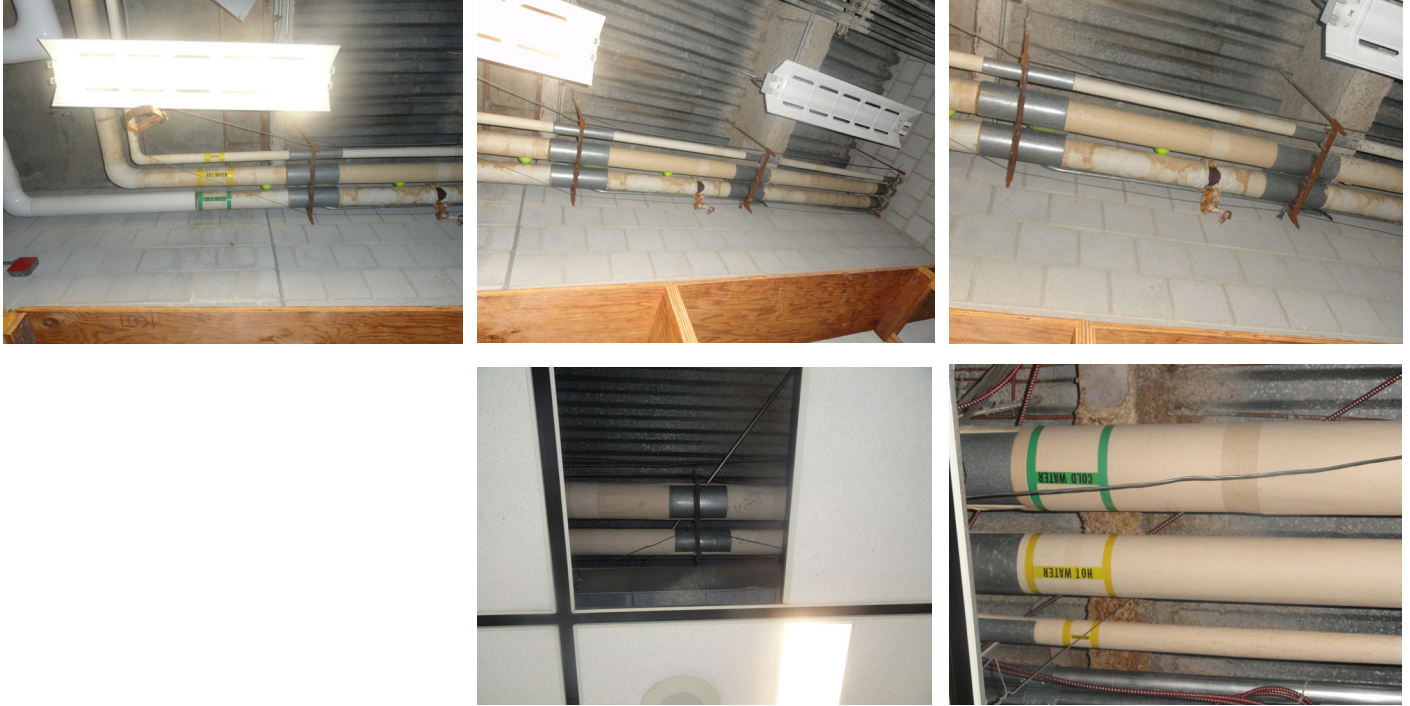
HW and HWC's pipe insulation is in poor condition (see photo 24).

Photo 24: Poor pipe insulation
