10 Year Facility Master Plan  
3 School Pilot Study for:

## *Boston Public Schools*

# *10 Year Facility Master Plan 3 School Pilot Study*

### **Evaluation of Existing Conditions: Jeremiah E. Burke High School**

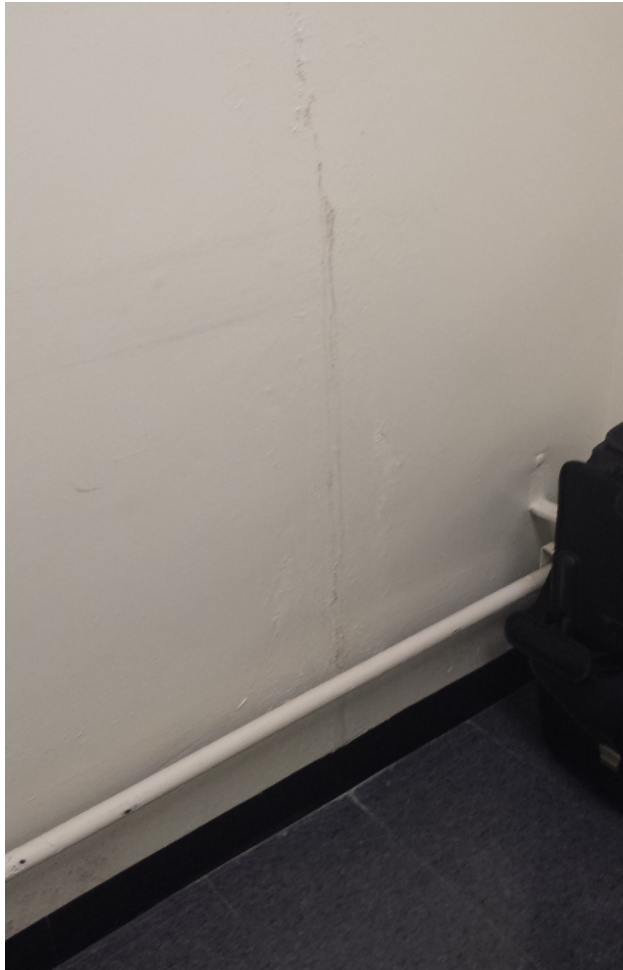
A significant vertical crack was observed in the exterior masonry wall of the stairwell located at the northeast corner of the existing building (adjacent to the new addition.) The cause of the crack could not be determined and it is possible that it occurred during the construction of the addition. The crack could not be observed on the outside face of the wall although it may have been repaired.

*Crack in Wall Finish*

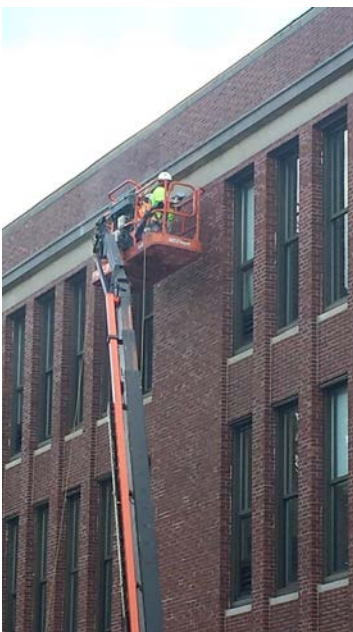
The exterior masonry walls are undergoing repairs in the form of repointing and rebuilding selected areas of the walls. Steel lintels are being cleaned and painted but it should be noted that surfaces that are not accessible will continue to rust.

*Repointing and Repair Work*

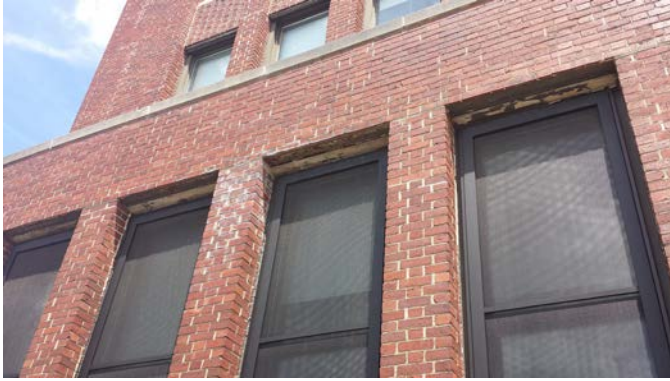
*Rusting Lintels*

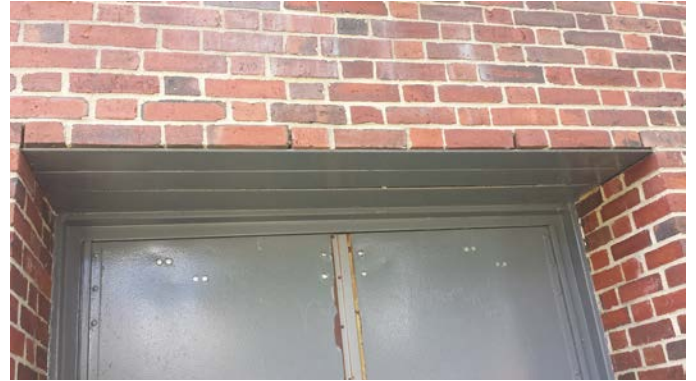
*Cleaned and Repainted Lintel*

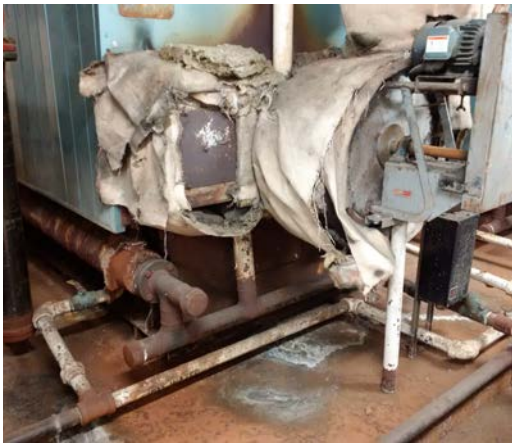
*Boiler Induced Draft Fan*

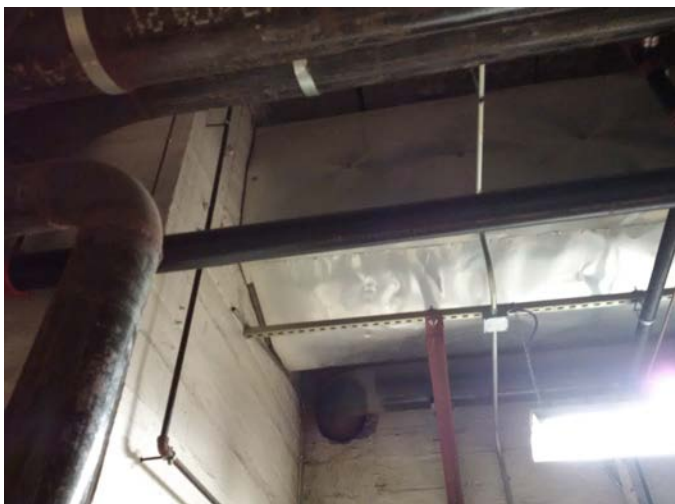
*Boilers Breeching Connection at Masonry Chimney*

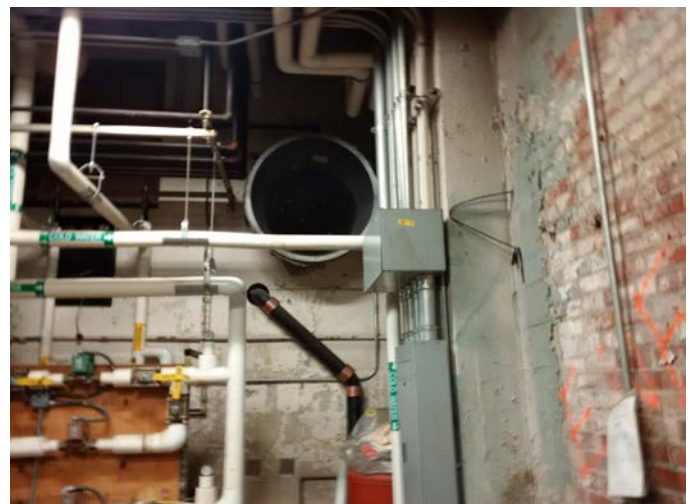
At the time of the visit boiler room ventilation/combustion air systems were not operational. The combustion air duct is missing its termination grille.

*Boiler Room Open End Ventilation/Combustion Air Duct*

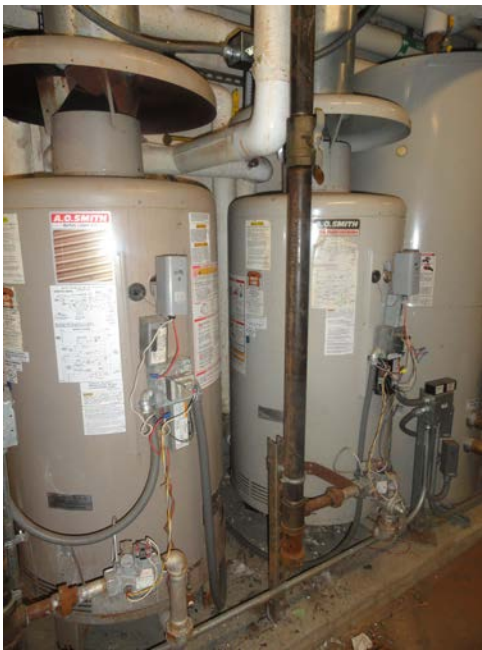
*Flues Disconnected from Domestic  
Water Heaters Venting*

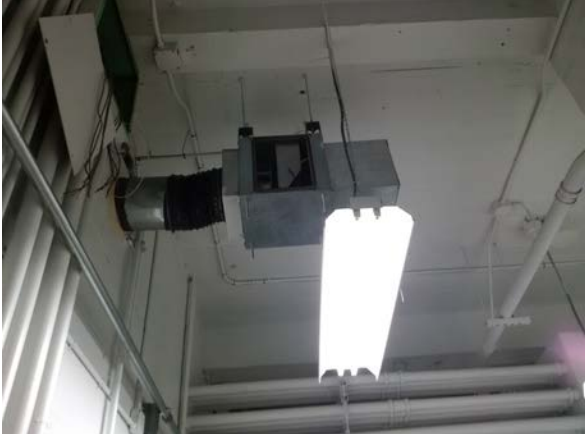
The other electrical rooms adjacent to Boiler room are not provided with any mechanical ventilation systems.

*Electrical Room Exhaust Fan with Disconnected Wiring*

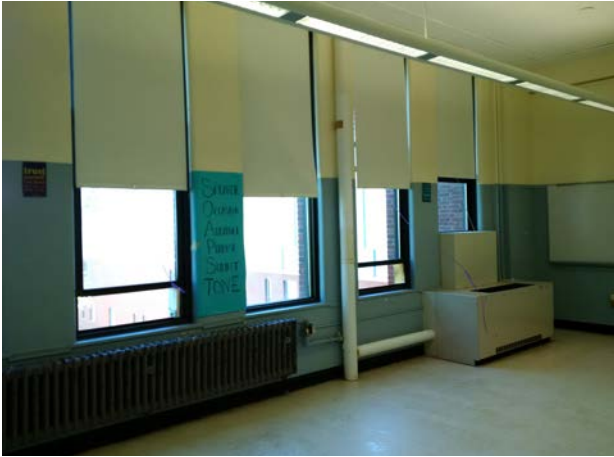
The classroom unit ventilators and finned tube radiation are original to the building, appear to be in fair condition, the interior of unit ventilator cabinets require cleaning and removal of debris. The operation of outside intake dampers could not be verified. All equipment has reached its maximum serviceable life.

*Classroom Unit Ventilator and Finned Tube Radiation*

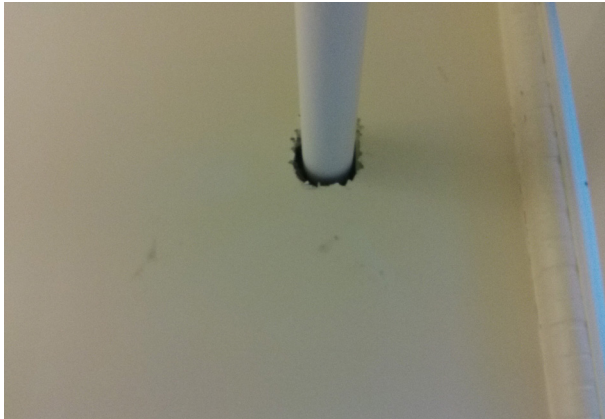
*Missing Seal around at Piping Wall Penetration*

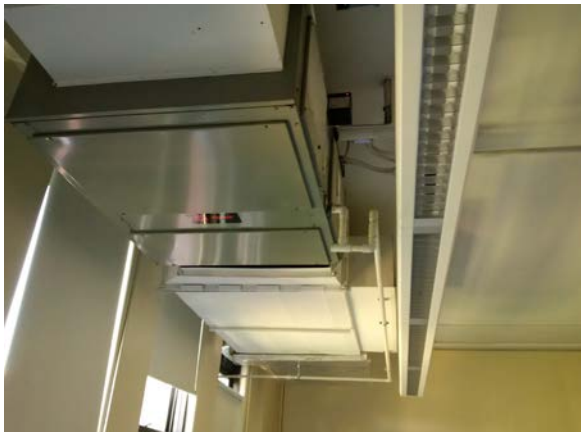
Several classrooms over the years were retrofitted with air conditioning fan coil units. The fan coil units appear in good condition. However, the condensate drain from fan coil units is being discharged directly through the windows and exterior walls to outside.

*Air Conditioning Condensate Drain Piped Directly through window to discharge outside*

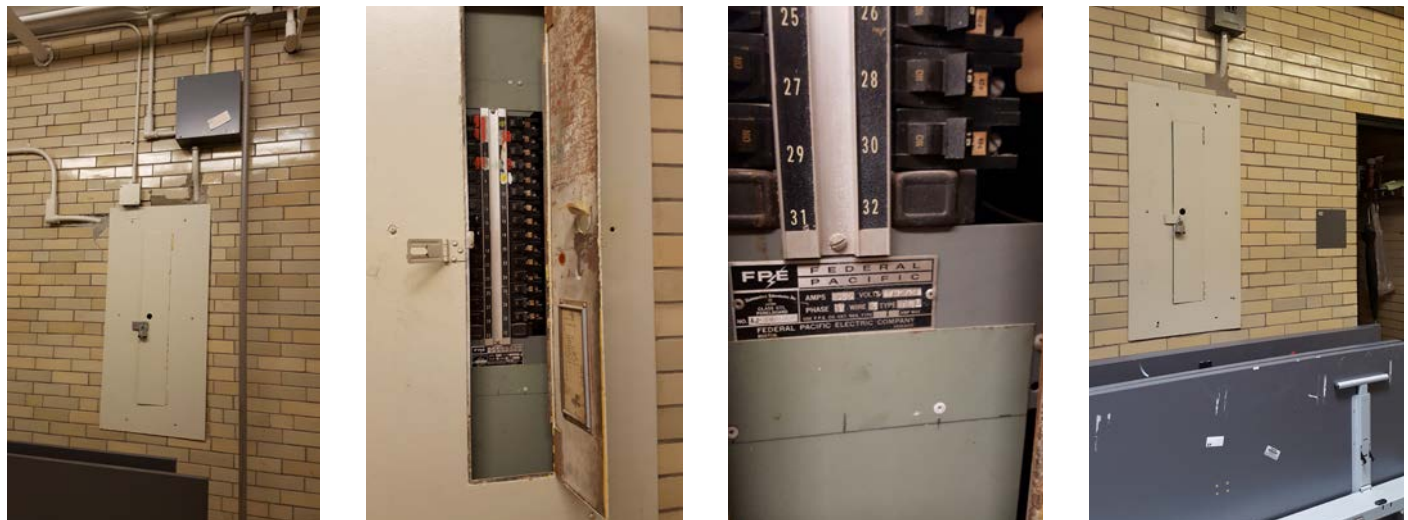
Photo 4: Examples of Old Panelboards

The old Switchboard is recommended for replacement. All old 120/208 volt panels throughout the building (observed and/or estimated quantity - about thirty total) and associated power feeders from the old Switchboard are recommended for replacement.

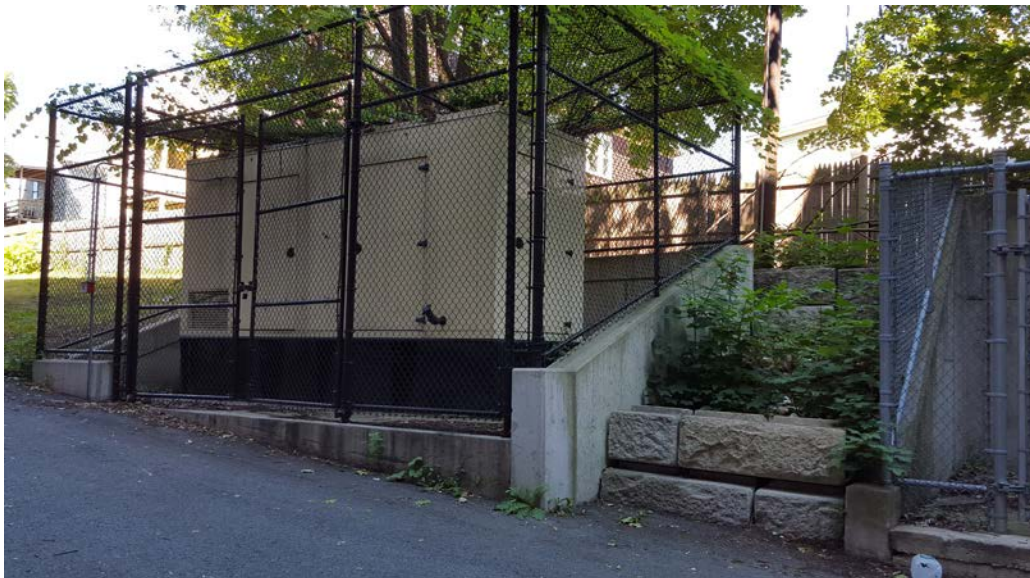
*Photo 5: Emergency Generator*

All "emergency power" distribution equipment installation and wiring methods are in good and code-compliant condition. The generator would not be classified as a emergency shelter type unit.

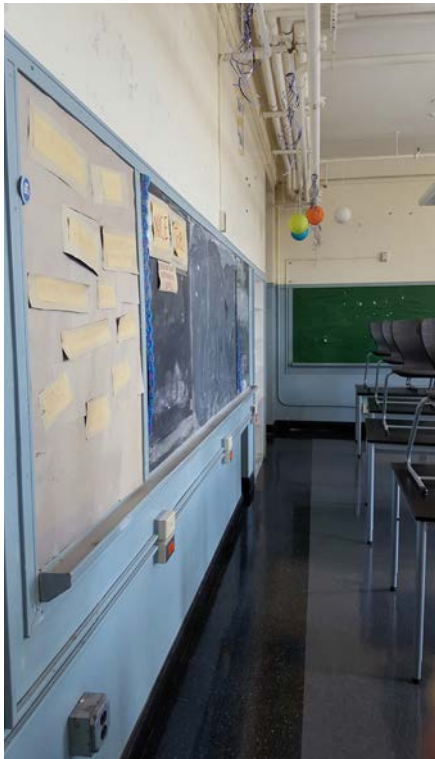
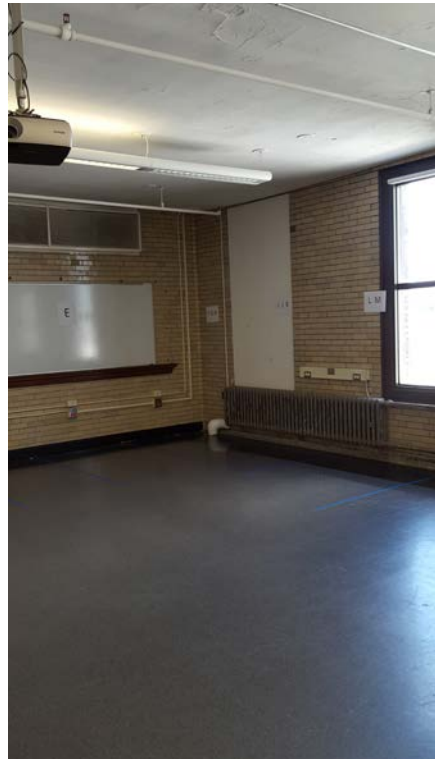
Overall, the quantity and location of duplex receptacles throughout the building, including 2009 addition, was found adequate and appropriate, but should be confirmed with educational plan for appropriateness.

*Photo 7: Example of New Receptacles and Surface Raceways in Labs and Computer Rooms*

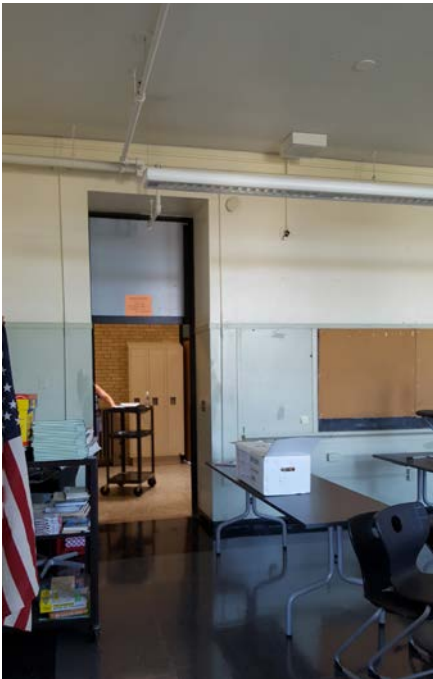
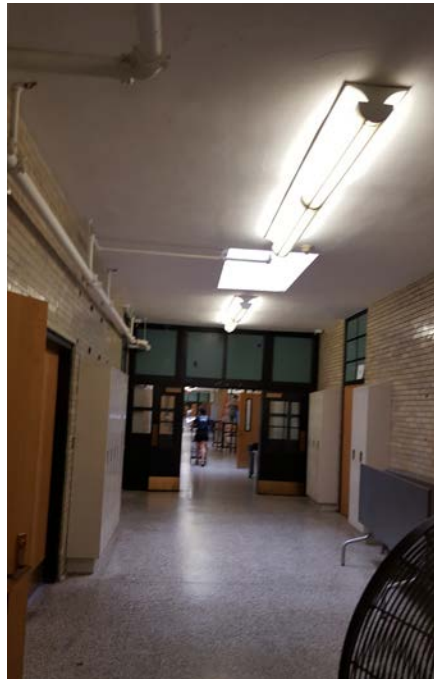
In general, the lighting system provides adequate illumination throughout and appears to be in good operational condition.

*Photo 8: Examples of New Lights in Classrooms/Labs and Corridors*

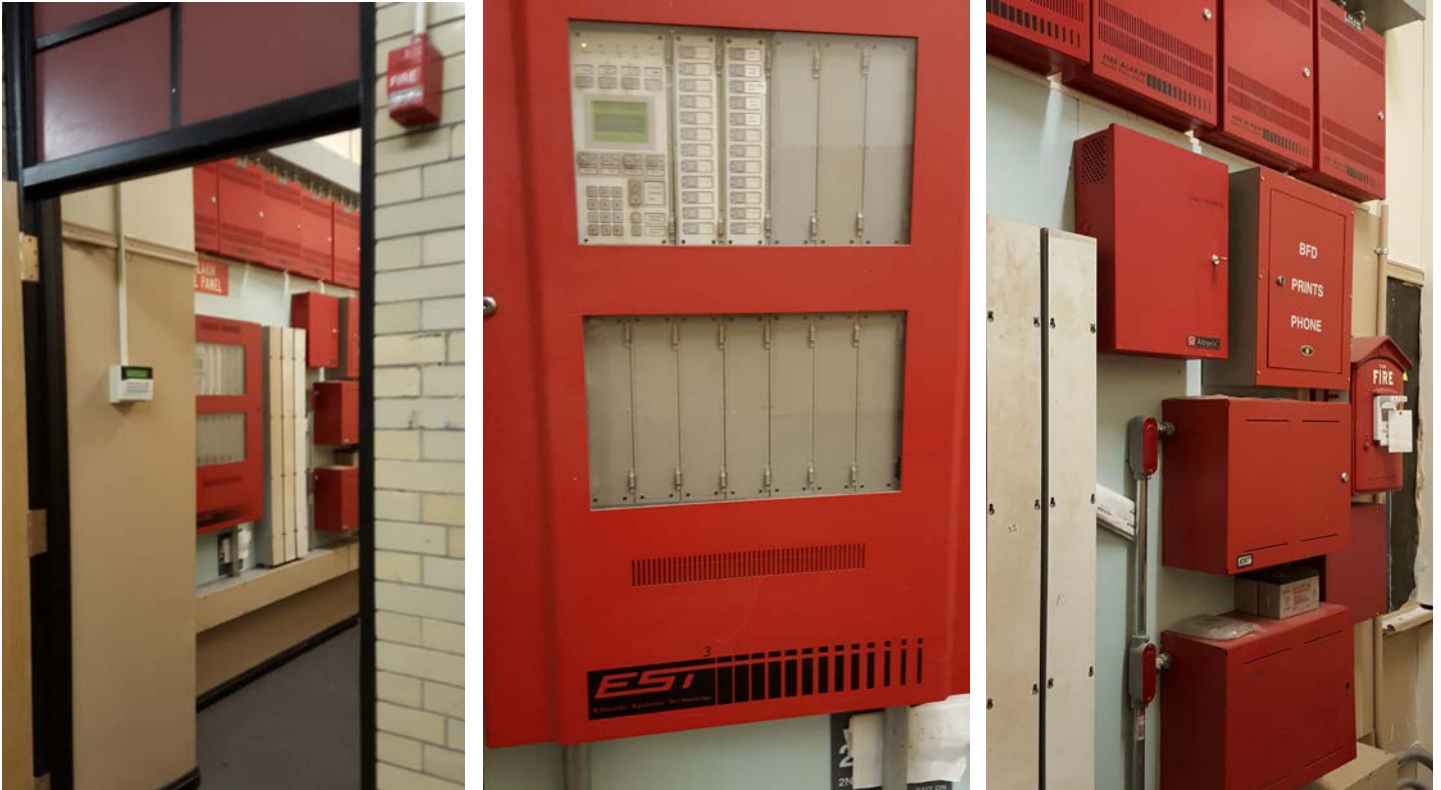
Photo 9: Existing FACP and Associated Equipment

- A few private and student bathrooms are not equipped with fire alarm signaling devices.
- Educational spaces such as classrooms, science labs and computer rooms are not equipped with fire alarm signaling devices.

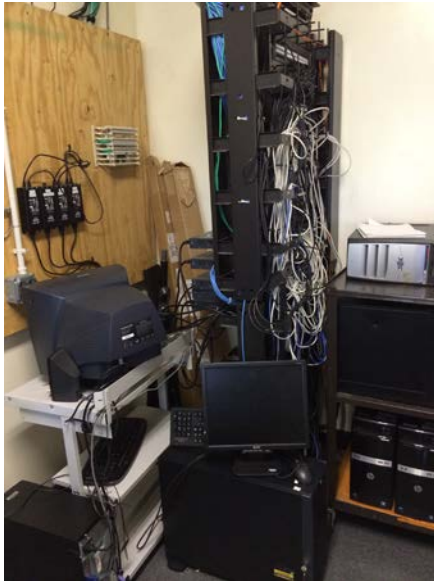
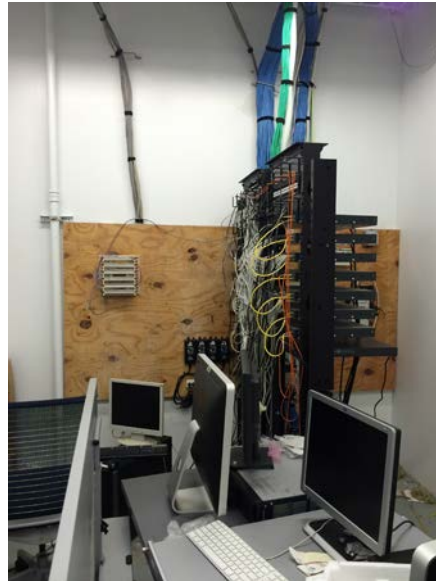
*Examples of IDFs in Original Building*

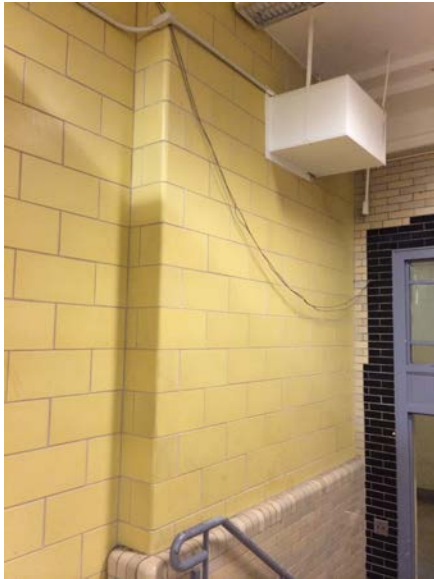
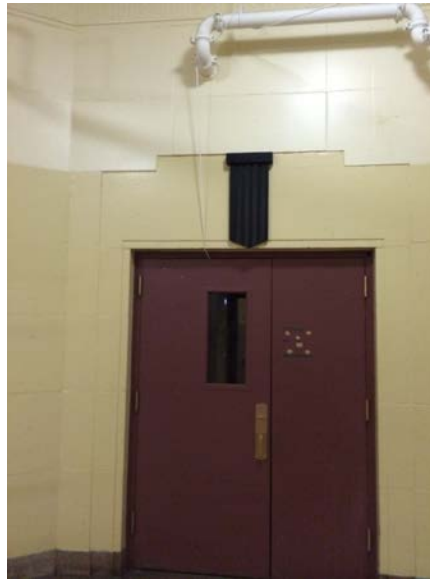
*Examples of Loose, Exposed Cables*

Remove all abandoned systems and devices, confirm long-term needs and replace systems in their entirety with District-wide policy and program.

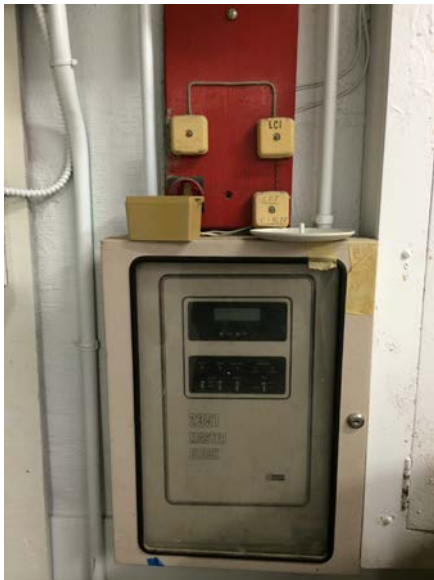
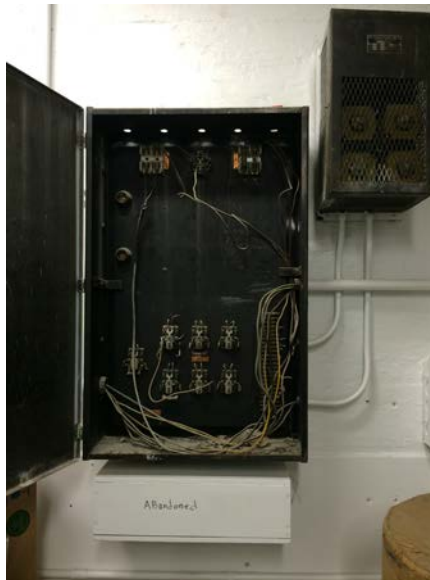
*Abandoned Systems in Main Electric Room*

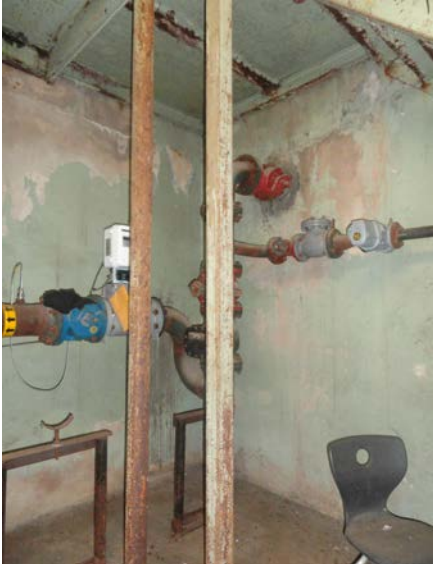
*Photo 6: Existing Gas Service*

The existing natural gas system enters the original building through the 1934 boiler room, located in the basement, via a 6 inch gas main which branches out into a 5 inch and 10 inch gas piping (Photo 6). The existing 10 inch gas piping includes a gas meter, valves, gas boosters, and gas regulator to the boilers and water heaters (Photo 7) & (Photo 8). The existing 5 inch gas piping includes a gas meter, and valves to the kitchen equipment, roof top make-up air unit and laboratory classroom gas turrets (Photo 9). Piping appears to be in fair condition.

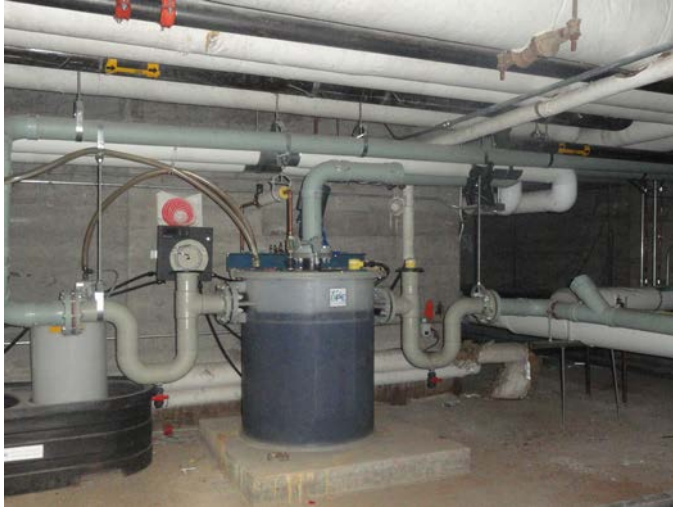
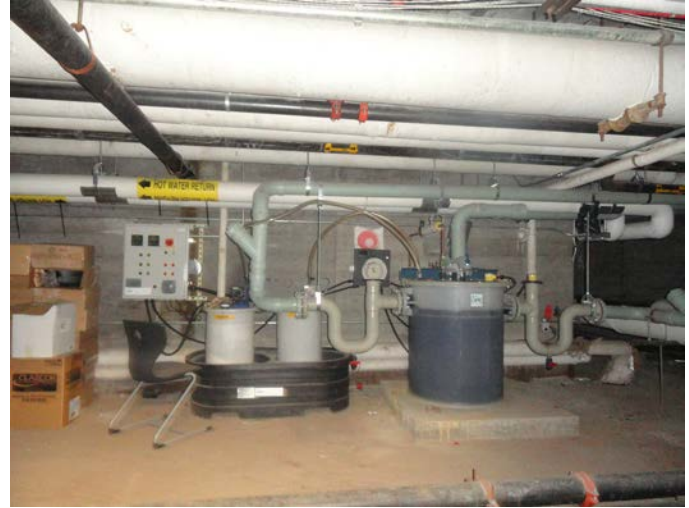
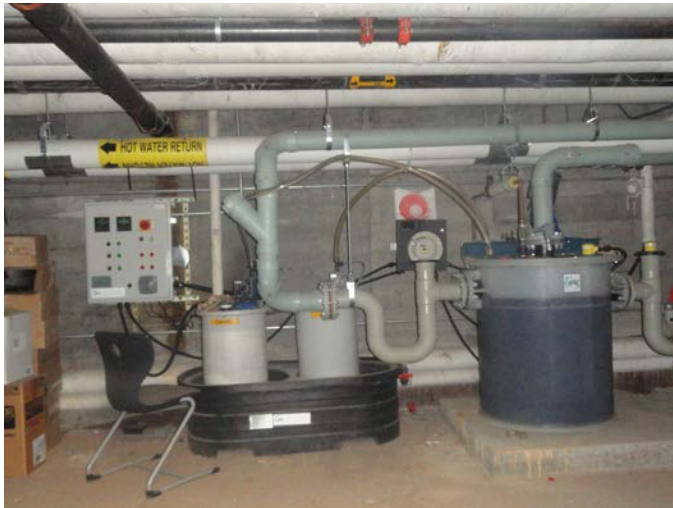
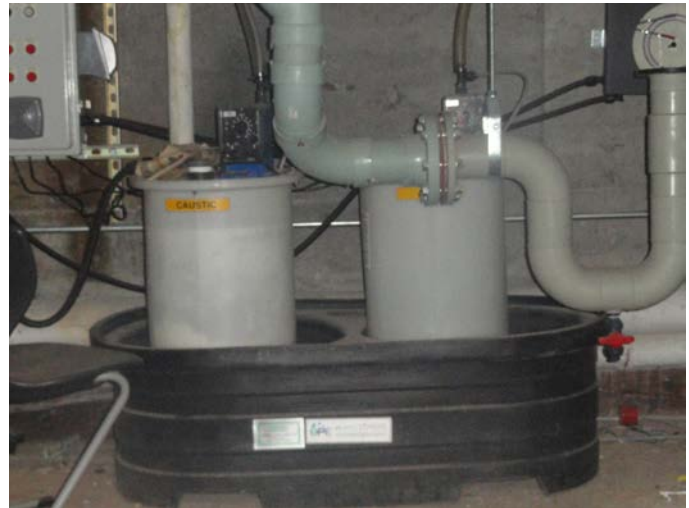
Photo 15: pH Adjustment System

The laboratory classrooms include an acid waste and vent system. A pH adjustment tank and two (2) reagent tanks are provided/installed in the crawlspace/pipe tunnel, in the original 1934 Boiler Room, to collect laboratory (acid) waste in the facility (Photo 15). pH adjustment system is in good to fair condition.

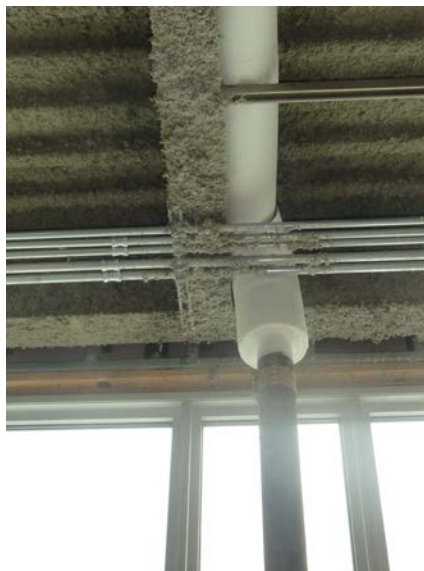
Storm piping does not have cleanouts areas and elbows are installed in the piping (Photo 18).

*Photo 18: Storm Piping*
