10 Year Facility Master Plan  
3 School Pilot Study for:

## *Boston Public Schools*

# *Henderson Lower School Report*

### **Evaluation of Existing Conditions: Henderson Lower School**

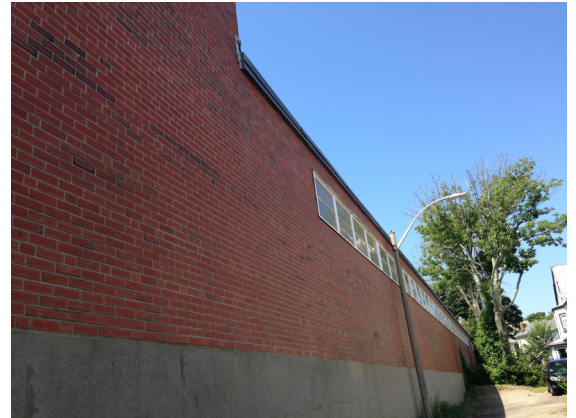
The walls are thermally inefficient. The wall is constructed of materials with good thermal mass, good moisture resistance and the mortar is generally in good condition. However there are no expansion joints and/or control joints in the exterior masonry façade.

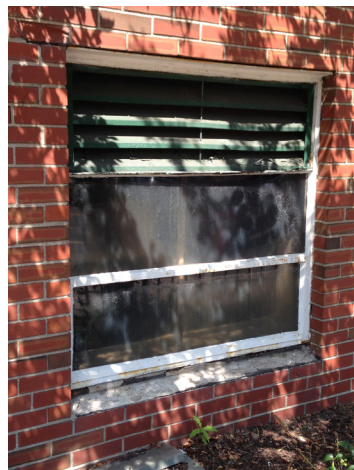
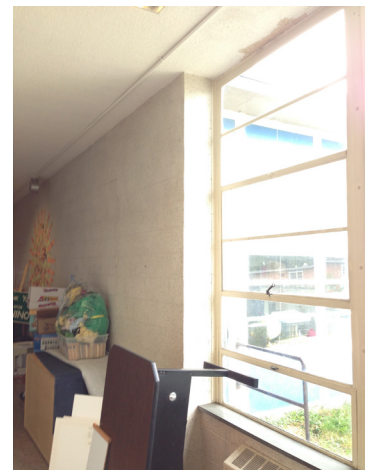
The window units have an operable hopper, awning and a fixed upper sash. All window units are without screens. The lintels are in generally good condition, even if surface rust is visible. The perimeter sealant at all window units throughout the building are in poor condition. The sash opening is more than 6" and most of the awning units do not stay open. It is a dangerous condition.

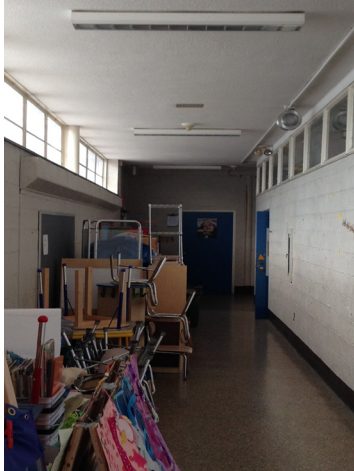
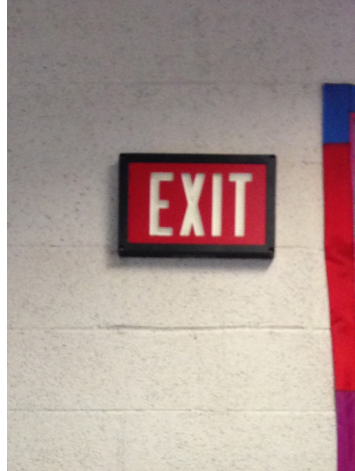
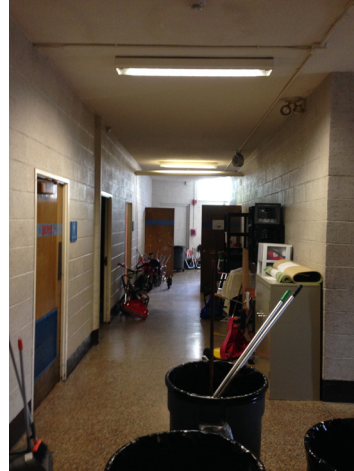
Corridor wayfinding is nonexistent for the layout and geometry of the building.

The egress signage is not placed correctly or missing. Some of the existing signs are not illuminated and do not meet code.

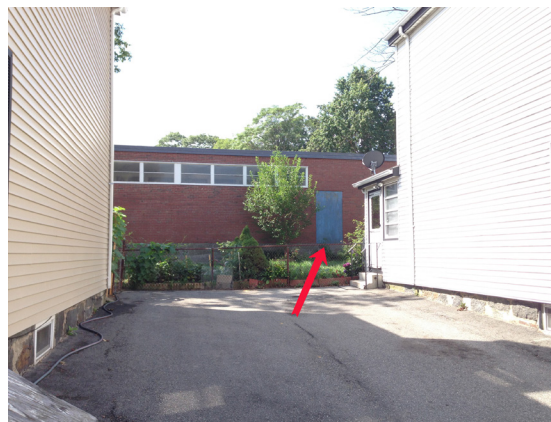
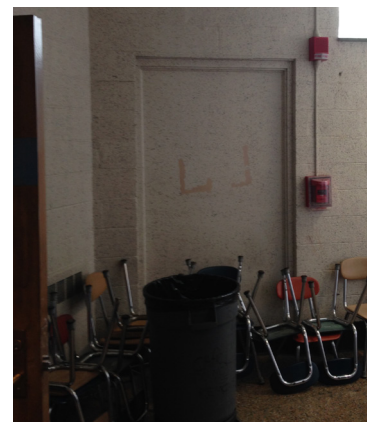
The configuration of the corridor egress system and capacity of the egress doors do not meet egress code requirements. One egress door was boarded up making the egress distance too far to comply with the code. Some of the egress doors open onto stepped landings with no ramps or areas of refuge provided.

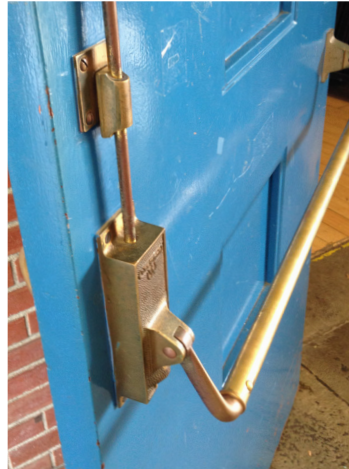
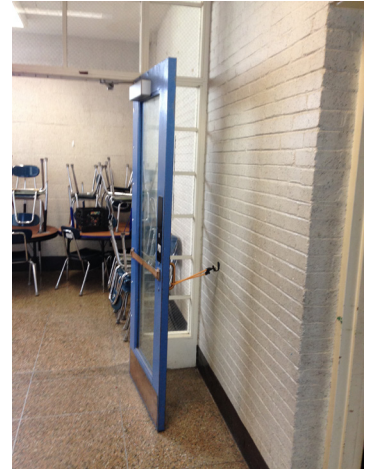
The doors and hardware are deficient in several categories. No indications were visible (labels either missing or painted over) that stair doors were labeled by UL or other testing agency for the required fire rating. In addition, almost all of the glazed doors contain wired glass which is no longer permitted as safety glazing by the current codes for educational use. Most of the classroom doors throughout the building have not been updated with new hardware or continuous hinges.

Some corridor doors are held open by floor stoppers or latches. Many of these doors have full transoms and sidelights of wired glass which is no longer permitted as safety glazing. The doors themselves have no fire rating as the label is either missing or was never labeled making these doors non-compliant for fire or smoke separation.

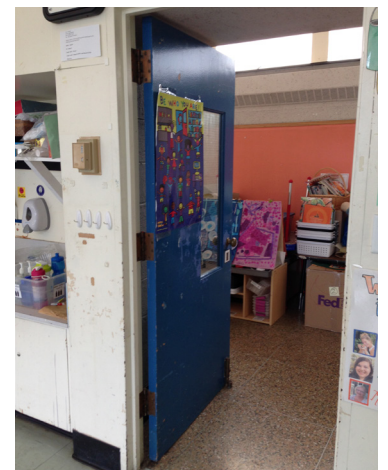
Many of the classroom entrance doors are without the necessary side maneuvering clearances required to meet accessibility code.

There are a number of projections in rooms and corridors along the accessible path that do not meet the 4" maximum projection rules under the MAAB. These conditions pose a hazard to vision-impaired students and teachers.

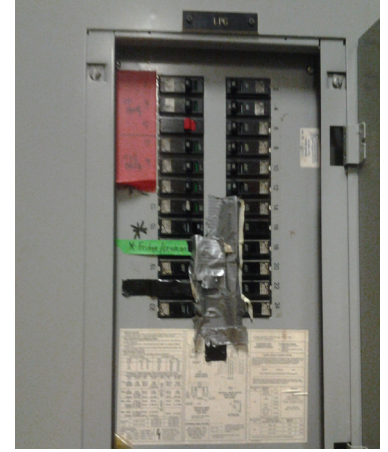
Photo 5: Example of old panel in unacceptable condition, Auditorium stage

Old distribution panel and original panelboards found in fair condition with associated power feeders from the old distribution panel are recommended for replacement. The panels observed to be in unacceptable condition need immediate repair or full replacement.

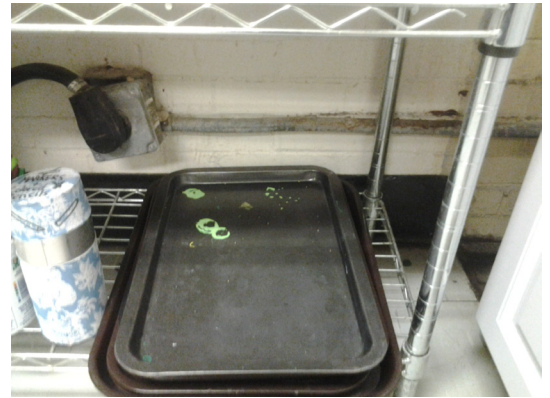
Duplex receptacles in the Cafetorium (Cafeteria/Auditorium) server area were found to be of a regular non-GFCI type which violates the latest Electrical Code installation requirements. In addition, the surface-mounted conduits and outlet boxes associated with server area receptacles are showing rust (photo 6).

Photo 6: Example of receptacle installation in server area

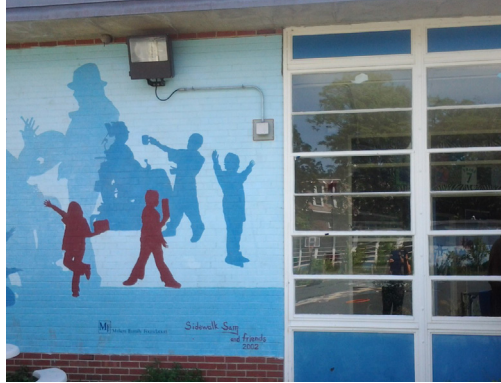
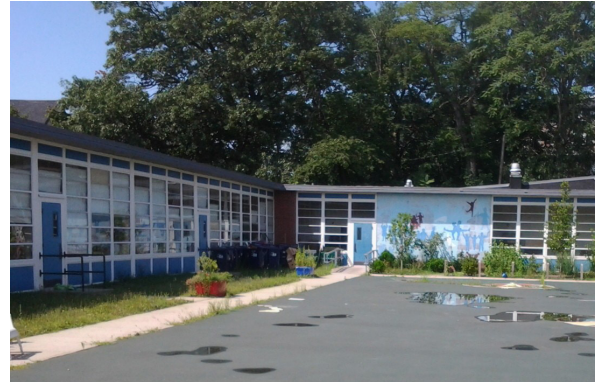
Photo 12: Existing courtyard lighting

Repair and/or replace existing not-operational lighting fixtures. Add lights near doors. Provide proper lighting controls including photocell and time clock.

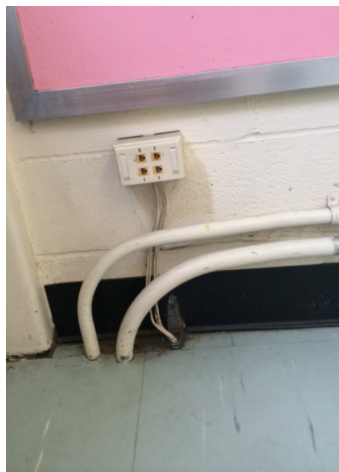
There are numerous locations where low voltage wire is exposed, obsolete wall mounted devices are damaged with exposed wires, and unused back boxes are not covered, leaving them open to rodents, insects or tampering.

*Exposed low voltage cabling*

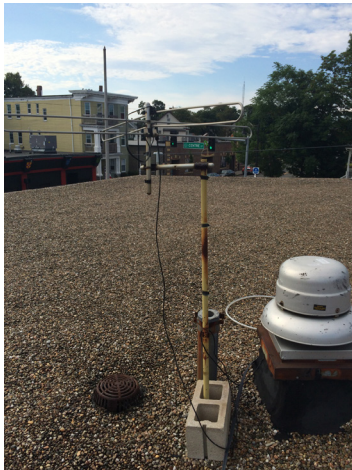
There are two antennas and a cable TV trunk cable on the roof. All three systems have been abandoned in place.

*Abandoned roof mounted antenna*

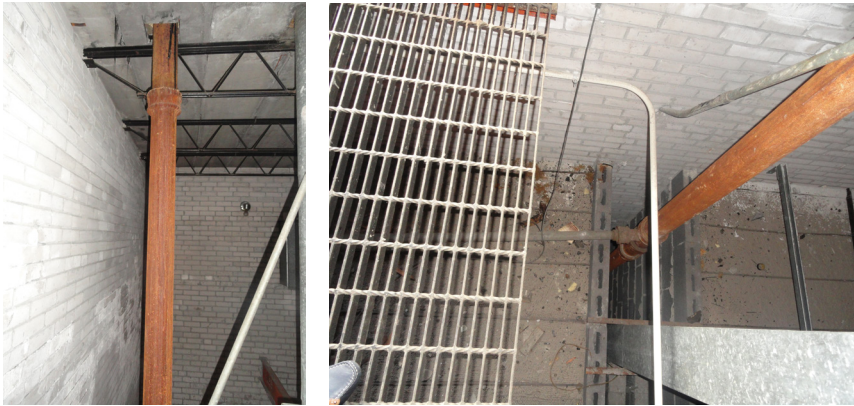
Photo 8: Rusted vent piping

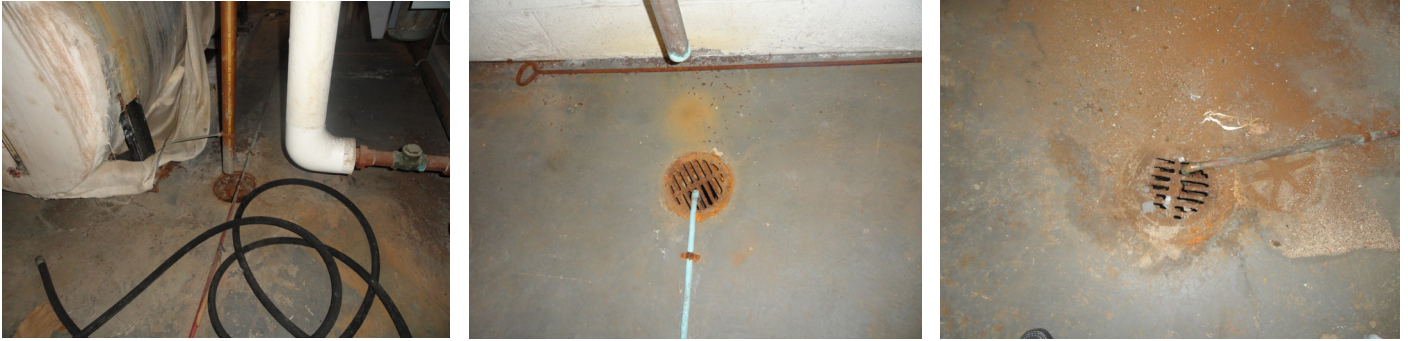
Photo 11: Rusted and deteriorating floor drain covers

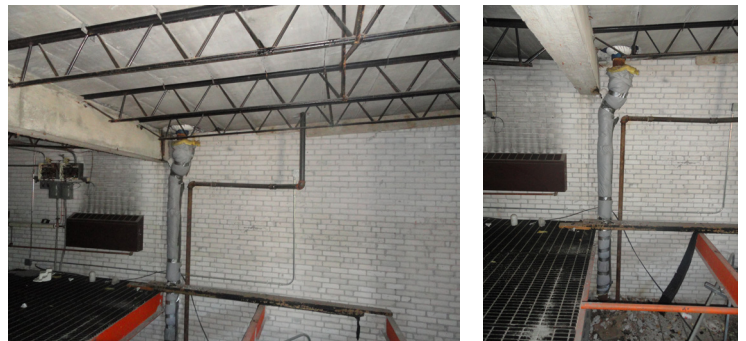
Photo 12: Storm piping with poor insulation

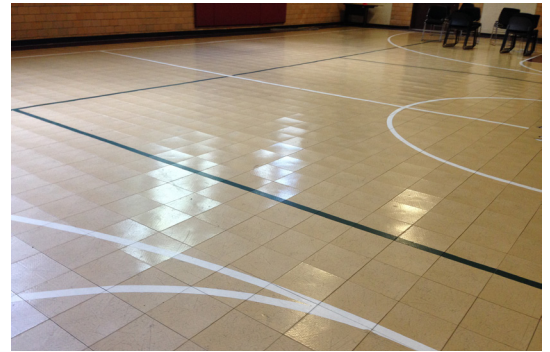
The main entry and corridors are original terrazzo and in good condition. In most classrooms the floor is a 12" x 12" vinyl and in good condition or wood strips and also in good condition. The auditorium is sealed concrete under the seats and vinyl tile in the travel areas - both in good condition. Wood floor at the stage is in good condition. The Gym has experienced flooding in the past and the original wood floor was destroyed. In its place is an unknown type of 12"x12" synthetic tile that is cupping and in poor condition.

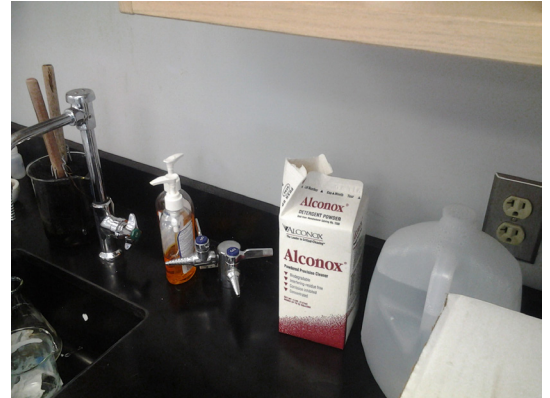
Photo 5: Example of non-GFI receptacles near sinks in science labs

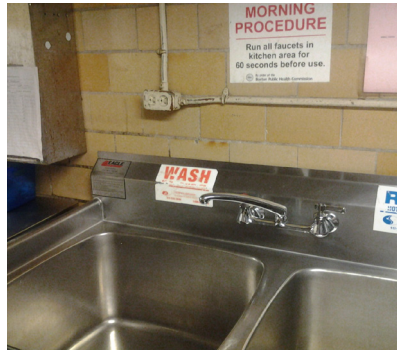
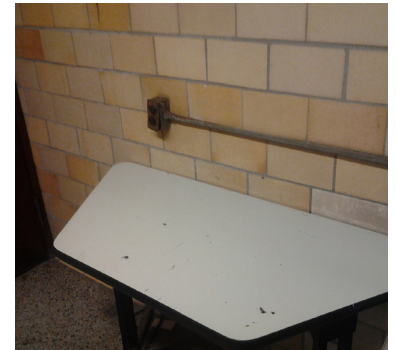
Duplex receptacles in the kitchen areas are old (some may not be functioning/broken) and non-GFCI type as required by the latest Electrical Code (photo 6).

Photo 6: Example of non-GFI receptacles in the kitchen areas

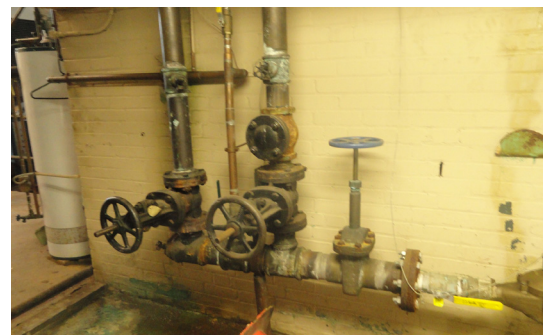
*Photo 3: Leaking cold water riser*

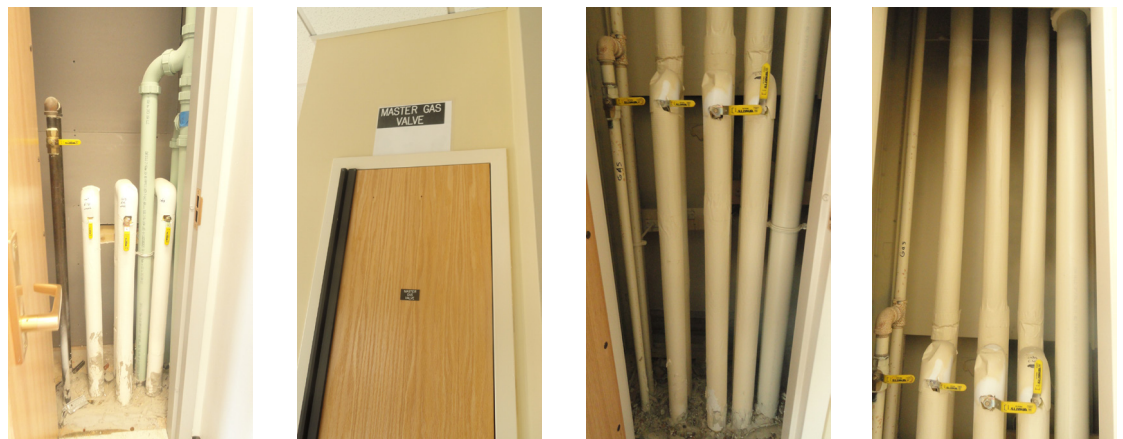
Photo 16: Pipe insulation in poor condition
