10 Year Facility Master Plan  
3 School Pilot Study for:

## *Boston Public Schools*

Boston, Massachusetts

### Evaluation of Existing Conditions: Mario Umana Academy

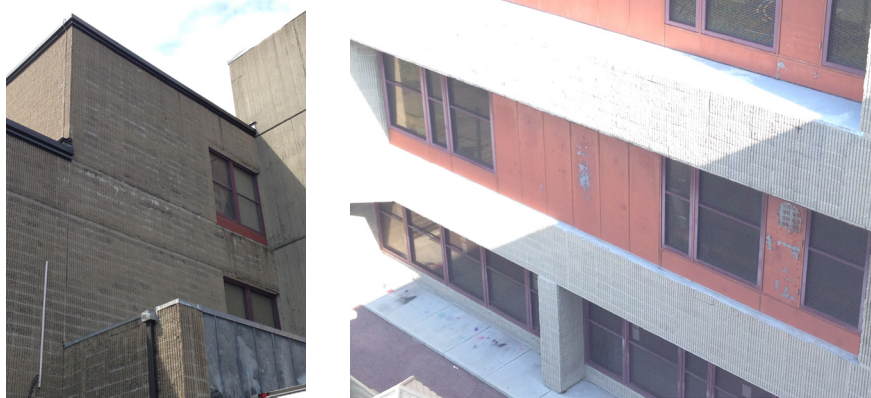
#### Exterior Walls

The exterior walls are a combination of steel studs with brick veneer, Poured concrete with

brick veneer, CMU backup with metal panels and curtain walls. The stair towers are formed reinforced concrete.

The the mortar is generally in good condition. In general, sealant at all joints are in need of replacement, particularly at building expansion joints. There were no control joints noted in the exterior masonry walls, however the expansion joints were noted to have missing or deteriorated seals that require replacement.

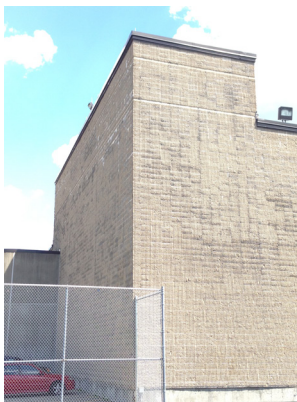
The north and east face walls show signs of efflorescence and a dark discoloration.

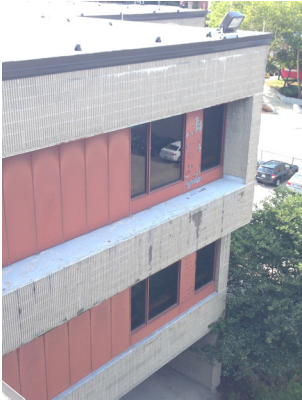
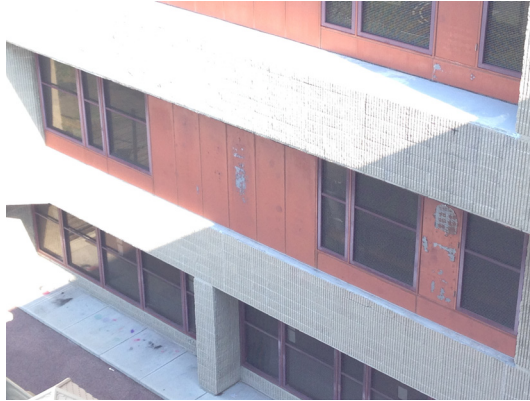
## Exterior Windows/Louvers

The various original windows and replacement windows are aluminum double glazed fixed windows with a few operable awning window units. The lintels are in generally good condition, even if surface rust is visible. The perimeter sealant at all window units throughout the building is in fair condition. Old sealant needs to be removed from the masonry. Window sills are in poor condition. Some of the replacement windows have a different tint from the original unit's glazing. The exterior panels and trim on the surface on the original windows are losing their finish.

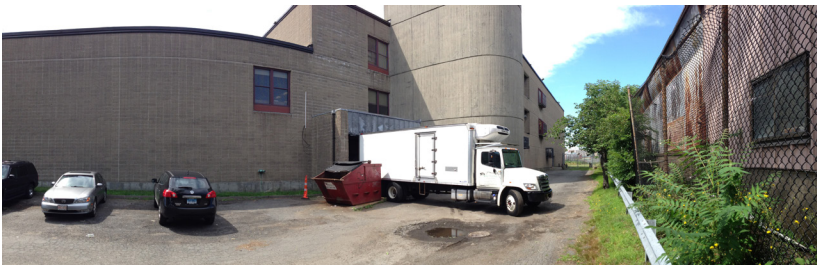
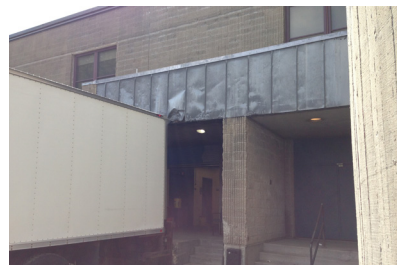
## Loading Dock

Space provided at the loading dock in its current configuration is adequate. The turning radius for delivery trucks is too narrow. The overhang covering the dock is too low for standard box trucks and has been damaged in the past.

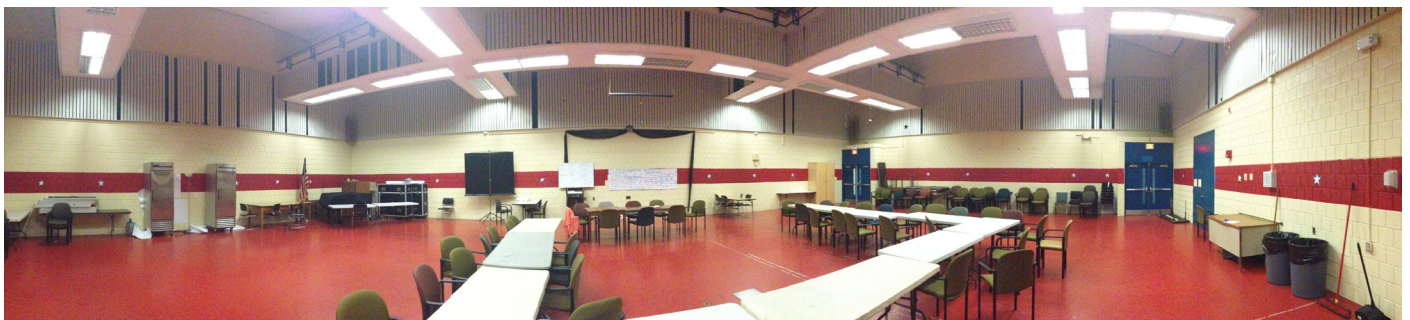
The partitions at the gymnasiums and locker rooms are painted or bare CMU or GCMU. The kitchen walls are painted CMU throughout. Cafeteria walls are painted CMU. The auditorium walls are painted CMU with acoustic fiber panels around the upper part of the auditorium.

Library walls are gypsum wallboard, glass and wood.

Generally, all walls are in good condition. The masonry walls do not exhibit any cracks or signs of structural movement.

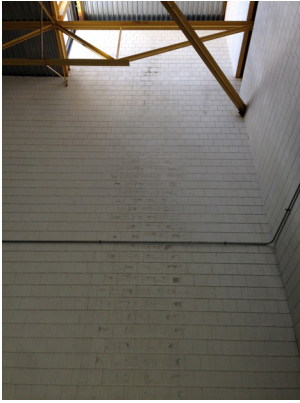
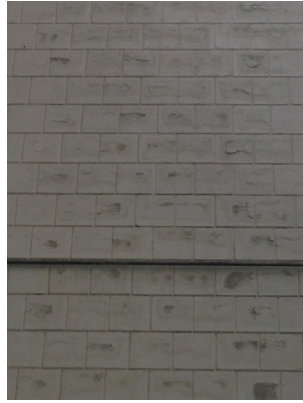
The interior pool walls show signs of water and humidity damage.

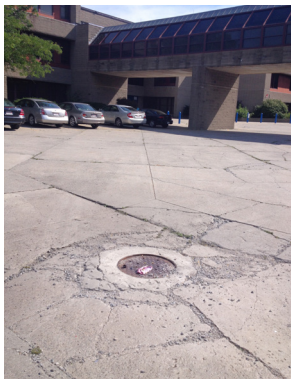
The site drainage is in poor condition. Most of the catch basin grates have been replaced with steel plates that limit flow, causing ponding. The ponding water has infiltrated around the catchbasins, undermining the subsoils, which cause the pavement to settle and crack. The catchbasins also appear to be settling, and should be inspected. No water quality structures were found on site. No stormwater systems to reduce runoff volume or rates were found on site.

*Failed catchbasin*

- Flood study of building and egress, and analysis of the risk of sea level rise and strategies to adapt.
- Install standard grates on catchbasins.
- Reconstruct sub base and repair courtyard.
- Mill and overlay north side parking lot and replace berms.
- Selective Border Street sidewalk panel repair.
- Repair basketball court crack.
- Study athletic field failures.
- TV sewer and drain systems to assess condition.

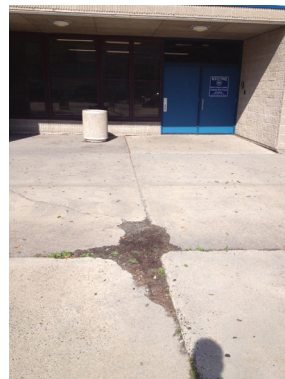
The pedestrian walkways and sidewalks are mostly in fair condition. The planters and other hardscape is also in fair condition. They all require some maintenance and weeding to continue serviceable condition. The sidewalk along Border Street does have some major cracking and settlement that have created 1" to 2" lips that create tripping hazards and impact ADA accessibility.

*Poor sidewalk*

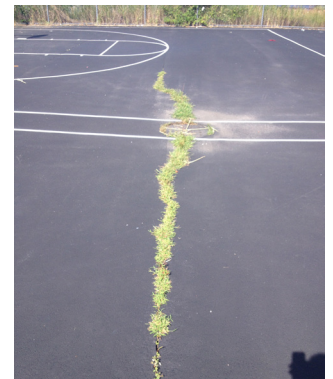
The asphalt play courts and playground are in good condition. The basketball court has one major crack adjacent to its catchbasin. This crack should be filled, and the catchbasin cover should be replaced with a standard grate.

*Basketball crack*

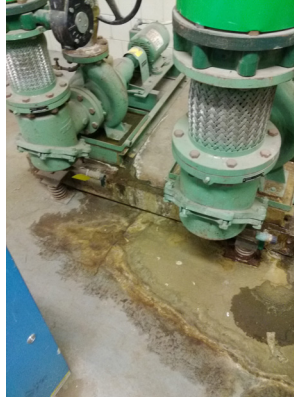
There are two (2) primary and two (2) secondary hot water pumps. All hot water pumps are leaking.

*Hot water pump leaks*

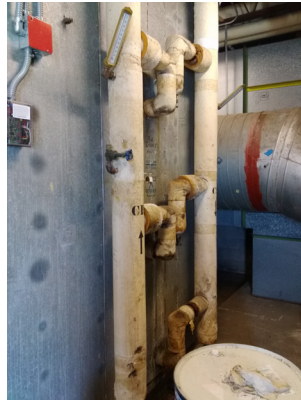
Piping insulation is damaged throughout. The valves and other appurtenances on piping in the penthouses appear corroded and non operational.

*Piping damaged insulation*

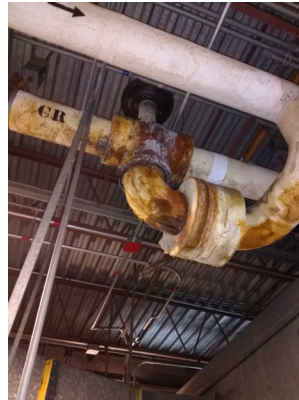
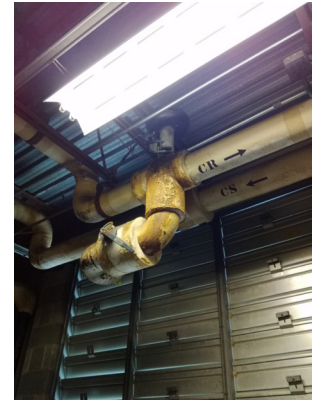
There are leaks at multiple locations on piping, including but not limited to the valves, piping connections and at the gauges/sensor inserts, etc. As a result there is a lot of rust/corrosion on all piping.

*Control valve leaks*

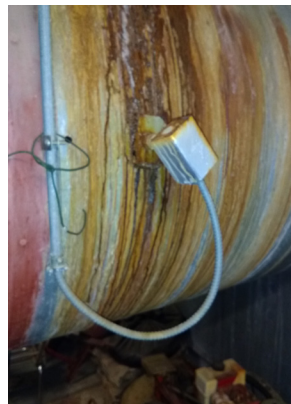
The ductwork is leaking at multiple locations, including but not limited to the ductwork connections, at the gauges/sensors inserts, etc. The ductwork insulation is either damaged or missing.

*Non-insulated ductwork leaks*

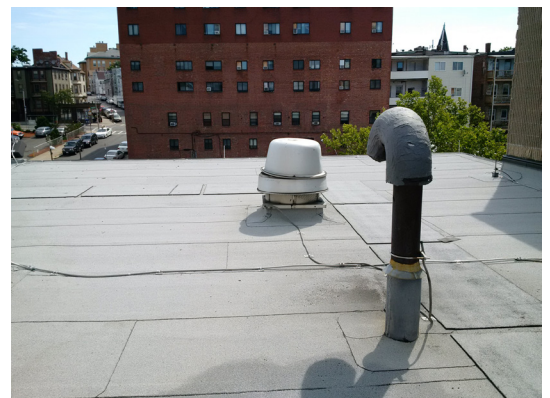
Roof exhaust fans are original to the building. Some fans do not appear to be operational.

*Exhaust fan on roof*

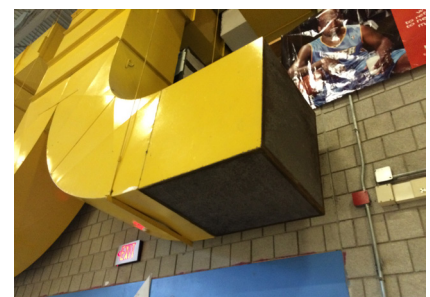
Gym return registers are dirty (blocking air movement) and require replacement.

*Gym return registers*

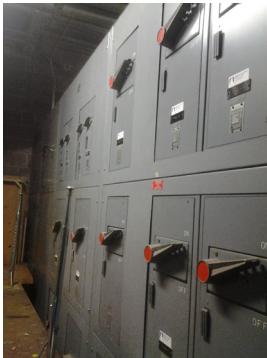
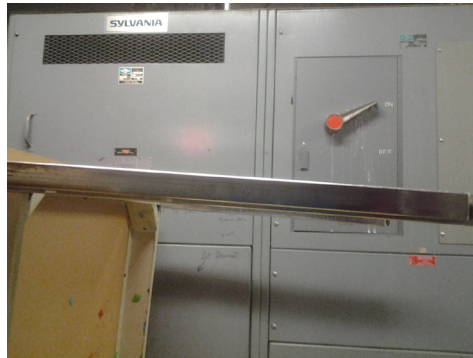
*Existing main switchboard*

The main switchboard is recommended for replacement. Existing main electrical room shall be cleared to provide the required Code maintenance clearances. All original panelboards, both at 480/277 volt and 120/208 volt systems, installed throughout the building and associated power feeders from the main switchboard are recommended for replacement. Those panels that are observed to be in a poor condition (broken/missing circuit breakers, open/missing covers, observed and/or estimated quantity - about ten total) need immediate repair or full replacement.

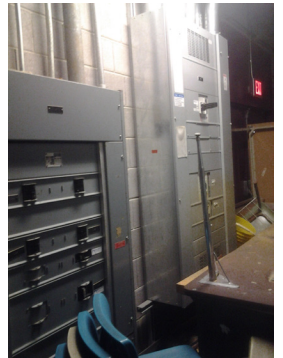
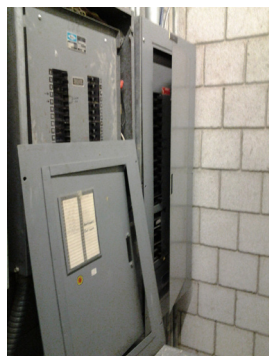
*Examples of original panelboards in poor/failing condition*

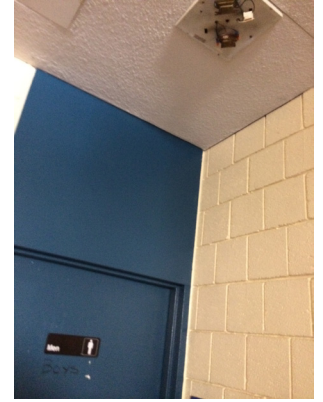
*Damaged motion detectors*

Motion sensors are distributed in corridors to detect intrusion. It was noted that some devices are damaged.

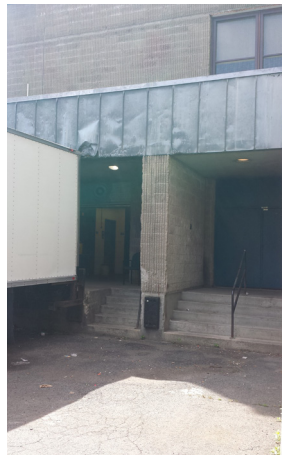
*Potential hideout in recessed area at loading dock*

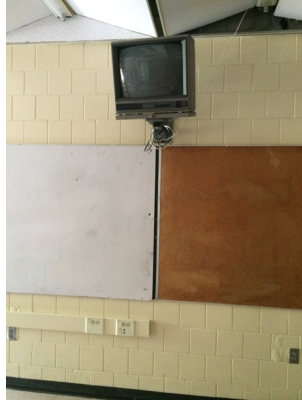
*Computer lab exposed power  
and network cables  
(Note: data/power poles)*

Classrooms are equipped with small CRT television monitors that appear to no longer serve an educational purpose. Cable television programming is not distributed in the building.

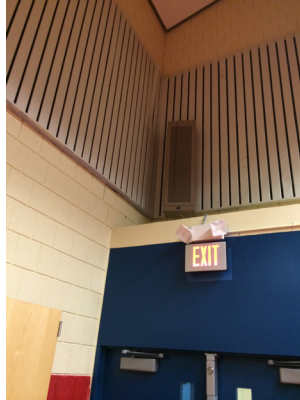
The paging system is outdated, does not provide adequate coverage and reaching the end of its service life.

*Classroom television*

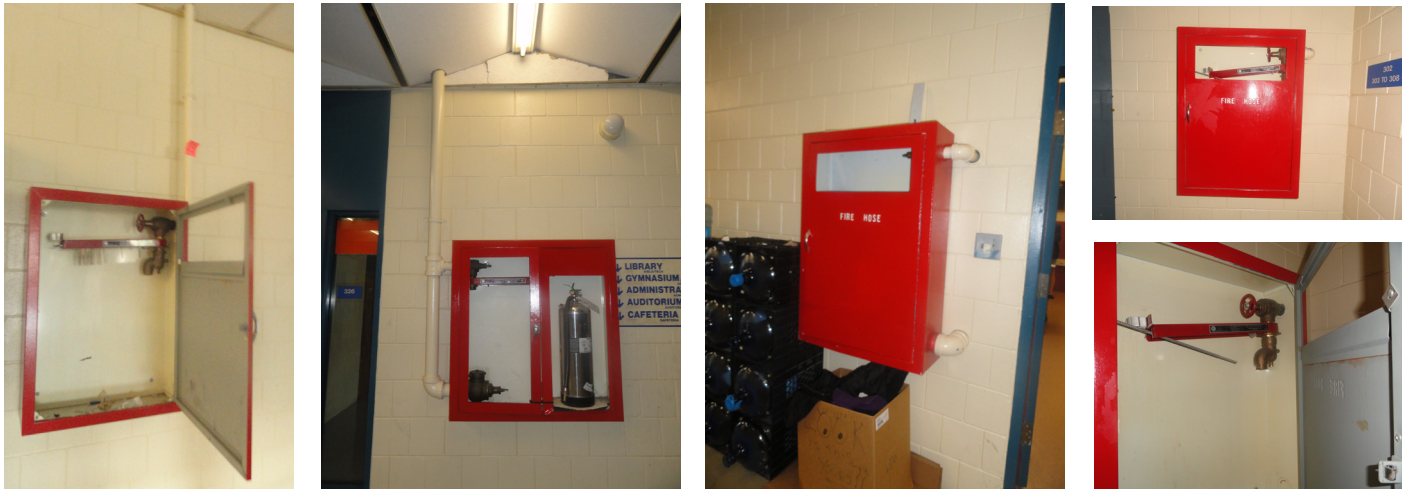
There is no wet sprinkler system in the buildings but there are existing surface mounted fire hose cabinets and standpipes which are installed throughout the buildings. However, the fire hose connections were removed a number of years ago (photo 1). Existing fire department connection test headers are located outside of storage room (photo 2).

Photo 1: Existing fire hose cabinets

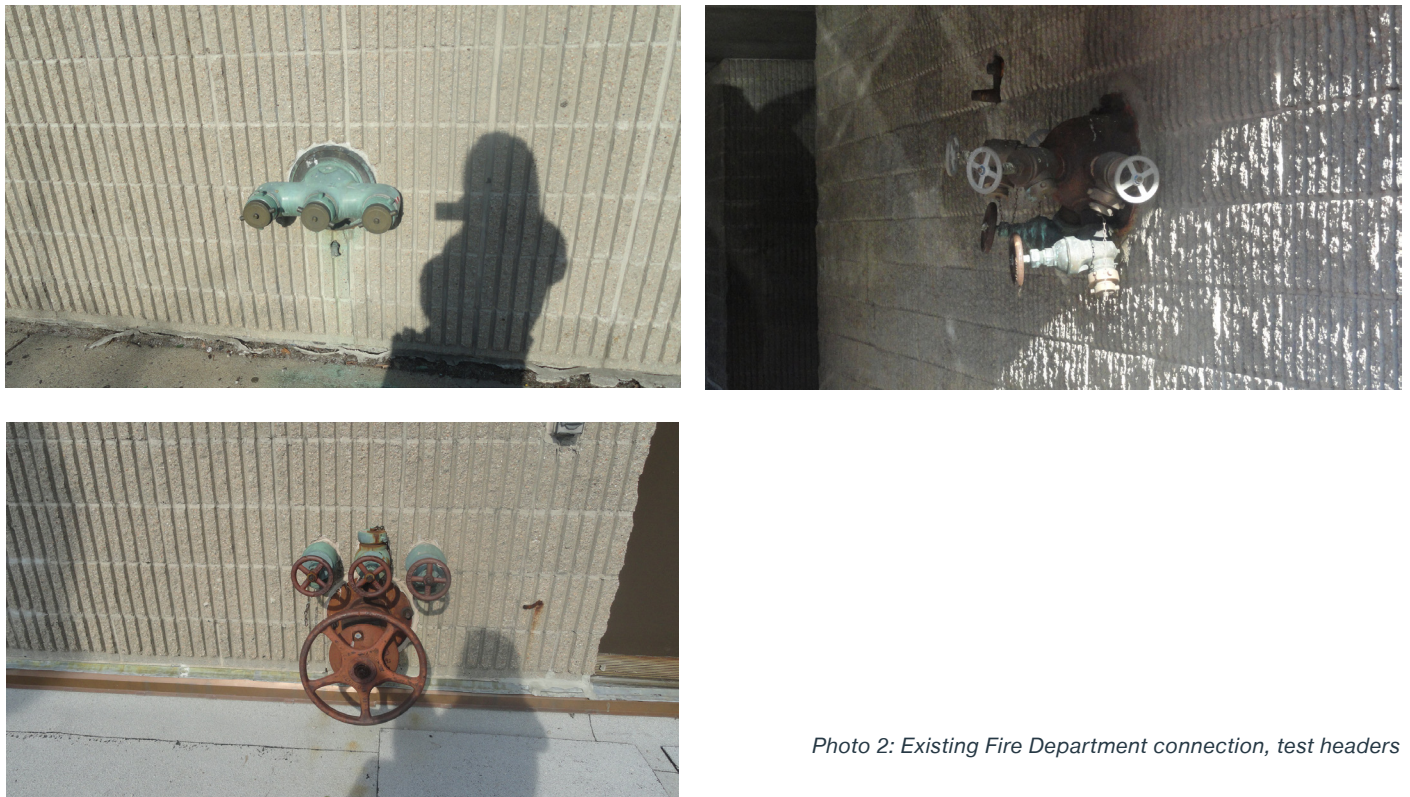
Photo 2: Existing Fire Department connection, test headers

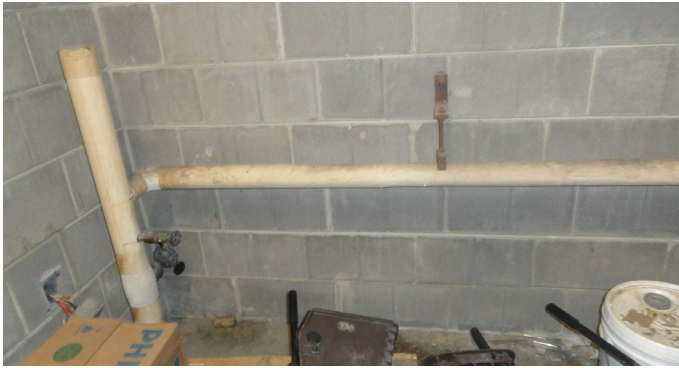
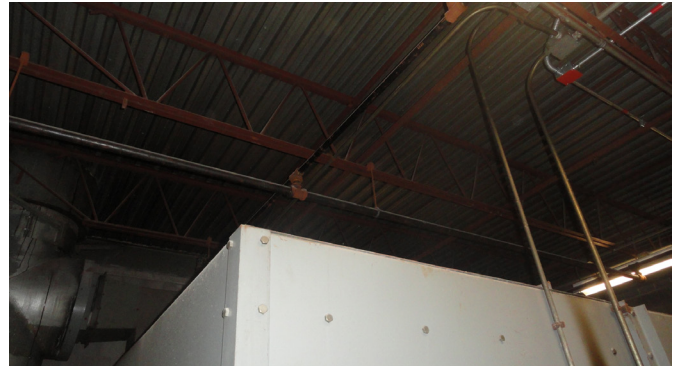
There are existing sprinklers, branch piping and other components in mechanical room 402, formerly the incinerator room, but they are not operational. There is no double check valve assembly installed and the fire protection riser is connected to a domestic water with pipe insulation (Photo 3). The fire protection components are not wired or disconnected electrically. The wiring is exposed and not secured (Photo 4). There is an existing fire hose cabinet and standpipe but the fire hose connection was removed a few years ago. The cabinet is not readily accessible or obstructed by a table and boxes of things stored in front of it (Photo 5). There is also an existing fire hose cabinet and standpipe in mechanical room 400 but the fire hose connection was removed.

*Photo 3: Existing fire protection system in Mechanical Room 402*

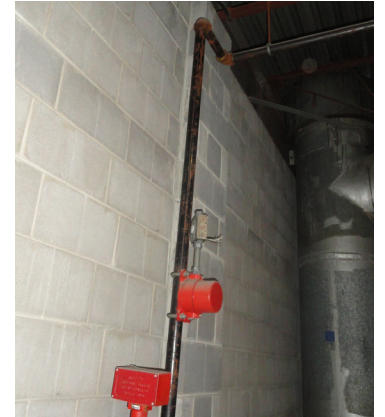
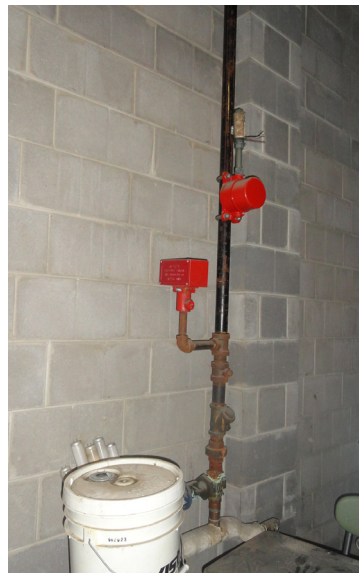
*Photo 4: Fire protection components that are not wired*

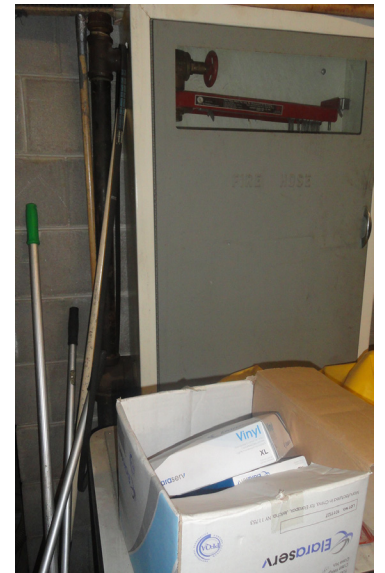
*Photo 5: Inaccessible fire hose cabinet*

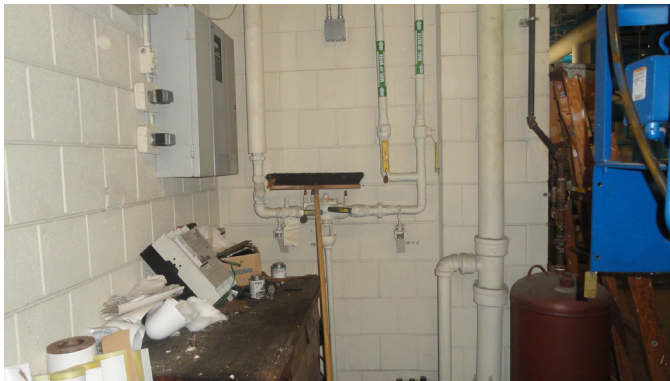
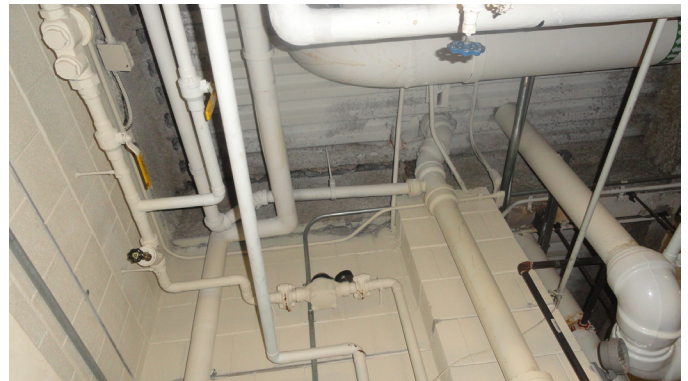
There is an existing backflow preventer and a separate water meter in the boiler room for HVAC make-up, non-potable cold water system (see Photo 1).

Photo 1: RPBP and Water Meter for HVAC Make-Up

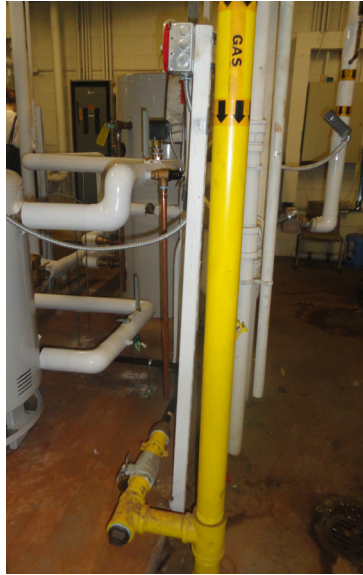
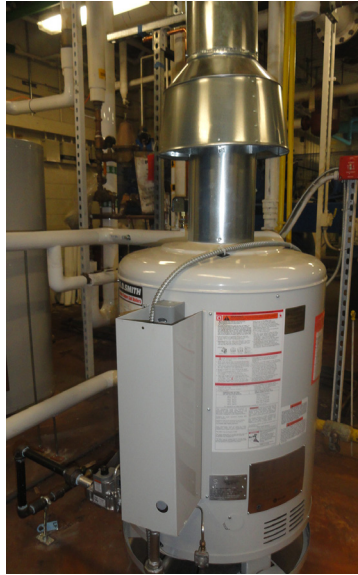
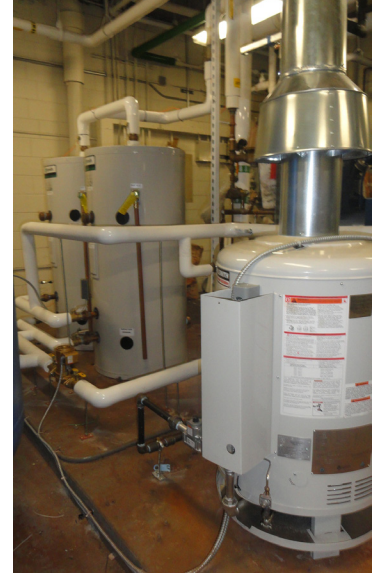
The gas-fired water heater, manufactured/built in 2015, is located in the boiler room, and in excellent condition. Domestic hot water system also includes two (2) 120 gallon glass-lined storage tanks, in excellent condition, and one (1) thermal expansion tank, in good condition. Hot water is circulated from hot water distribution loops by pumps in the boiler room (see photo 2). The gas-fired water heater and storage tanks were replaced early this year (2015). Valves and piping appear to be original. However, some PVC jackets and pipe insulation were damaged and stained. Some piping is not insulated (see photo 3).

Photo 2: Gas-Fired Water Heater, Storage Tanks, Expansion Tank and Circulation Pump

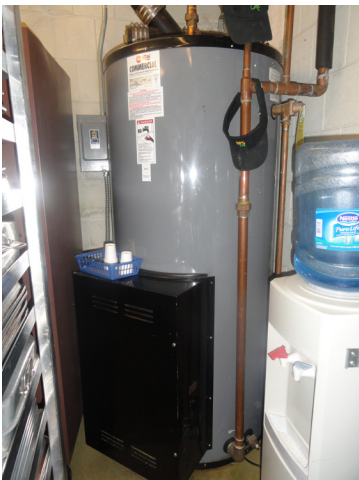
The other water heater is a 120 gallon electric water heater located in room 162 and serves the kitchen. It was installed more than 16 years ago and it has exceeded its warranty. The electric water heater is not expected to last more than 10 years without exhibiting problems and possible failure (see photo 4).

*Photo 4: Electric water heater*

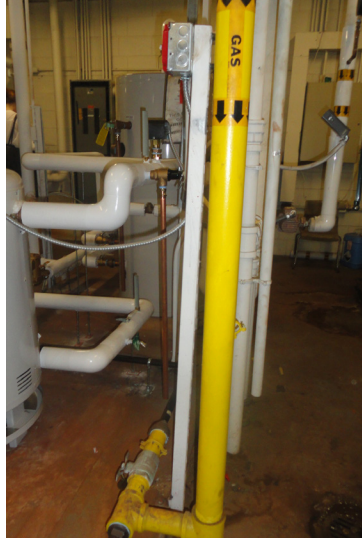
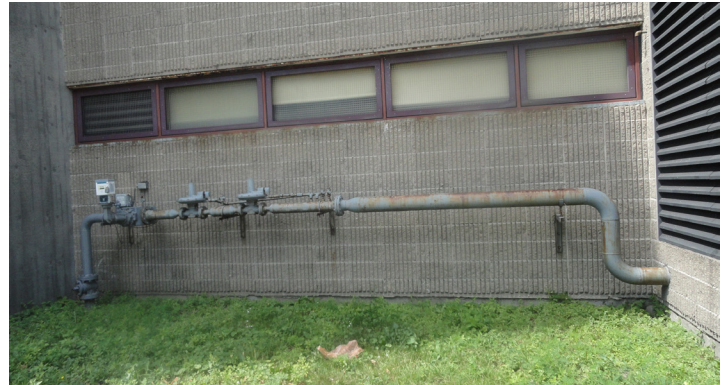
The existing natural gas system enters the building through the service/mechanical room located on the first floor. The existing gas piping includes a gas meter, valves, and gas regulators (see photo 5). Gas is distributed throughout for the kitchen equipment, water heaters and gas boilers. Piping that is visible appears to be in fair condition and should last 10 more years.

Photo 5: Gas Service, Gas Meter and Piping

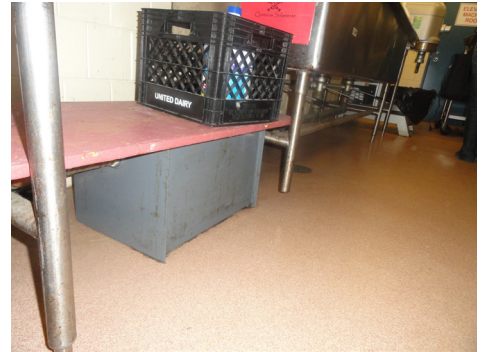
The kitchen's triple pot sink is provided with above slab grease trap. A piece of wood is placed on top of the grease trap which is used as a shelf (see Photo 6).

Photo 6: Grease trap at triple pot sink

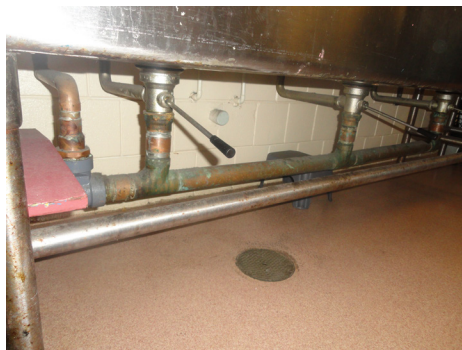
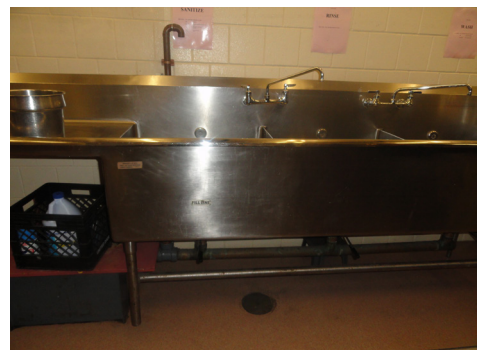
Piping installation at triple pot sink is not code compliant (see photo 7).

Photo 7: Waste Piping Installation at Triple Pot Sink

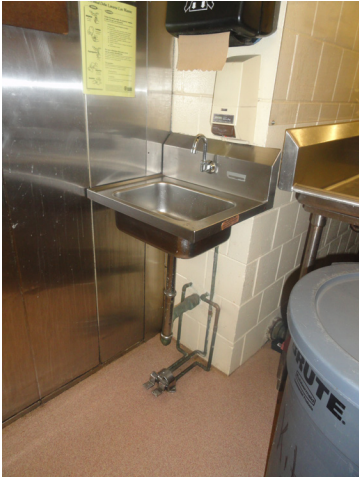
Hand Sinks are not ADA compliant and piping is not insulated (see photo 8).

*Photo 8: Hand sink*

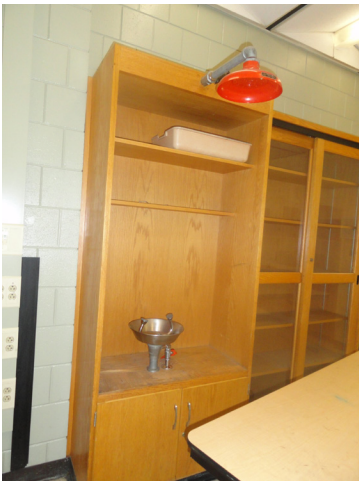
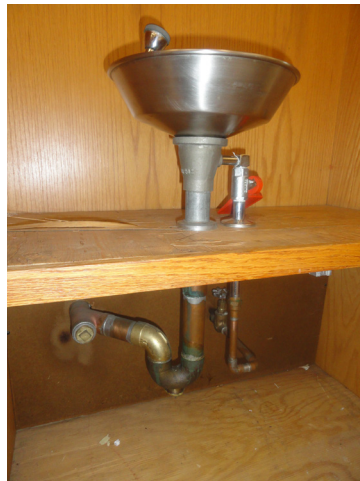
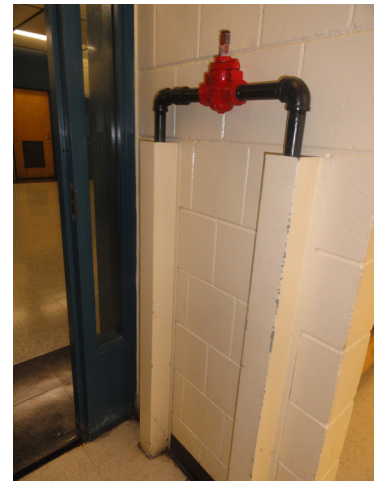
There is an existing non-ADA emergency shower/eyewash that is no longer operational in computer lab room 225 (formerly science lab) (see photo 9).

*Photo 9: Non-ADA, not operational Emergency Shower/Eyewash*

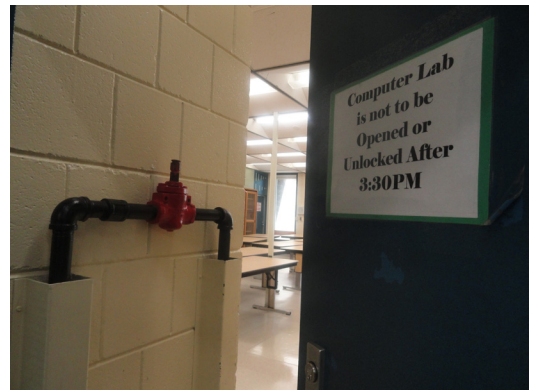
There is existing exposed gas valve and piping in computer lab room 225 (formerly science lab). This installation is not code compliant (see photo 10).

*Photo 10: Exposed gas valve*

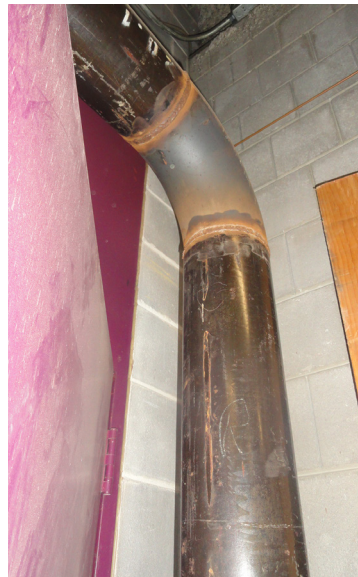
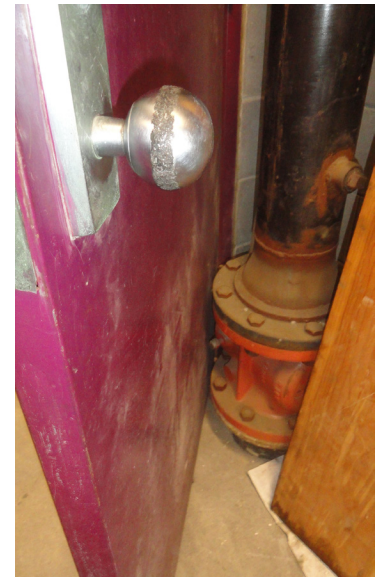
An existing pipe with a valve is installed behind a door and the pipe prevents the door from opening/swinging fully (see photo 14).

*Photo 14: Pipe Installed behind a door*

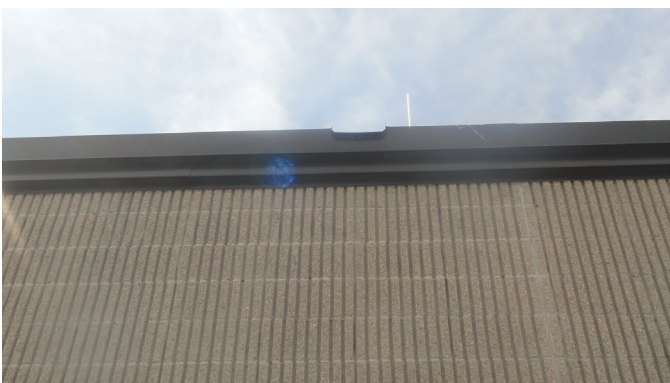
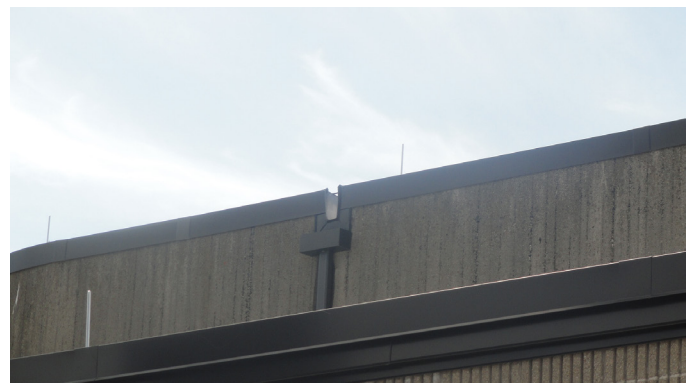
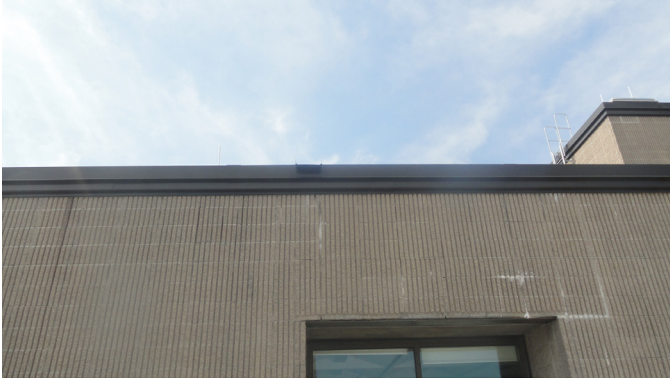
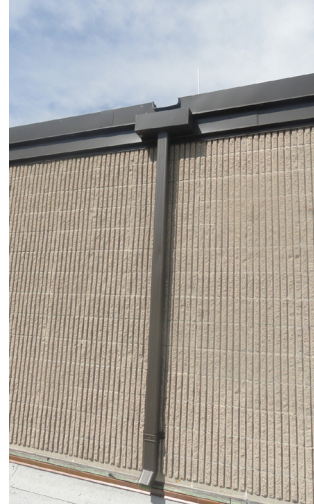
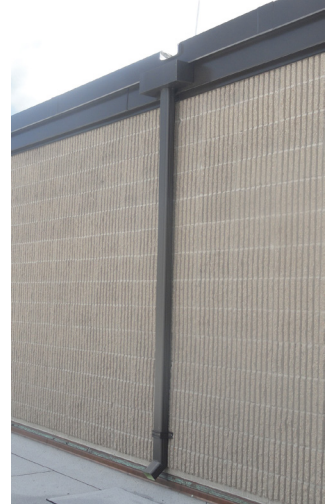
Scuppers are installed around the perimeter of the high roofs. Some areas have downspouts, others don't (see photo 15).

*Photo 15: Scuppers and Downspouts*

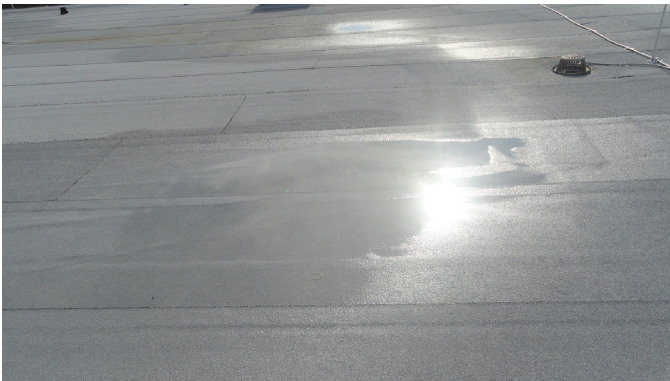
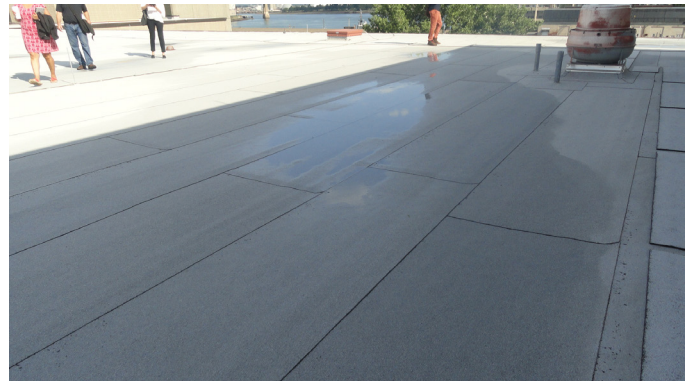
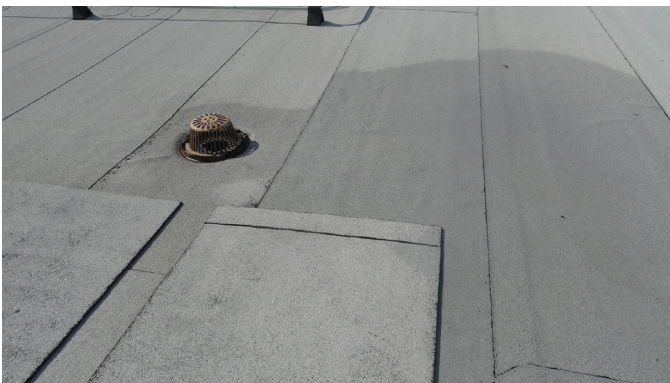
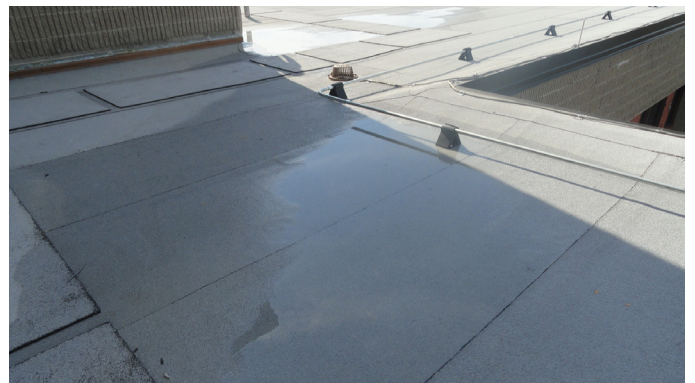
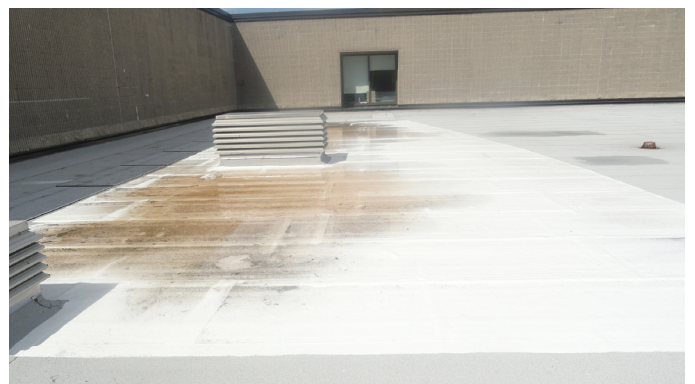
There are major ponding issues on the roof (see photo 16).

*Photo 16: Ponding Issues on the roof*

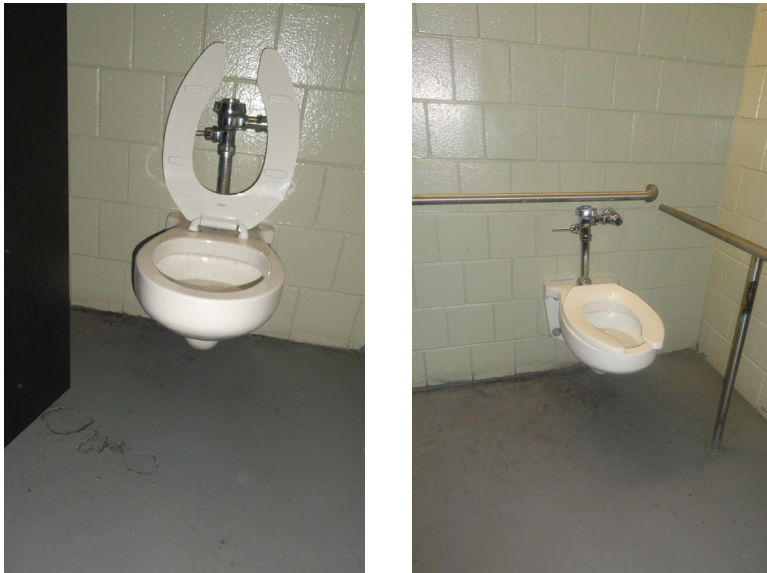
Water closets are primarily wall mounted with manual flush valves, generally in fair condition (see photo 17).

*Photo 17: Existing Water Closets*

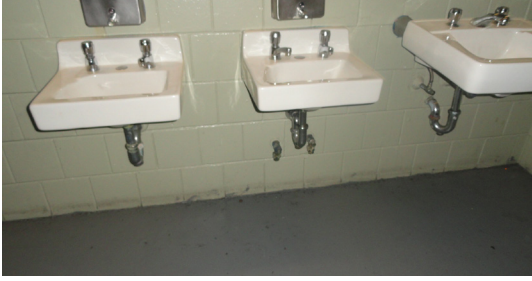
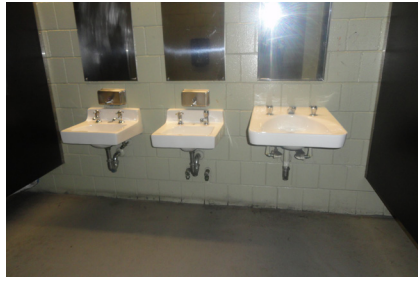
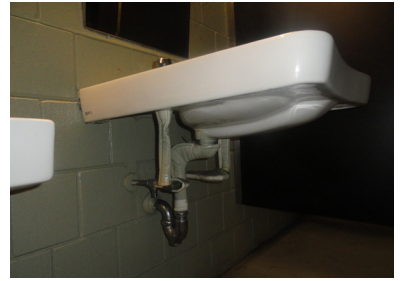
Pipe insulation installed in some lavatories are not pre-formed type (see photo 18).

Photo 18: Existing lavatories

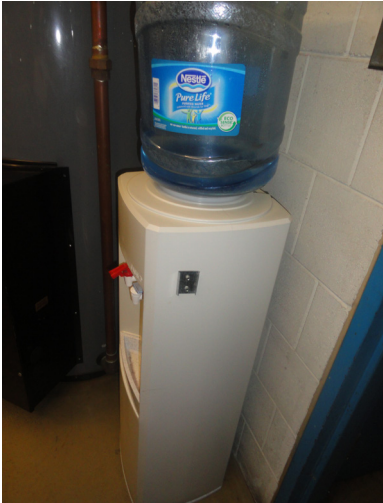
Bi-level electric water coolers are not installed in Buildings A and B. Potable water cooler dispensers are used throughout the entire facility (see photo 19).

Photo 19: Existing Water Dispenser

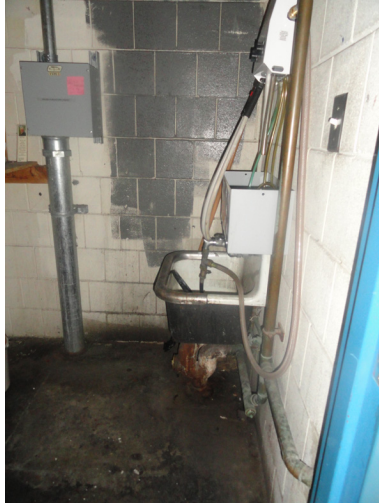
An existing mop receptor is in poor condition (see photo 20).

Photo 20: Existing Mop Receptor

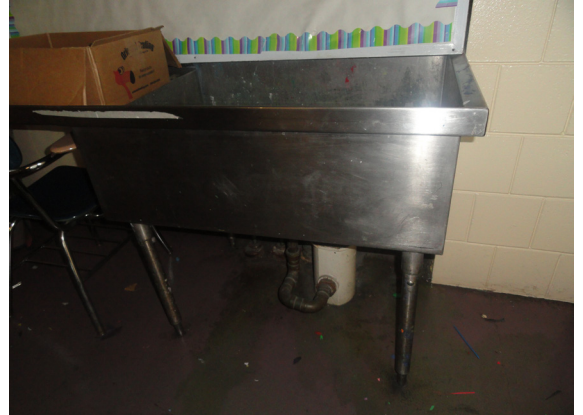
The sink installed in the art room is non-ADA compliant and is in fair condition (see photo 21).

Photo 21: Existing Art Room Sink

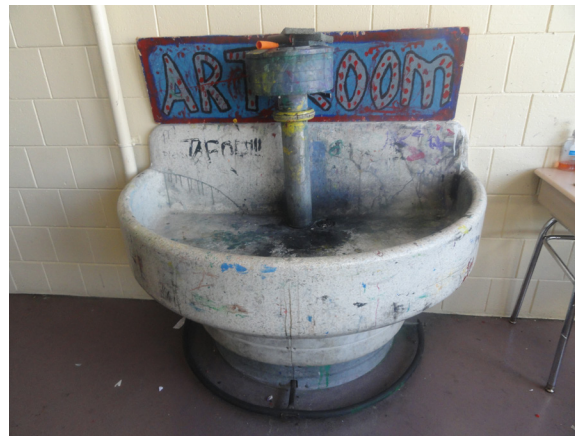
The warewasher installed in the art room is in poor condition (see photo 22).

Photo 22: Existing Warewasher in Art Room

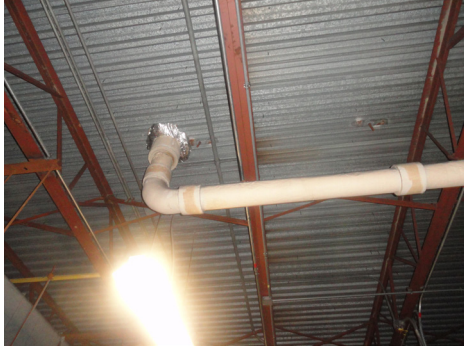
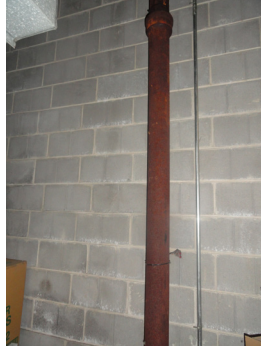
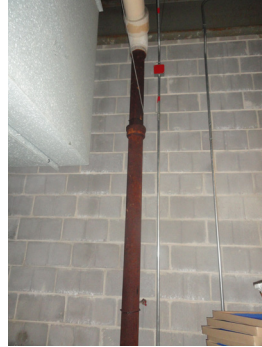
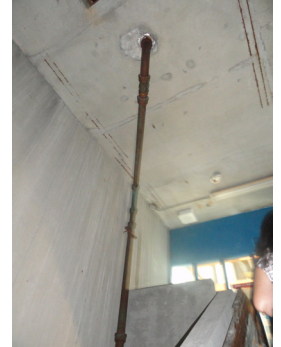
An existing storm pipe in the penthouse is rusted/corroded, in poor condition. The piping is not expected to last more than ten (10) years without possible failure. The pipe insulation is stained and in poor condition (see photo 25).

An existing pipe in the Stairwell to Penthouse is rusted/corroded (see photo 26).

*Photos 25: Existing rusted/corroded storm piping*

*Photos 26: Existing rusted/corroded piping*

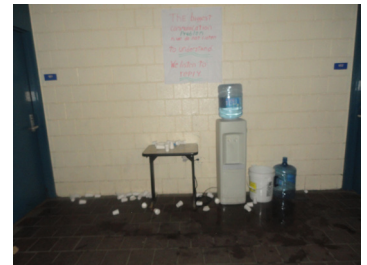
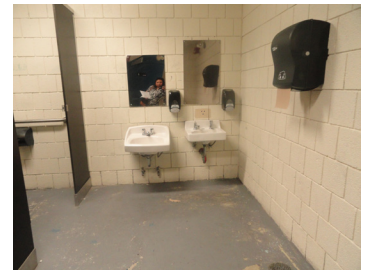
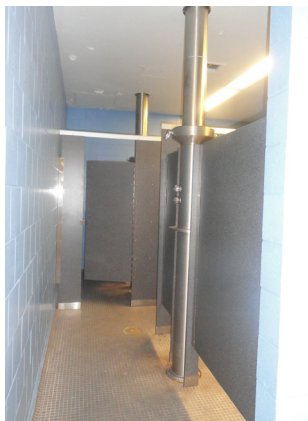
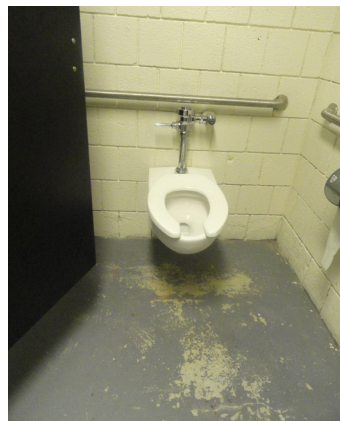
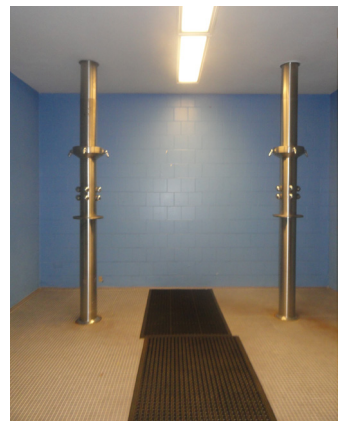
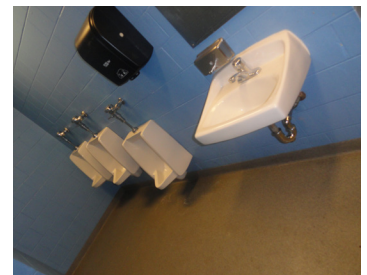
Lavatories/faucets, gang showers, water closets and urinals in boy's locker room 263A are not operational. There is a major leak that has damaged the ceiling and flooded the floor.

*Photo 27:  
Existing plumbing fixtures*

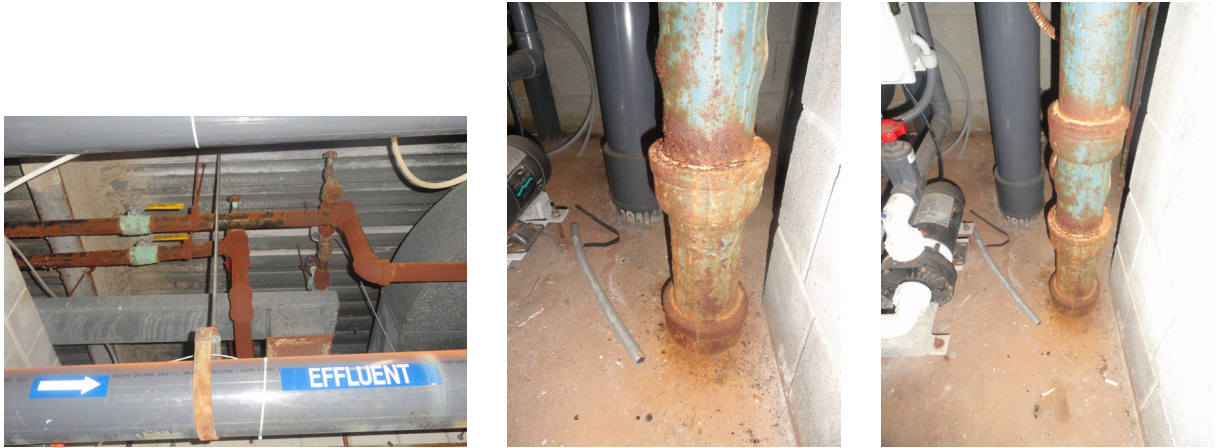
Some pipes in filter room 187 are rusted/corroded and in poor condition. Some are deteriorating and some are not insulated (see photo 28).

*Photo 28: Existing piping in the filter room*

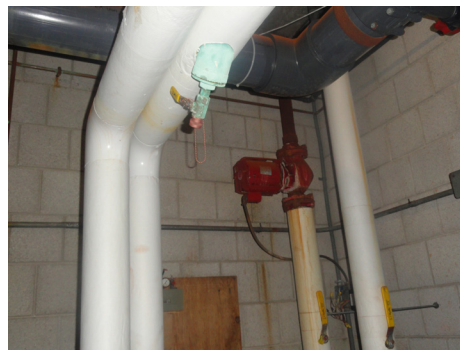
An existing pump in filter room 187 is leaking (see photo 29).

*Photo 29: Leaking pump in the Filter Room*

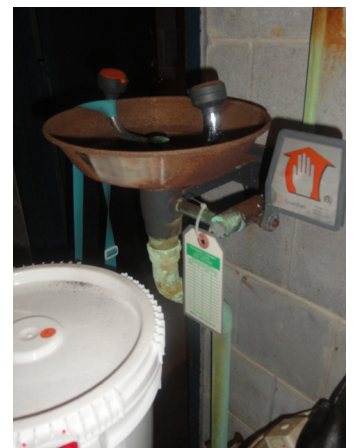
There is an existing non-ADA emergency eyewash in filter room 187 (see photo 30).

*Photo 30: Non-ADA Emergency Eyewash in the Filter Room*

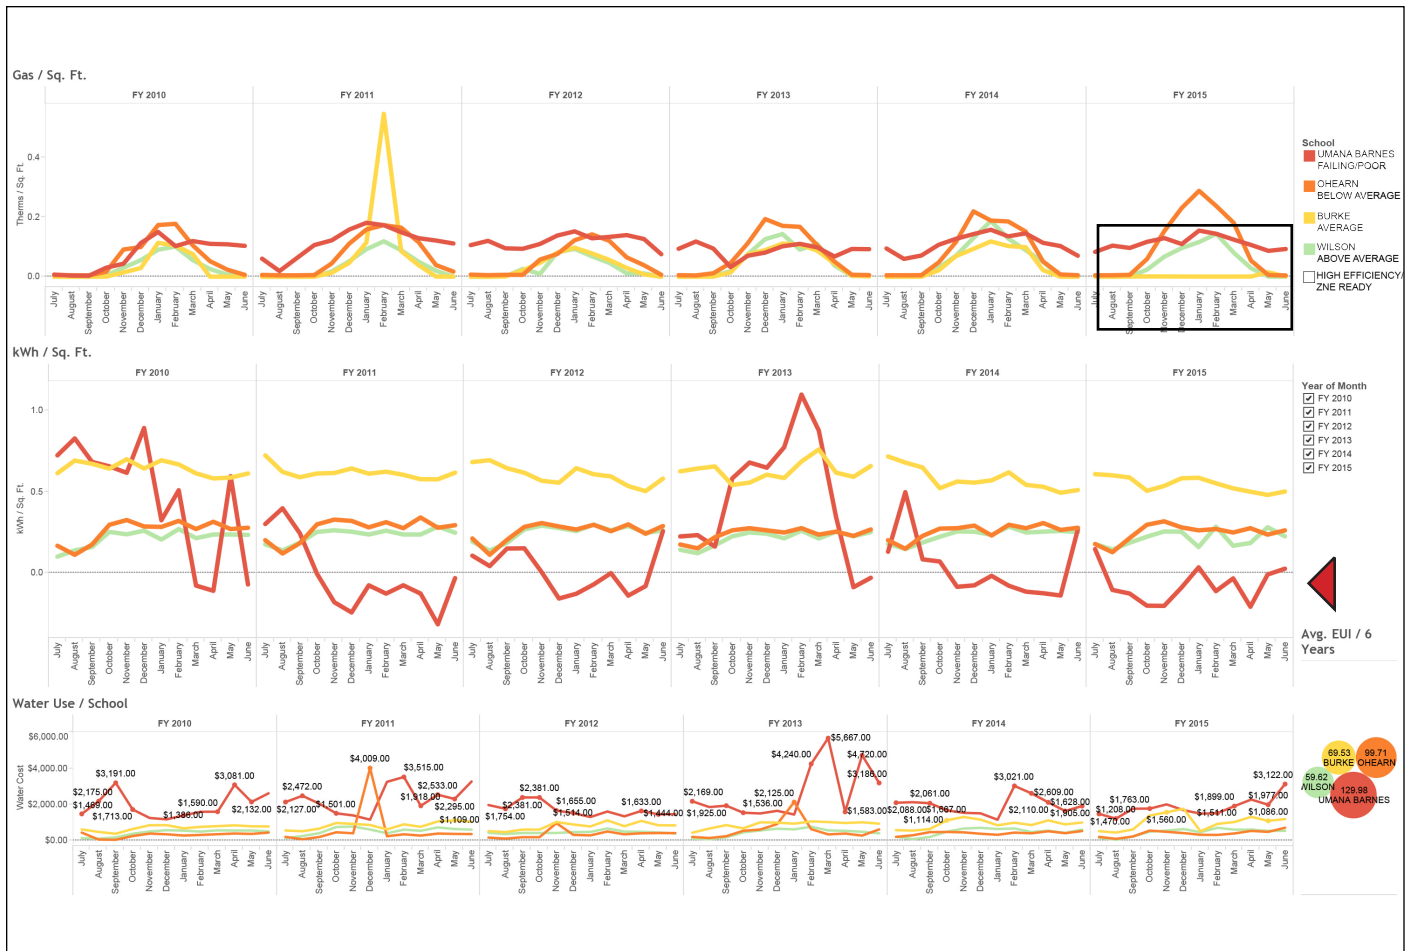
## Month by Month Utility Use

☐ Example: Burke High School's flat line gas use through the winter of 2014/2015 reflects a failed meter, so consumption data is not captured correctly for this period throwing off year over year statistics.

▶ Negative electrical use at Umana suggests necessary investigations as well.
