10 Year Facility Master Plan  
3 School Pilot Study for:

## *Boston Public Schools*

# *10 Year Facility Master Plan 3 School Pilot Study*

### **Evaluation of Existing Conditions: Jeremiah E. Burke High School**

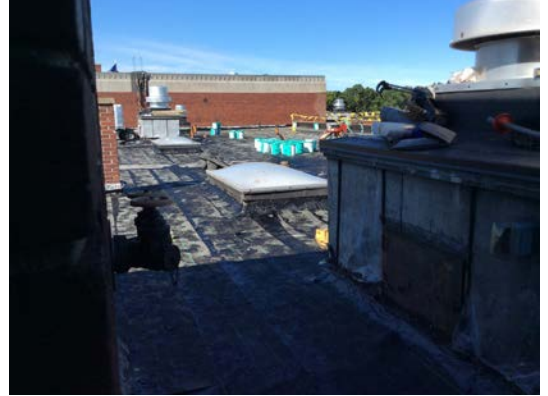
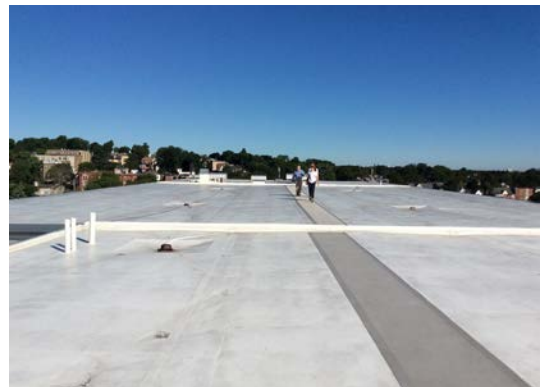
The original flat roofs were comprised of a traditional multi-ply asphalt and bitumen built-up roofing system. Flat roofs are minimally pitched and drained internally. The original roofing was being replaced at the time of the visit utilizing white membrane (likely TPO) to match the new. It is unclear if the original insulation was removed. The new roof membrane generally appears to be in good condition.

Drains appear to be existing, and in their original locations. Many of the original skylights appear to be in good condition, but with evident old leaks. Mechanical curbs also appear to be in good condition.

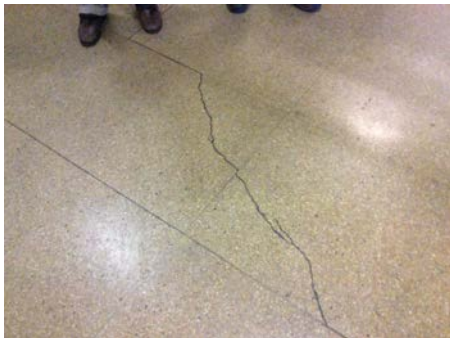
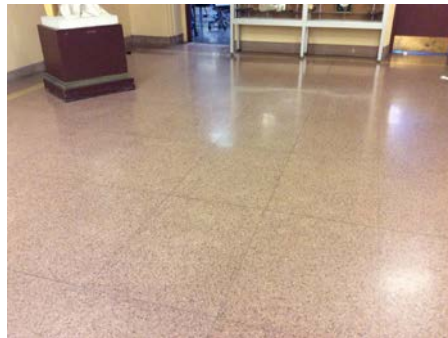
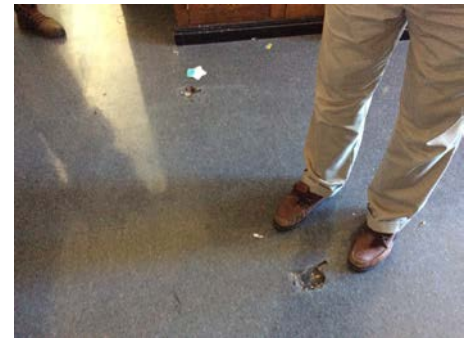
Corridor terrazzo floor is original and in good condition. It shows some minor cracks. In most classrooms, new vinyl composition tile has been installed over the existing wood floor. Stairs in the original building have stone treads with nosing (non-ADA compliant). Stairs in the new building have rubber treads and risers as well as landings and are ADA compliant. The Library's meeting rooms and second and third floor areas have broadloom carpet that is worn. The first floor is covered with cork tile that is still in very good condition. Locker and toilet room floors have the original terrazzo flooring. Kitchen floors have quarry tile. Entries are generally the original terrazzo in the original building and entry grilles in the new building.

Flooring in general is in good condition other than a few locations where the conditions are poor. Carpets should be replaced due to age and cleanliness. Vinyl Composition Tile (VCT) flooring is generally in good condition. Wood floors at the stage, some classrooms and gymnasiums are in good condition. Quarry tile at the kitchen is in good condition.

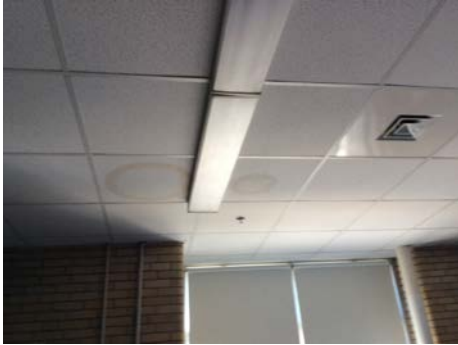
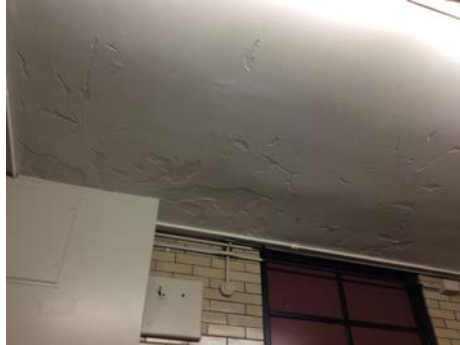
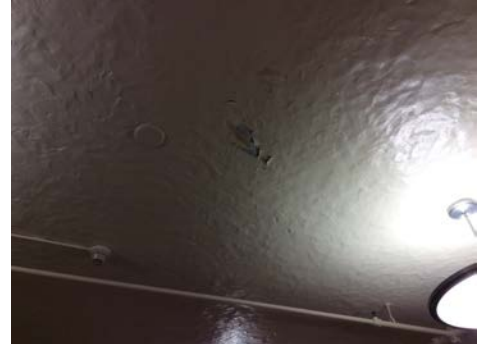
Most classrooms and corridors have the original plaster ceiling and the paint is peeling off the surfaces. Where rooms have received new Acoustiactal Celing Tile (ACT), they are 2'x2' with exposed lay-in grid. Many tiles need replacement due to water damage. On exposed plaster ceilings, light fixtures are surface-mounted, and reportedly have been upgraded to efficient ballasts and fluorescent lamps. 2'x4' ACT tile system was installed in the cafeteria and it is in good condition. The plaster ceilings are in good condition other than needing a fresh coat of paint. Ceiling heights are generous and provide for ample natural light throughout.

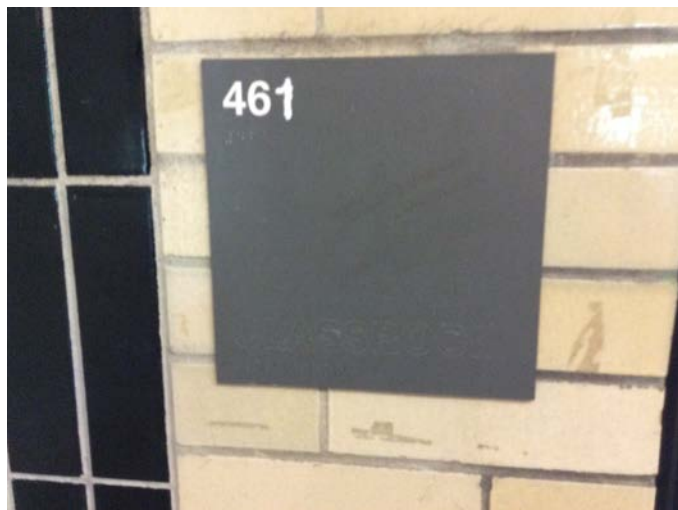
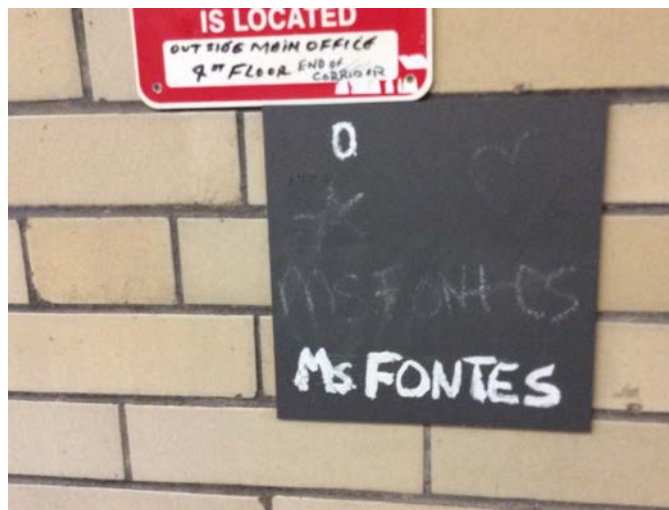
The building received new thermal plastic signs during the 2009 renovation, but many signs are damaged and have lost their alpha-numeric information. Corridor way finding is inconsistent for the layout and geometry of the building.

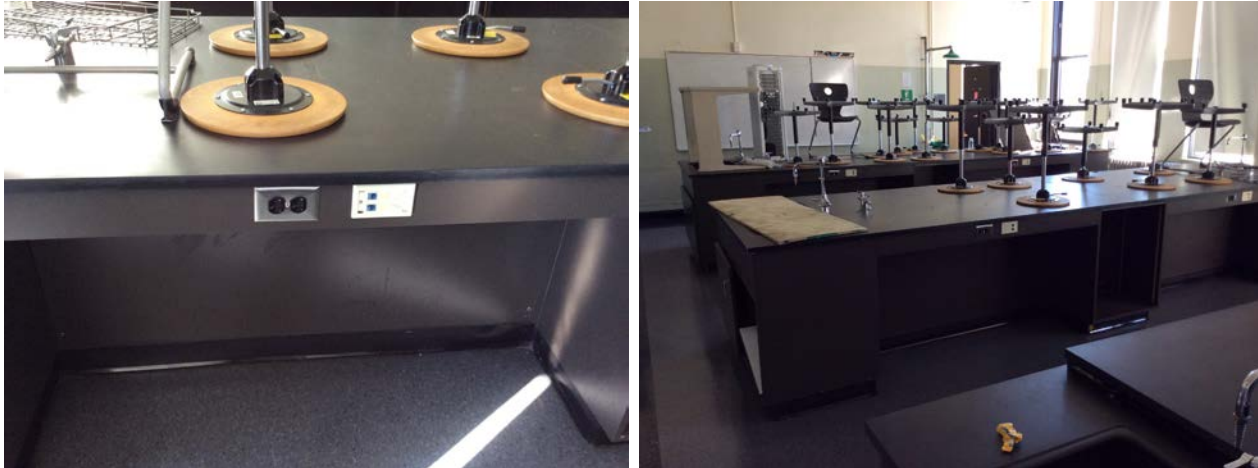
Offices, workrooms and administration spaces have original built-in wood casework. Casework at administrative areas is generally in fair condition. Existing casework in general does not provide accessible units. Classroom storage is the original natural wood built-in units and are generally in good condition. Quantity of storage appears inadequate. The science labs received new casework and lab benches during the 2009 renovation, but are fixed islands making space use inflexible.

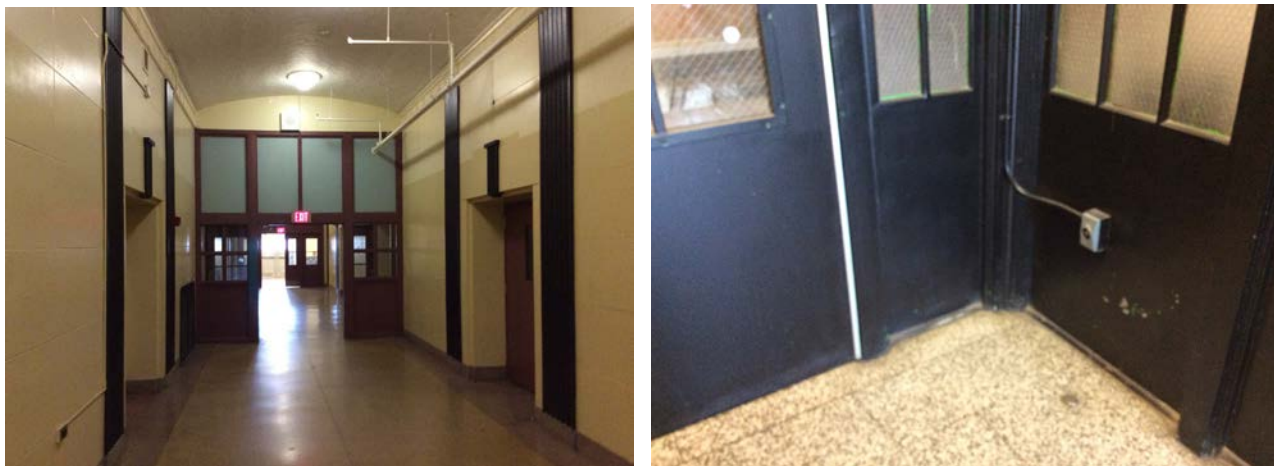
The configuration of the corridor egress system and capacity of the egress doors appears to meet egress code requirements to allow the calculated population of the various building wings to safely exit the building. There are several existing corridor partitions constructed with combustible (wood) materials and large glazing panels that served as smoke partitions prior to sprinkler systems. These doors impede student flow and should be evaluated for removal. Some of the egress doors open onto stepped landings with no ramps or area of refuge provided.

In most corridors, there are several pairs of non-latching smoke partition doors that limit corridor widths and lengths. Some door swing directions create excessive dead-end corridor lengths. The door panels match those at the stairs. These doors are held open by floor hooks only and will not close upon activation of the fire alarm. Many of these doors have full transoms and sidelights of wired glass, which is no longer permitted as safety glazing. The doors themselves have no fire rating as the label is either missing or was never a labeled door making these doors non-functioning for fire or smoke separation.

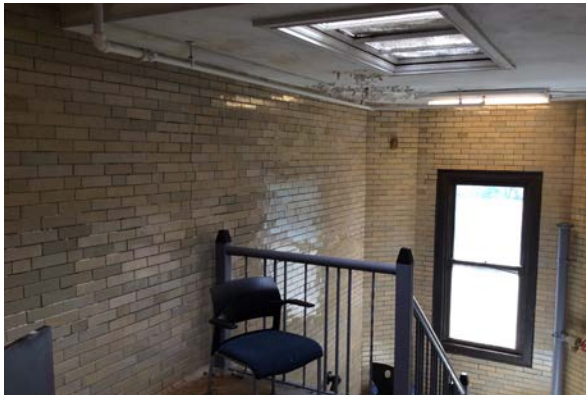
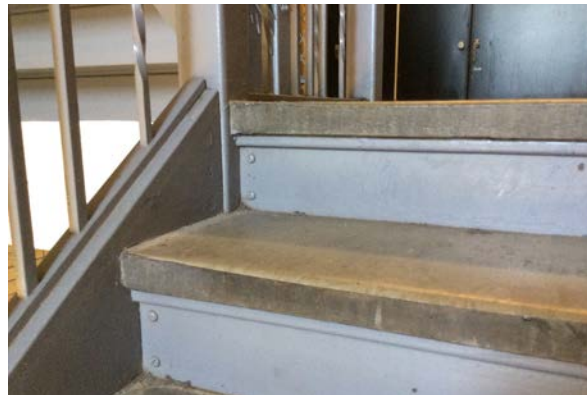
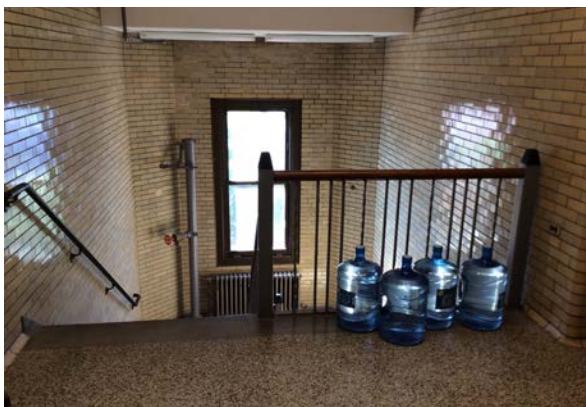
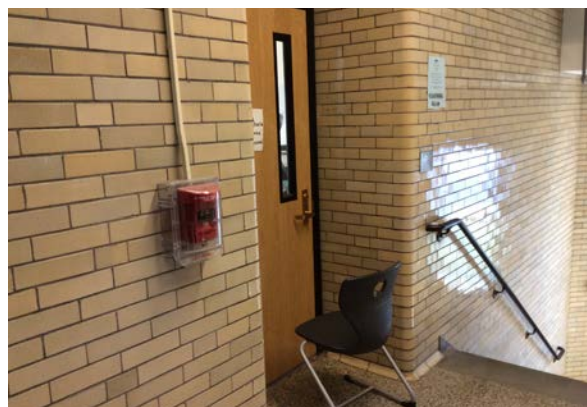
The riser and tread dimensions of all the stairs in the original building appear to comply with egress code but the presence of a nosing makes those stair non-code compliant. The railings and guardrails do not comply with the 42" height requirement. The guardrail openings below the top rail exceed the maximum 4" open space requirement. The handrails do not comply with the extension requirements at the walls for the top and bottom of each run of stairs. The width of the stairs appears to be sufficient to meet the required egress capacity.

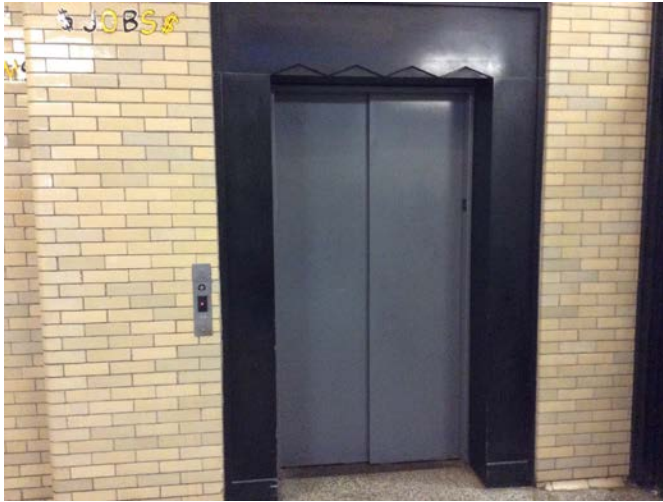
The original building elevator was locked and not accessible, but is reportedly in unreliable working condition. Controls and systems appear out of date. The elevator cab appears undersized for accessibility standards. The size of the existing hoistway will not accommodate an accessible cab, but would accommodate the minimum size allowed in the exception. The two elevators in the new building are fully compliant with the code and work well. Neither extend to the mechanical penthouse.

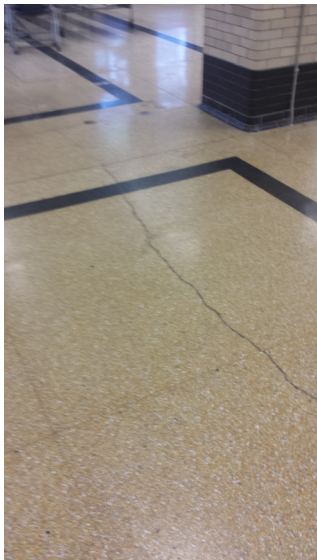
*Crack in Terrazzo at Tunnel Slab*

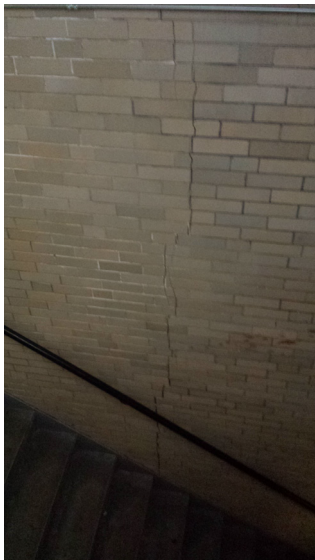
*Crack in Stairwell*

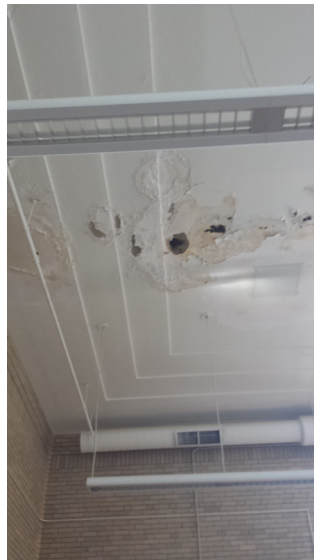
Several signs of water damage in ceilings below the roof were observed. The building is currently undergoing reroofing.

*Ceiling with Water Damage from Roof Leaks*

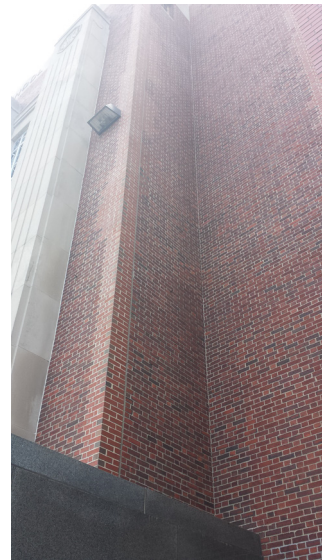
*Exterior Face of Stairwell Wall (crack inside stairwell is located at the inside corner of the walls)*

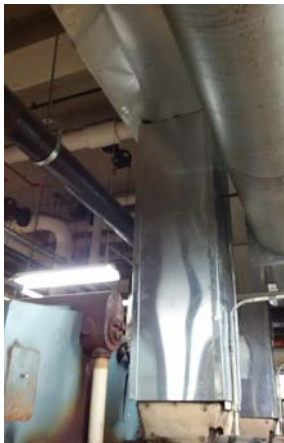
*Boilers Venting*

The portions of the boiler vents and breeching were replaced over the years, but currently show signs of wear. The venting connections to boilers appear damaged, seals missing, portions of vents/breeching insulation/jackets are missing, or damaged. The breeching discharges into a masonry chimney which is vented vertically through the building to the exterior. The breeching connection to the masonry chimney does not appear to be sealed. The boilers are provided with induced draft fans. There is a surface and interior contamination on these fans. The fans insulation is damaged. The connection between the induced draft fans and boiler vents, boilers vents & breeching and breeching connection to masonry chimney should be tested for leakage.

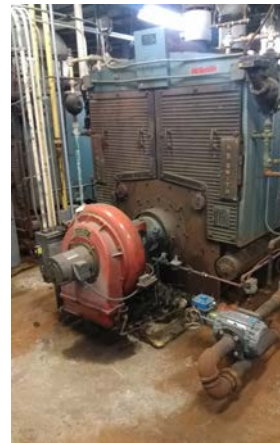
*Existing Boiler*

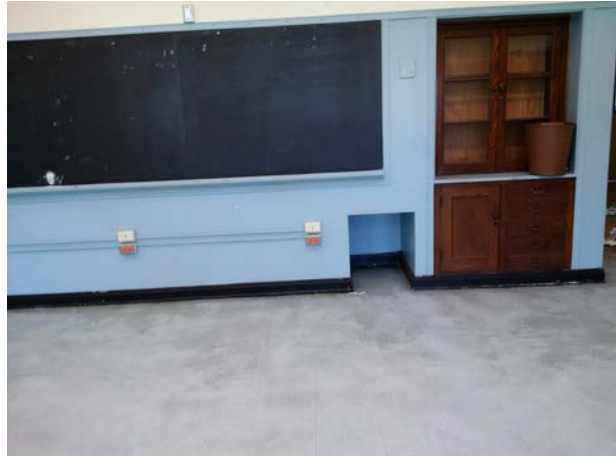
*Classroom Low Return Chase Opening*

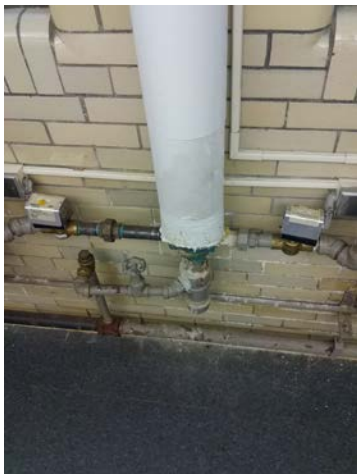
Parts of the school's classroom heating distribution appear to be retrofitted with new sections of piping and new control valves. The rest of the building is being controlled by the original pneumatic controls.

*Retrofitted Control Valves*

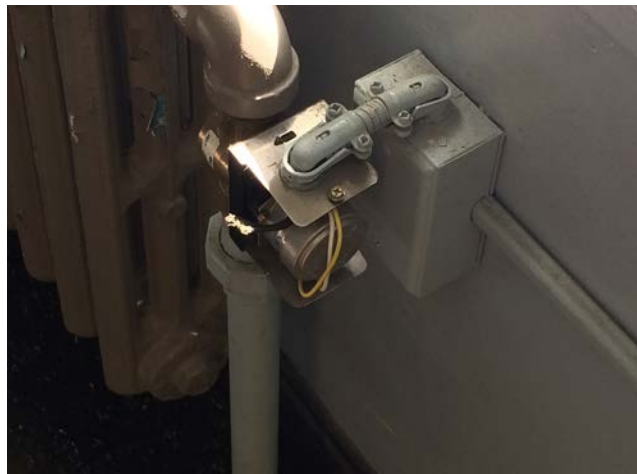
*Original Pneumatic Control Valve*

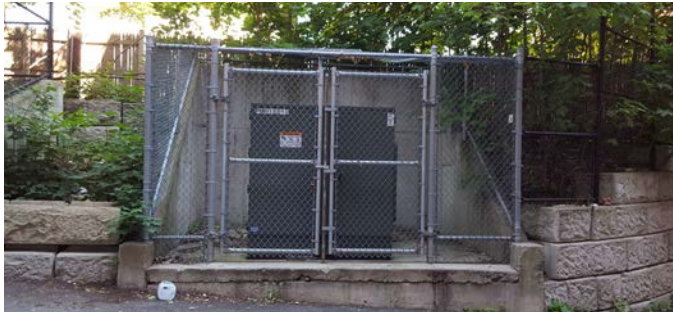
Photo 1: Pad-Mounted Transformer

The Burke High School utility service was upgraded in 2008 when the original outdoor utility transformer, owned by NSTAR, was replaced, refer to Photo 1. The new utility transformer secondary feeder was terminated in a new 2,000 Amp 277/480 volt 3 phase Main Switchboard (Photo 2). The original 3,000 Amp 120/208 volt 3 phase Switchboard (Photo 3) was reconnected and fed via a new indoor dry type 750 KVA step-down transformer. Both Switchboards and new indoor type step-down transformer are located in the Main Electric Room. It's situated at the Lower Level of the old school building wing, directly across from the new utility transformer.

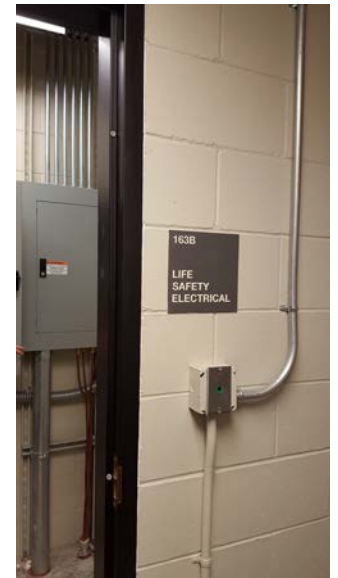
*Photo 6: Example of "Emergency Power" Closet*

Emergency Generator's Automatic Transfer Switches (ATS) and emergency power distribution panels are located in dedicated 2-hour fire-rated rooms in compliance with Massachusetts Electrical Code requirements for the "emergency power" equipment (Photo 6).

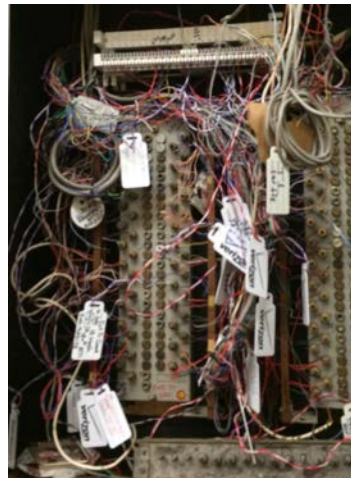
*Verizon Terminal Cabinet and  
Example of Broken Latch*

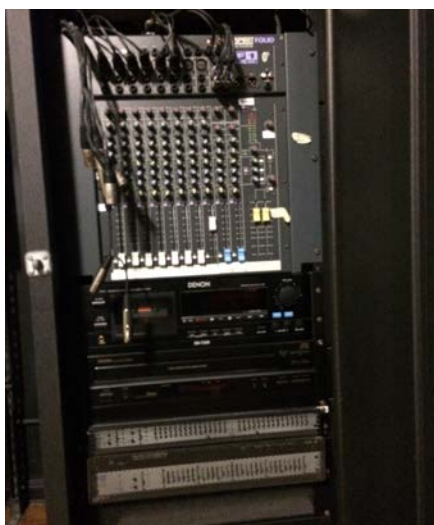
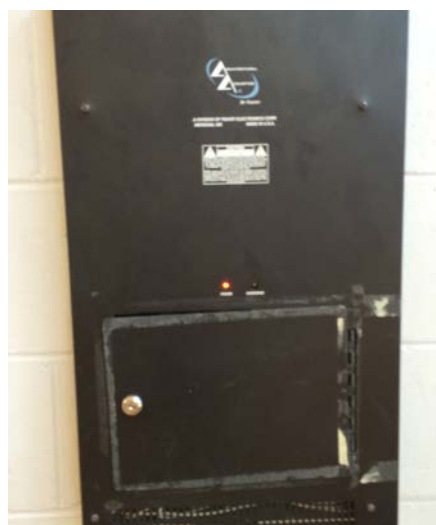
The Auditorium local sound system is relatively new and appears to be in good working order. The local sound system in the Gym is wall mounted, exposed to activities in the space. The cabinet shows evidence of wear and tear.

*Auditorium Sound System (l) and  
Gym Sound System (r)*

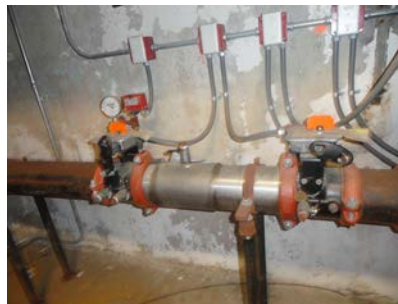
There is fire protection system in the original and new buildings. The existing fire service is a 10-inch main entering the original 1934 building in the Boiler Room located in the basement (Photo 1). The existing fire service includes a 6-inch double check valve assembly (Photo 2), a 6-inch riser with alarm valve for the new building, a 6-inch riser with alarm valve for the main building (original building) and a 4-inch riser to Fire Department Connection (Photo 3). There is no fire pump in the building.

*Photo 2:*  
*Existing Double Check Valve Assembly*

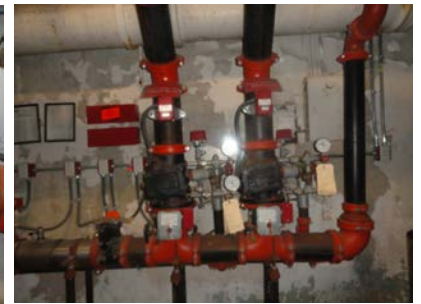
*Photo 3:*  
*Existing Fire Protection Risers*

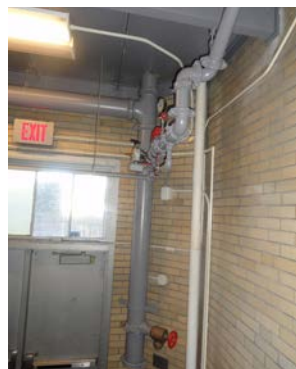
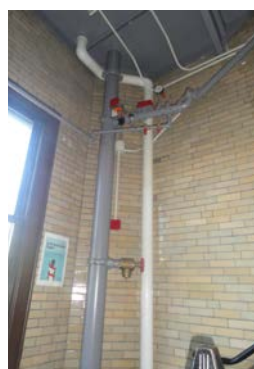
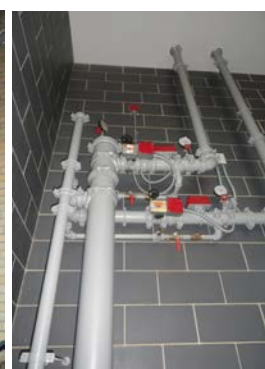
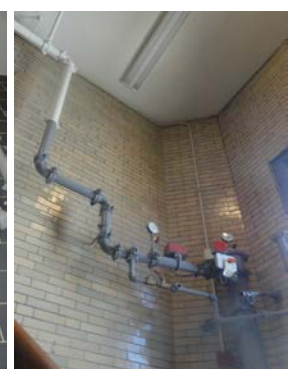
The building is protected with a combination standpipe/sprinkler system with floor control valve assemblies and fire department valves that are located in the stairwells. There is no check valve installed as part of the FCVA, which is a code requirement (Photo 4). Upright sprinkler heads are installed in areas with no suspended ceilings and pendent sprinkler heads in areas with suspended ceilings in the original and new buildings. There are existing sprinkler heads that are obstructed by HVAC unit and/or ductwork in the original building (Photo 5). In Mechanical room 402 in the new building, sprinklers are not installed below fixed obstructions over 4 feet wide such as ducts (Photo 6). Sprinklers that are installed in this room above and below ducts do not have sprinkler guards (Photo 7).

*Photo 4:*  
*Floor Control Valve Assemblies in the Original and New Buildings*

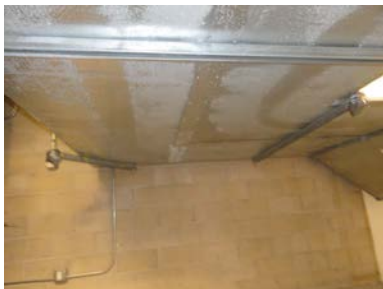
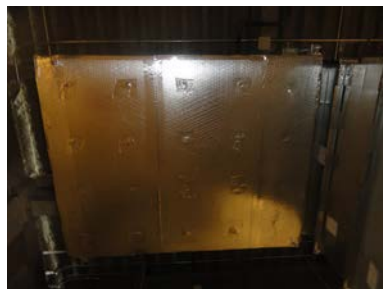
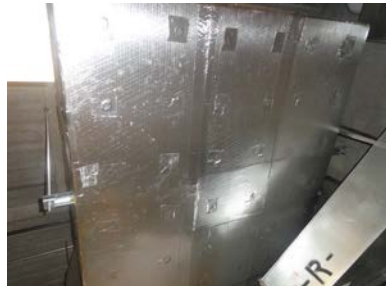
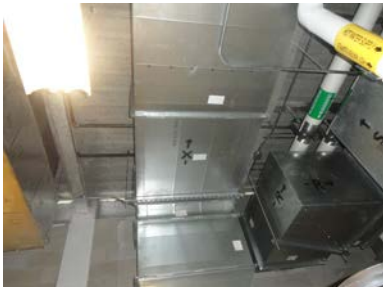
*Photo 6: Fixed Obstructions Over 4 Feet Wide that are not Protected in the New Building*

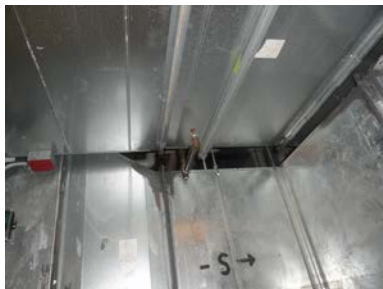
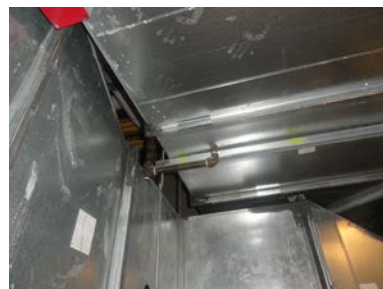
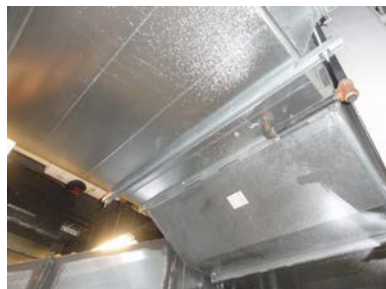
*Photo 7: Examples of Sprinklers Installed Below HVAC Unit/Duct that do not have Guards in the New Building*

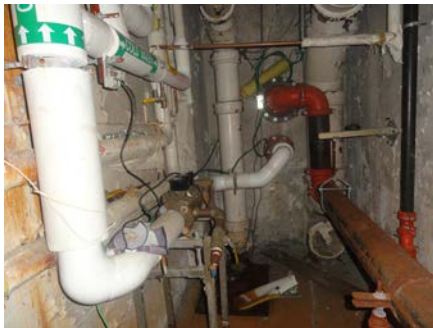
Domestic cold water for the facility is fed from a single water service; a 6-inch main entering the original 1934 building in the boiler room located in the basement (Photo 1). Existing cold water mains appear to be original and in poor condition, and has outlived/exceeded its useful life, and has insulation missing. Valves appear to be original in many cases and in poor condition. The original domestic cold water mains are not expected to last many more years without exhibiting widespread problems and failure. A 4 inch cold water riser, cold water main, pipe insulation, 3-inch water meter were installed in 2006 and appear to be in fair condition.

*Photo 1: Existing Domestic Water Service*

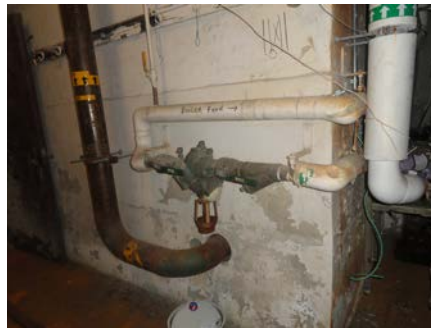
Backflow preventers installed in the original 1934 boiler room appear to be in poor condition, and in the new building's penthouse, appear to be in good condition, for HVAC make-up (Photo 2).

*Photo 2: Existing Backflow Preventers for HVAC Make-up*

Backflow preventers were installed in the original 1934 Boiler Room and appears to be in poor condition, while in the new building's Penthouse they appear to be in good condition, for HVAC make-up (Photo 2).

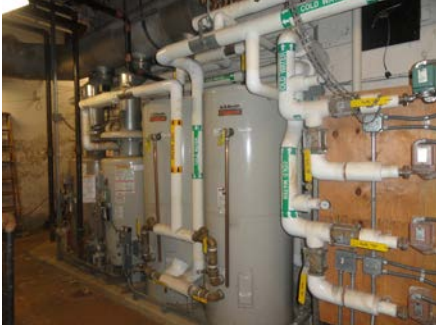
*Photo 3: Existing Water Heaters, Storage Tanks and Thermal Expansion Tank*

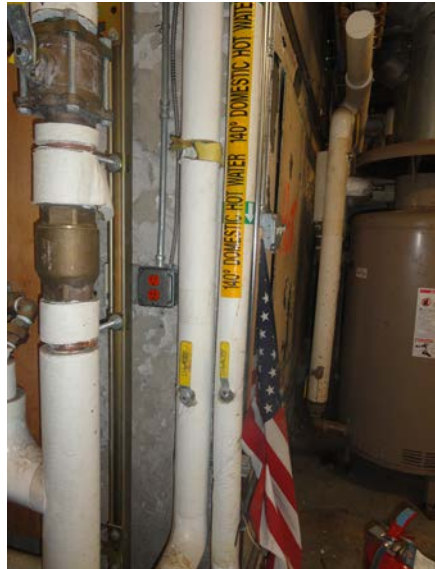
Domestic hot water for the facility is supplied from a single source in the original 1934 building, in the basement boiler room located. The existing hot water system includes one (1) gas-fired (up to 82% efficient) water heater, built in 1998, in fair to poor condition, one (1) gas-fired (up to 82% efficient) water heater, built in 2006 and two (2) custom 180 gallon glass-lined storage tanks, and one (1) thermal expansion tank, in fair condition (Photo 3). The 1998 water heater has outlived/exceeded its useful life and warranty. The original domestic water piping and valves for the 1998 water heater were replaced in 2006 (Photo 4). The 2007 water heater has a 10 year warranty and the storage tanks have only a 5 year warranty. Hot water is circulated from hot water distribution loops by pumps in the 1934 boiler room (Photo 5). There seems to be inadequate clearance for maintenance in front of the hot water circulation pumps.

*Photo 5: Existing Domestic Hot Water Circulation Piping and Pumps*

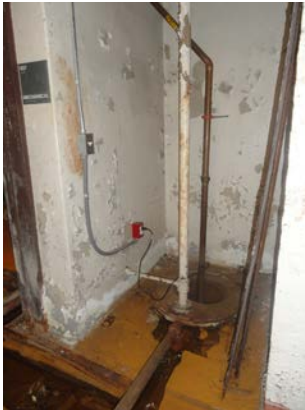
There's an existing sump pump in the original 1934 Boiler Room that is in poor condition (Photo 10).

Photo 10: Existing Sump Pump

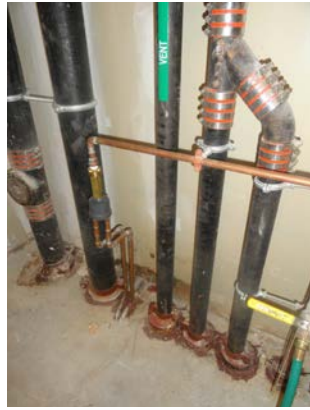
Photo 11: Mechanical Trap Primer

A mechanical trap primer is installed in Mechanical Room 402, in the new building, which is not in compliance with the latest Mass. State Plumbing Code (Photo 11).

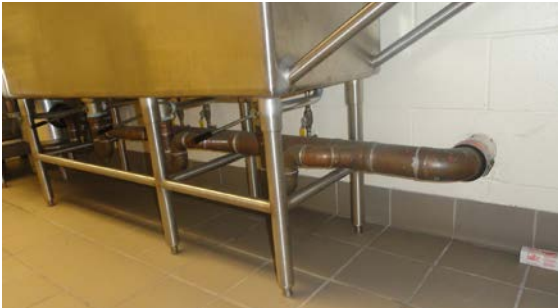
Piping installation at triple pot sink is not code compliant (Photo 12).

*Photo 12: Piping Installation at Triple Pot Sink*

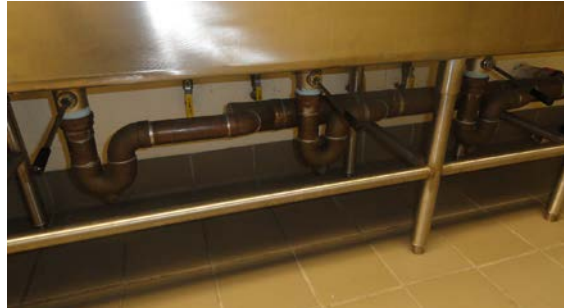
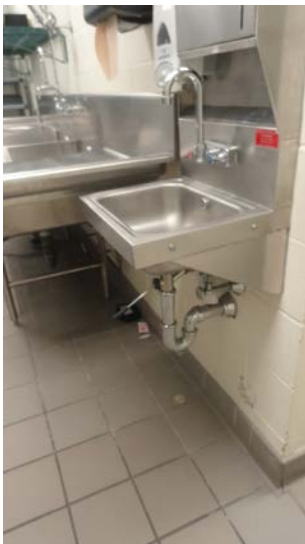
Hand sinks are not ADA compliant and there's an exposed piping below one of the hand sinks, appears to be in fair to poor condition (Photo 13).

*Photo 13: Piping at Hand Sink*

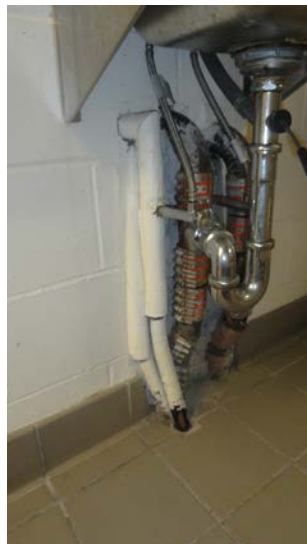
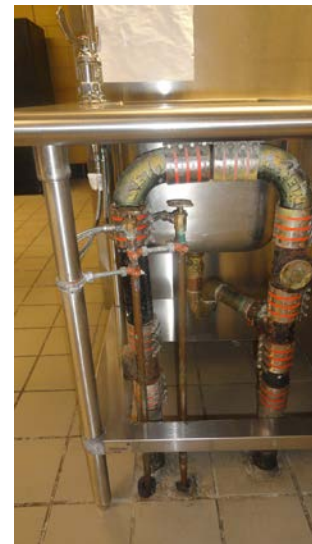
Bow venting at island sink is in poor condition (Photo 14).

*Photo 14: Bow Venting at Island Sink*

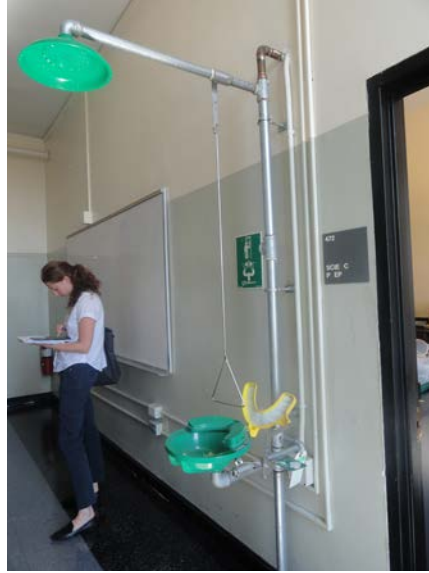
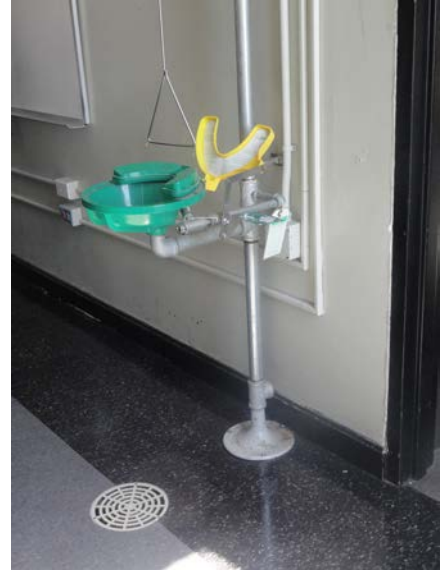
Emergency shower/eyewash is not operational and not ADA compliant in laboratory room 473 in the original building, fourth floor (Photo 17). Emergency shower/eyewash is not installed in laboratory room 272 in the original building, second floor.

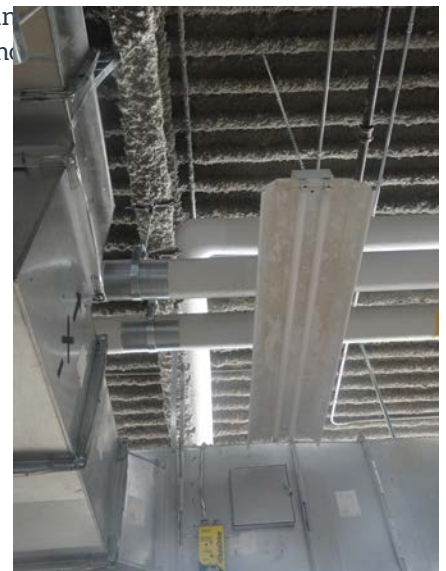
Storm piping does not have cleanouts areas and elbows are installed in the piping (Photo 18).

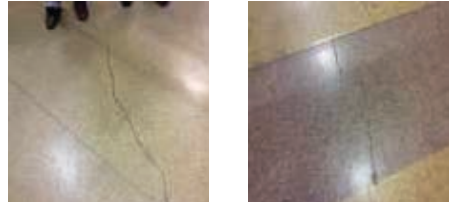
Floor <b>Basement</b>	Room ID <b>throughout</b>	Room Alias		
System <b>C-INTERIORS</b>	Subsystem - Assembly <b>Floors</b>	Component <b>Terrazzo</b>	Type <b>Cracked</b>	Deficiency/Need <b>Generic - Per Correction/Enhancement</b>
Correction/Enhancement <b>2-Repair</b>	Reason to Correct <b>3-Wear/Damage/Asset Preservation</b>	Priority/Urgency <b>4-Years 0 to 2</b>	Photo(s)

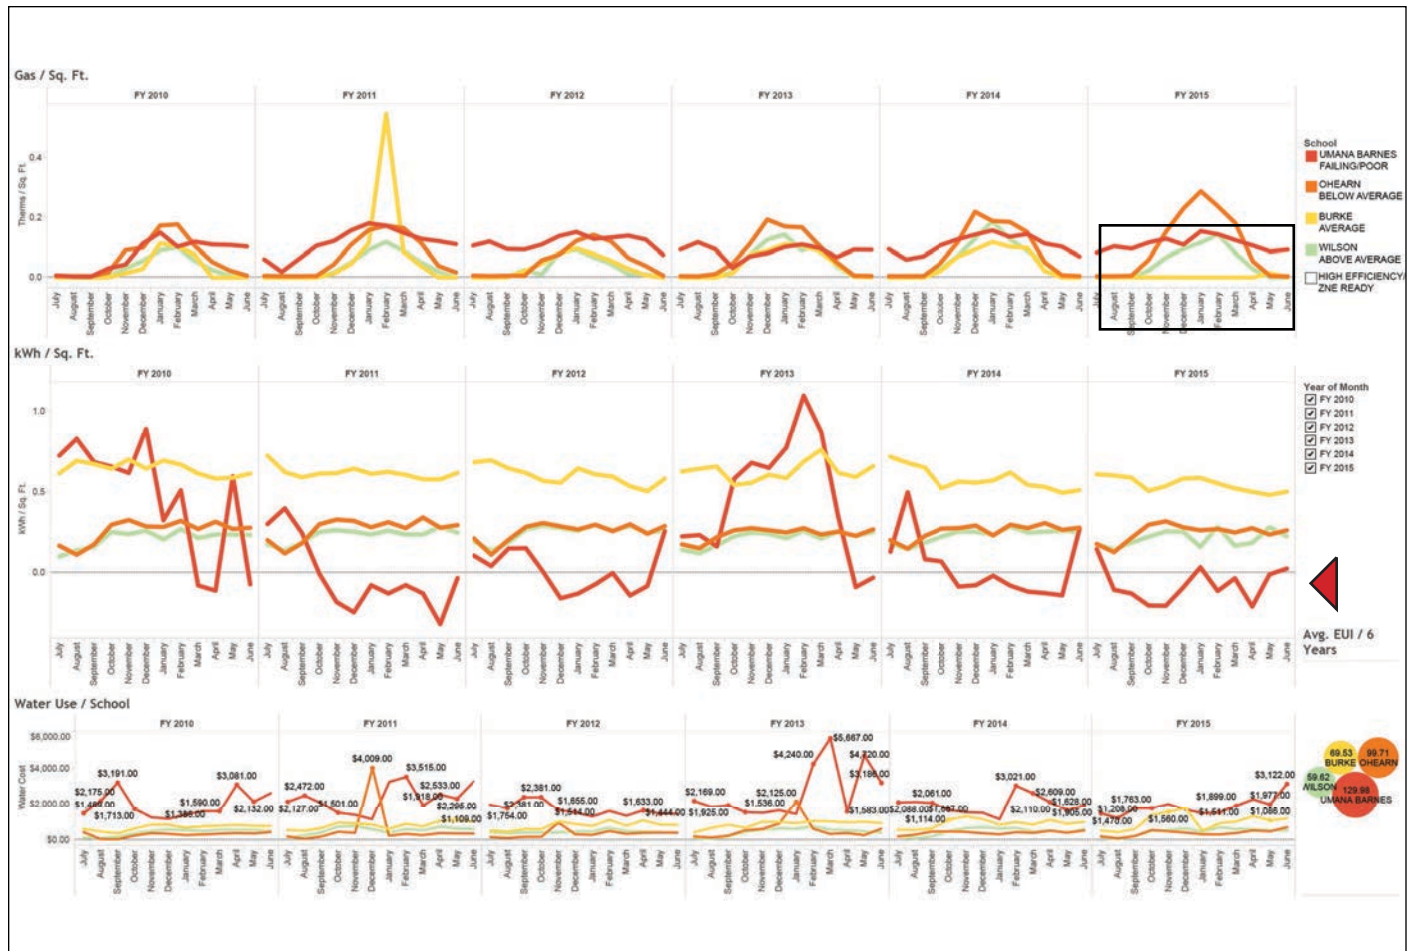
## Month by Month Utility Use

Example: Burke High School's flat line gas use through the winter of 2014/2015 reflects a failed meter, so consumption data is not captured correctly for this period throwing off year over year statistics.

Negative electrical use at Umana suggests necessary investigations as well.
