10 Year Facility Master Plan  
3 School Pilot Study for:

## *Boston Public Schools*

# *Henderson Lower School Report*

### **Evaluation of Existing Conditions: Henderson Lower School**

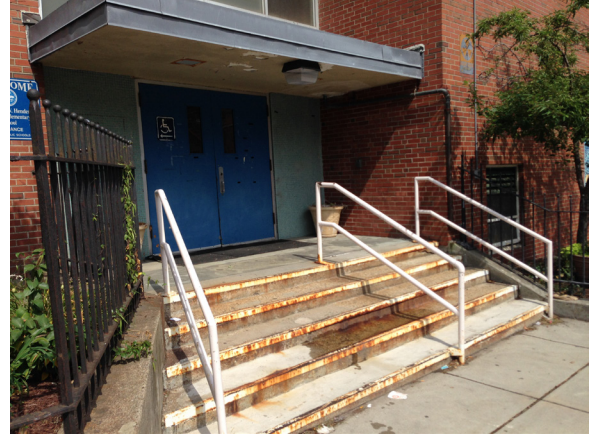
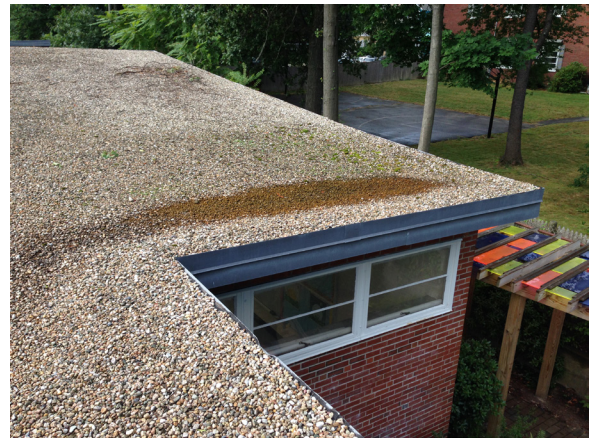
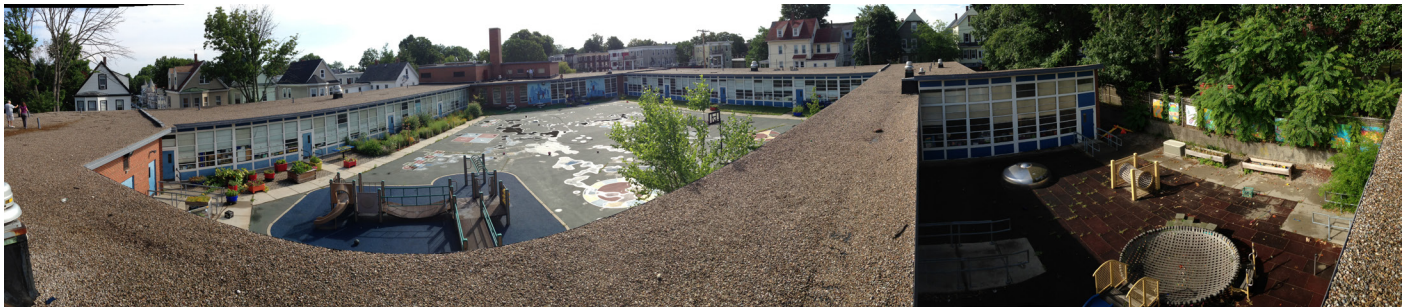
The flat roofs were comprised of a traditional multi-ply asphalt and bitumen built-up roofing system with a gravel ballast. Flat roofs are minimally pitched and drained internally. Ponding is occurring at different areas throughout the surface.

Drains appear to be original and in their original locations. Mechanical curbs appear to be in good condition.

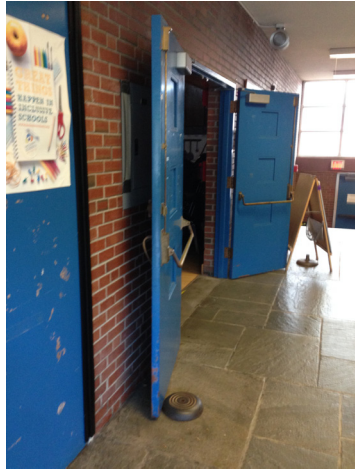
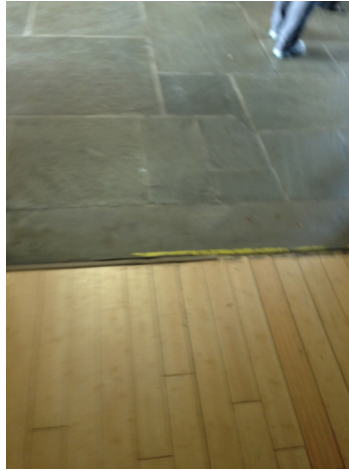
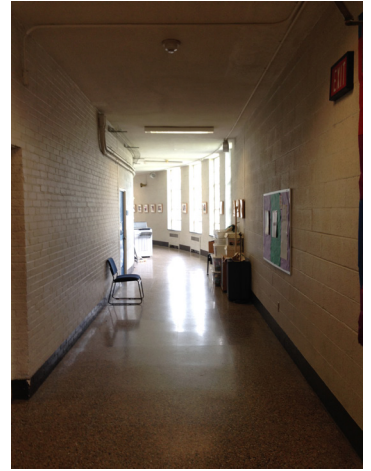
The main entry is sealed flagstone and in good condition. The corridors are original terrazzo and in good condition. The flooring shows some typical expansion/shrinkage cracks. In most classrooms the floor is a 24" x 24" vinyl and is in need of replacement. Toilet room floors have the original 2" x 2" ceramic tile and are in fair condition.

Flooring in general is in good condition other than a few locations where the conditions are poor. Wood flooring at the stage and in some classrooms is in good condition.

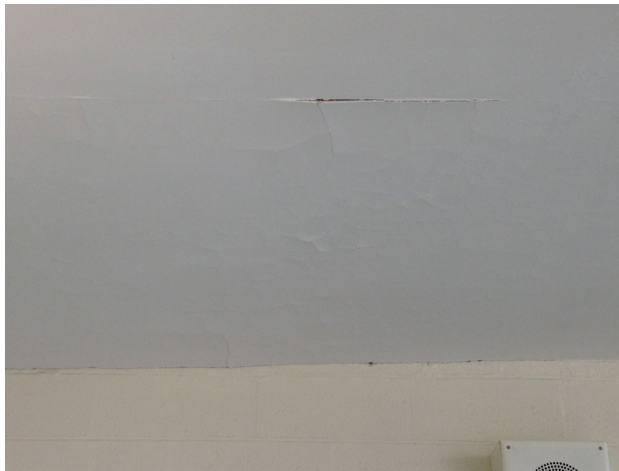
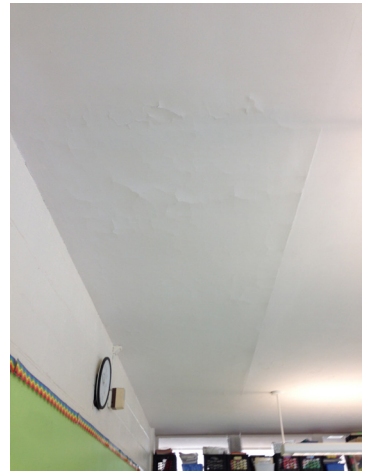
Most classrooms and corridors have the original plaster ceiling and the paint is peeling off the surface. The plaster ceilings are in good condition other than needing a fresh coat of paint.

Ceiling heights are generous and provide for ample natural light except in some of the corridors.

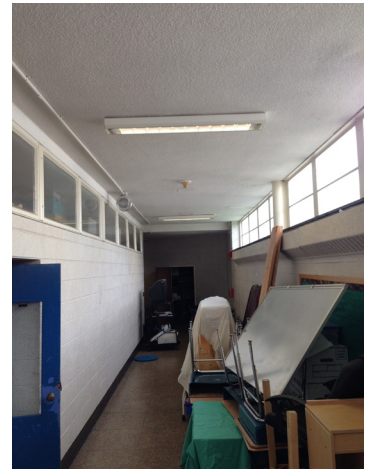
Vestibules are not present at the entries. Ceiling heights in corridors are generous although the width is too narrow. Corridor lighting is surface mounted and is insufficient.

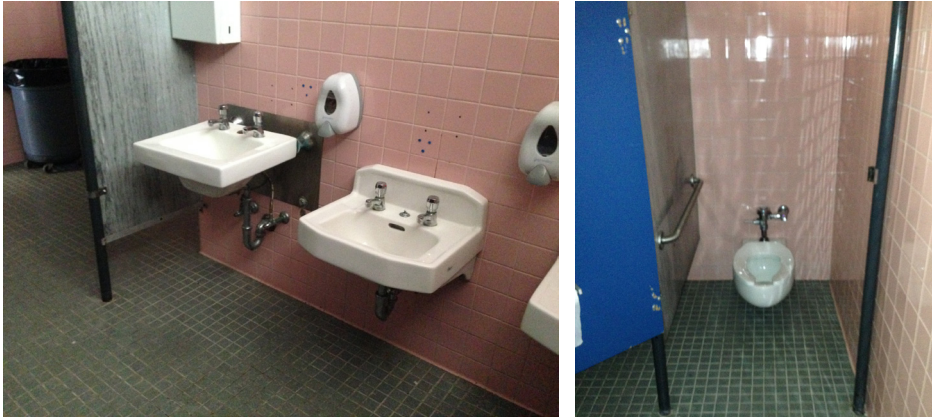
In general, the building does not meet current accessibility standards. Most toilet rooms do meet current standards, and some multi-fixture toilet rooms do provide a handicapped stall.

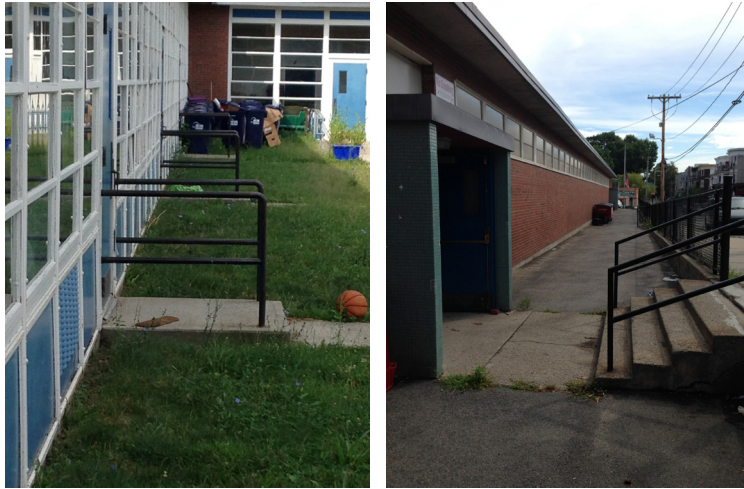
Handicapped door operators are not present at the main entries. The main entry is not accessible. Other means of egress doors open onto stepped pads without ramps or the ramp is too far away and leads onto the access road. While most of the auditorium is accessible, the path of travel to gain access to the stage is indirect and non-compliant.

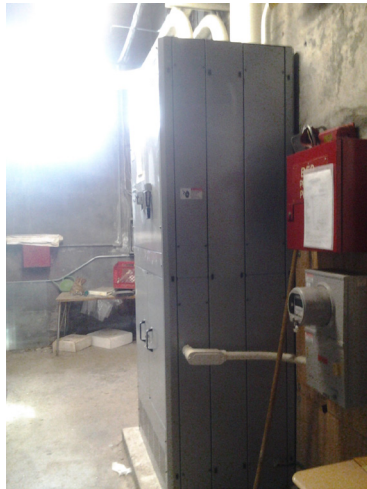
*Photo 1: New main distribution equipment and utility meter*

The O'Hearn School utility service was upgraded around 2001. During this upgrading the old 600 Amp distribution panel was re-fed from the new 800 Amp 120/208 volt 3 phase main switch/utility section and the new 800 Amp 120/208 volt 3 phase main switchboard, both manufactured by Siemens (photo 1). The old and new main distribution equipment and utility service meter are located in the main electric room at the lower level.

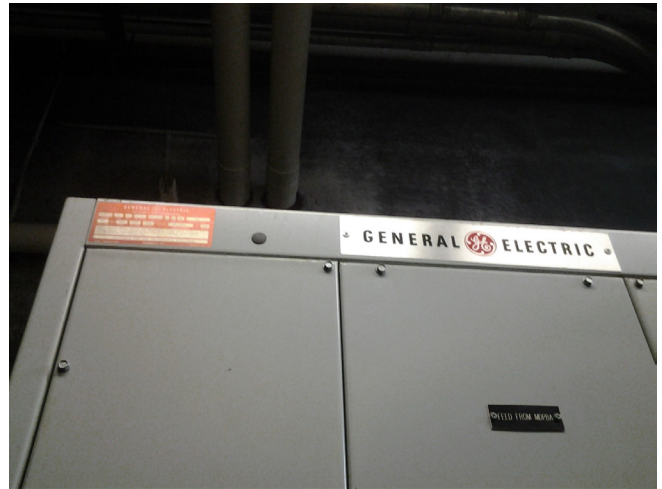
*Photo 2: Old distribution panel*

The old distribution panel was manufactured by GE and appears to be original to the building. Although it appears to be in fair and operational condition, its useful life expectancy is reaching its limit (photo 2).

Old distribution panel and original panelboards found in fair condition with associated power feeders from the old distribution panel are recommended for replacement. The panels observed to be in unacceptable condition need immediate repair or full replacement.

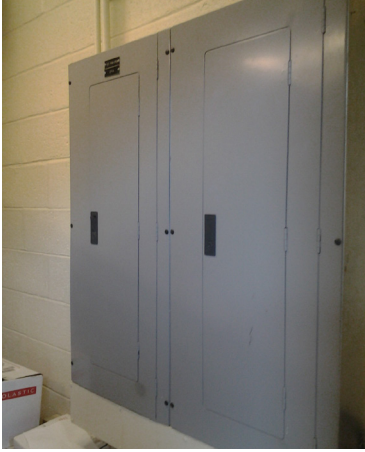
Photo 3: Example of new computer panel

In general, branch panelboards throughout the building appear to be original to the building, except for two "computer" panels, installed in 2001 (photo 3). The old panels, manufactured by GE, appear to be in fair, operational condition however their useful life expectancy is reaching its limit (photo 4), while a few panels found in unacceptable condition need to be repaired or replaced sooner (photo 5).

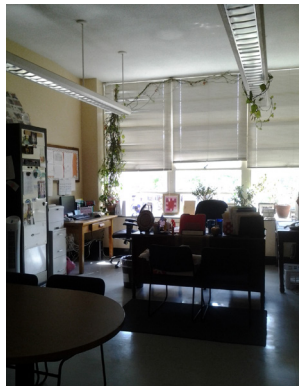
Photo 7: Example of lighting in classrooms, offices, and corridors

The school lighting system was recently upgraded. New lighting fixtures were installed in administration area offices, corridors and classrooms. The new lighting system consists of the pendant-mounted direct/indirect and surface-mounted linear fixtures with energy-efficient T8 lamps and ballasts. These lights are found to be in good and operational condition. Lighting illumination levels (FC levels) produced by these fixtures appear to be adequate (photo 7).

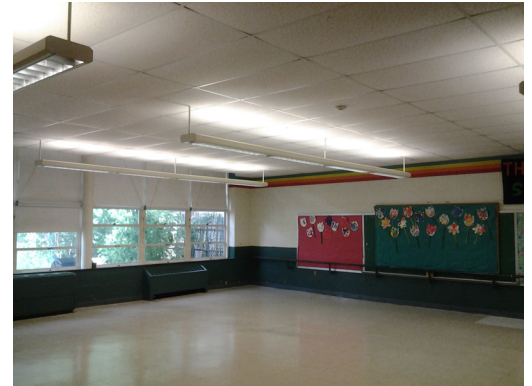
Photo 8: Cafetorium lighting

Cafetorium (cafeteria/auditorium) lighting system appears to be old and probably original to the building. Lighting consisting of recessed fluorescent downlights appears to provide inadequate lighting illumination (photo 8). Also, a few downlights were observed to be not operational.

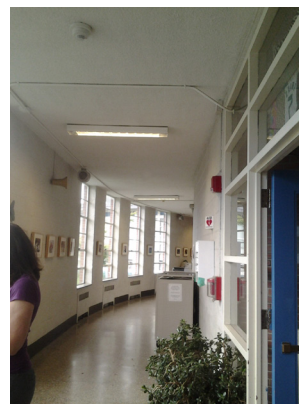
Photo 9: Egress exit signs

Emergency and egress lighting is implemented by use of battery packs/remote light heads and non-electrical exit signs (photo 8). Exit signs are marked non-electrical and were observed being not illuminated during site visit. Such arrangement is not in compliance with Building Code Chapter 27 requiring exit signs to be powered and illuminated at all times. At the same time, it was noticed that exit signs are installed at all exterior doors leading into the school courtyard. It was also noticed that a few exit signs are not visible in corridors (blocked from viewing by columns or wall extensions).

The appropriate egress path and location of exit signs should be examined throughout. non-electrical exit signs shall be replaced with electrical models in compliance with Building Code, the not-required exit signs shall be removed and additional exit signs as required shall be added.

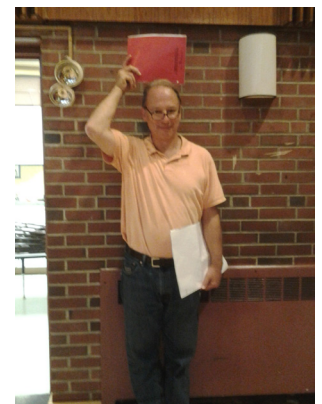
Photo 10: Cafetorium (cafeteria auditorium) emergency lighting installation

Emergency battery packs/remote heads in the cafetorium are installed too low, in violation of ADA, which requires installation of any equipment extending more than 4 inches from the wall minimum at 6'-8" (80") A.F.F. to the bottom (photo 10).

Installation of emergency battery packs/remote heads in the cafetorium shall be reviewed and mounting height of those in violation should be adjusted accordingly.

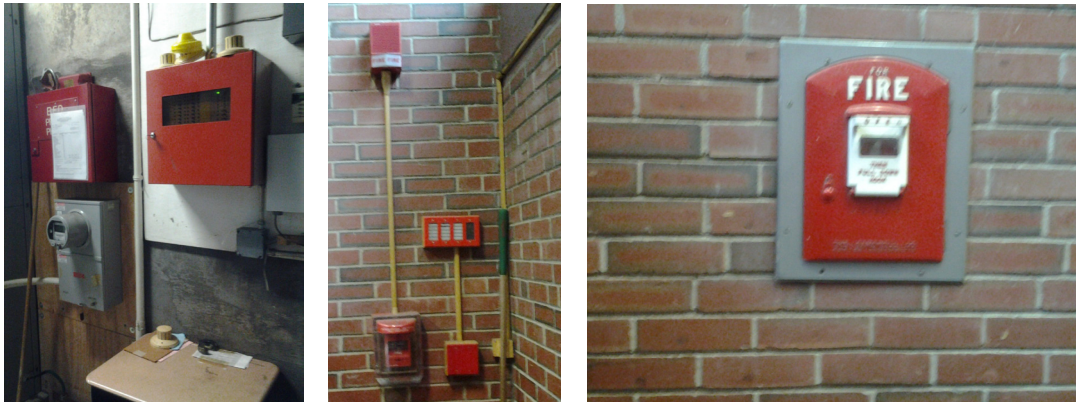
Photo 11: Existing FACP and associated equipment

The Fire Alarm Control Panel (FACP) is installed in the main electric room at the lower level. The fire alarm system remote annunciator and master box are installed in the main vestibule (photo 11).

Upgrades to eliminate deficiencies noted above.

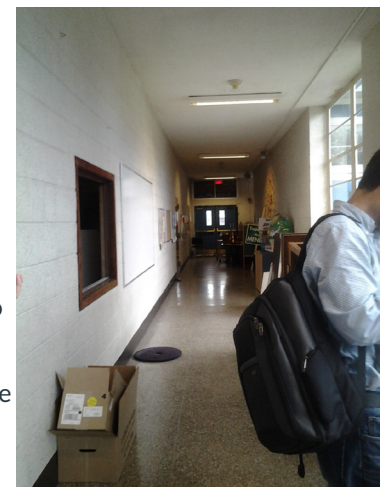
Corridors are generally wide and long with straight views. There are numerous corridor intersections throughout the building where CCTV cameras would be useful for documenting events. Classroom doors are keyed.

Typical corridor sight lines

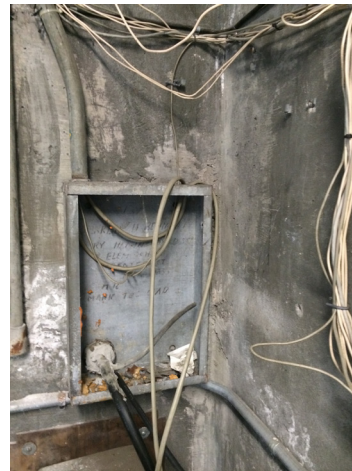
Fiber optic and multi-pair copper communications service cabling is provided by Verizon. They are terminated in the lower level of the school. These cables and the associated entrance facility appear to be new and in good order. There is also a wall-mounted communications cable pull box in the entrance facility that has a variety of cables that are unmanaged and potential trip hazards.

*Wall-mounted communications cable pull box*

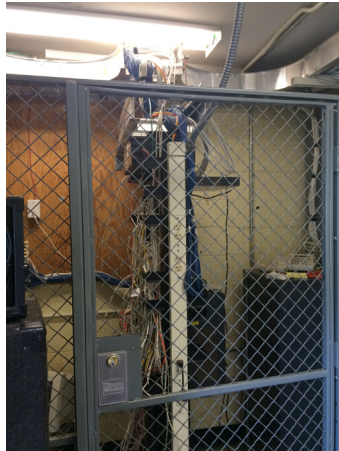
The horizontal cabling system for the school is Category 5e. Two telecommunication equipment rooms were observed. Room 33 (in the survey numbering scheme) is located in a room that is divided by a locked caged divider. The room has minimal air conditioning. A second telecommunications equipment room is located adjacent to room 19 (in the survey numbering scheme). The room has no air conditioning. Lighting and access is adequate in both spaces. The rooms are interconnected by a fiber optic cable backbone. Power services in the room will require upgrades to accommodate future equipment loads.

*One of two telecommunication equipment rooms*

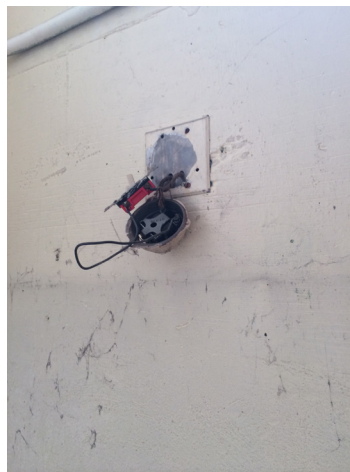
There are numerous locations where low voltage wire is exposed, obsolete wall mounted devices are damaged with exposed wires, and unused back boxes are not covered, leaving them open to rodents, insects or tampering.

*Exposed low voltage cabling*

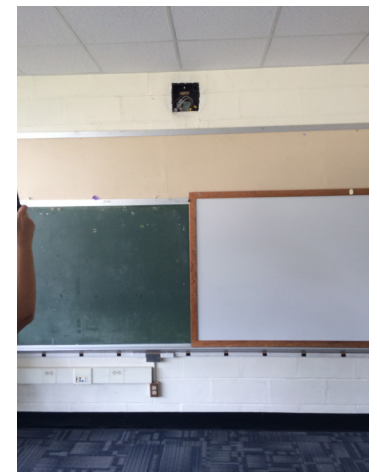
*Empty back box with exposed electrical cabling*

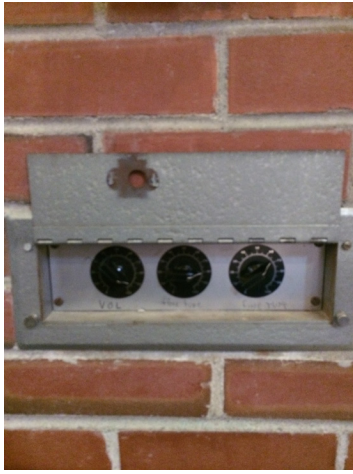
The auditorium is equipped with a local sound system that is no longer functional with unrelated components that do not interconnect. There is no permanent video projection system in the auditorium.

*Auditorium sound system control panel*

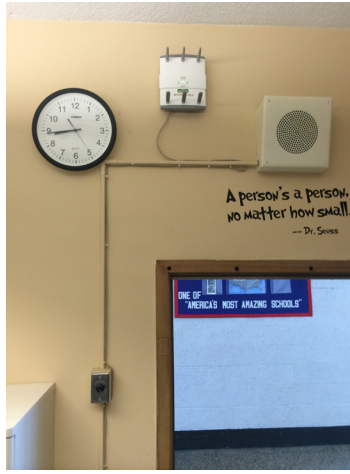
*Battery operated clock, paging speaker and wireless access point in main office*

The master clock system is no longer functioning. The school uses battery operated clocks that are individually set. The interior paging system speakers appear to have been replaced in the past 10 to 15 years. Exterior speakers in the courtyard are no longer operating.

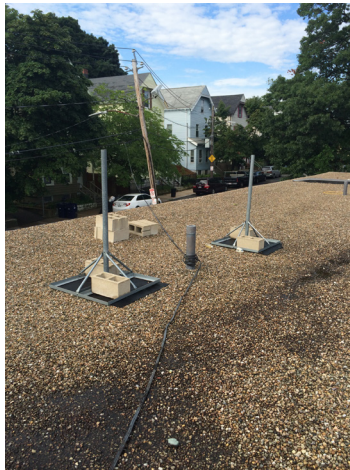
*Abandoned CATV trunk cable*

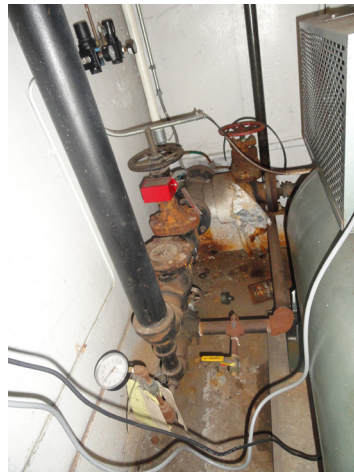
The existing fire protection system includes a 3-inch main, O.S. & Y valve, check valve, 3-inch fire protection rise, flow switch, pressure gauge, drain piping. The existing fire protection service does not include double check valve assembly. Valves are in poor condition (see photo 1). Upright sprinkler heads without guards are installed and appear to be original. Sprinklers and piping are in fair condition (see photo 2).

Photo 1: Fire protection service

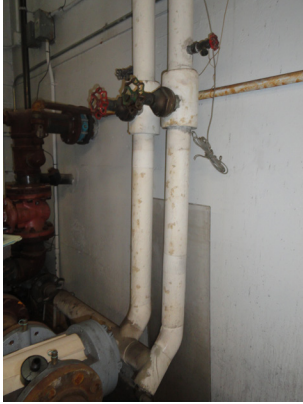
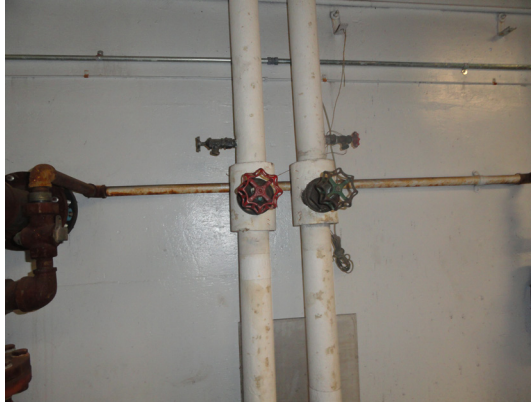
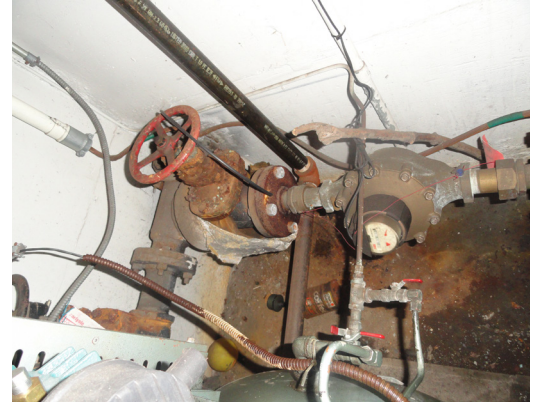
Domestic cold water system for the facility includes a 3-inch main, main shut-off valve, 2-inch water meter, cold water rise for potable water system and cold water rise for non-potable water system (see photo 1). Water meter is in fair condition. All piping and valves appear to be original, in fair to poor condition, and has outlived/exceeded its useful life. Domestic cold water piping is not expected to last many more years without exhibiting widespread problems and possible failure. Some pipes are not insulated, others have poor insulation (see photo 2). Valve tags, pipe labels and flow arrows are not installed.

*Photo 1: Domestic water service and water meter*

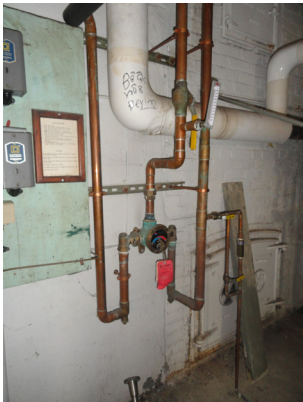
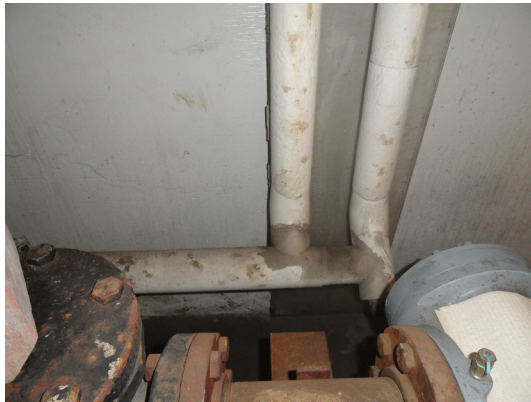
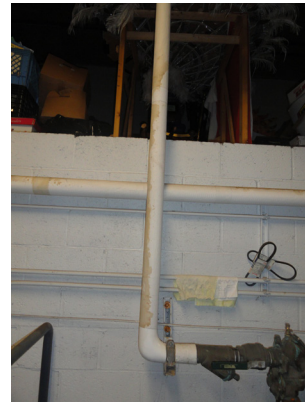
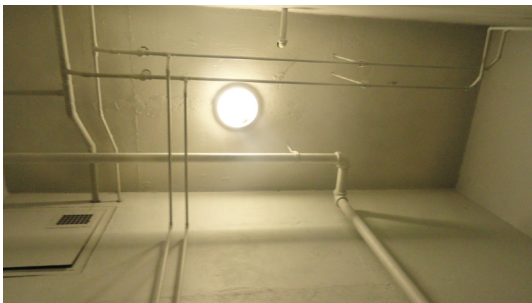
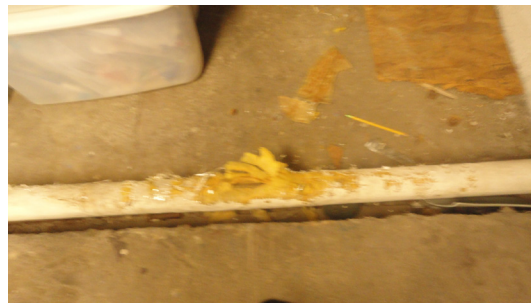
*Photo 2: Uninsulated pipes and poor insulation*

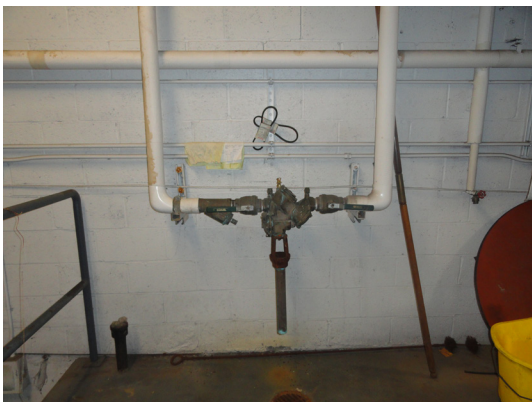
There is an existing backflow preventer in the boiler room for the HVAC make-up, non-potable cold water system (see photo 3).

*Photo 3: RPBP for HVAC make-up*

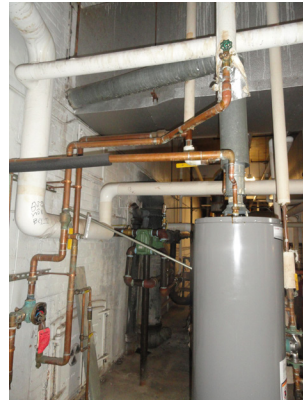
The gas-fired water heater, manufactured/built on July 10, 2014, is located in the boiler room, and in excellent condition (see photo 4). All piping and valves appear to be original, in fair to poor condition, and has outlived/exceeded its useful life. Domestic hot water piping is not expected to last many more years without exhibiting widespread problems and possible failure. Hot water is circulated from hot water distribution loop via pump in the boiler room. Some pipes are not insulated and others have poor insulation. There are two types of insulation, black and white (see photo 5). Valve tags, pipe labels and flow arrows are not installed.

*Photo 4: Gas-fired water heater in the boiler room*

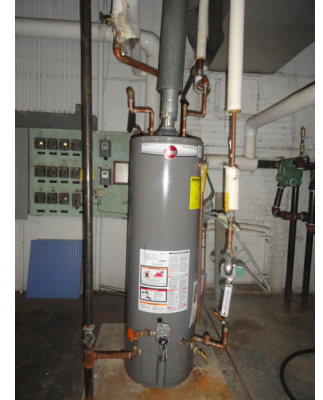
*Photo 5: Uninsulated pipes and poor insulation*

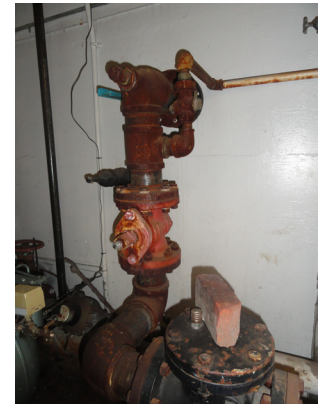
The existing natural gas system enters the building through the Boiler Room via a 4-inch gas main, in poor condition (see photo 6). The existing gas system includes two (2) gas meters, Romet gas meter and gas piping for the two gas boilers, and American meter and gas piping for the water heater (see photo 7). Piping and valves appear to be original, in fair to poor condition, and has outlived/exceeded its useful life. Gas piping is not expected to last many more years without exhibiting problems and possible failure.

*Photo 6: Gas service in poor condition*

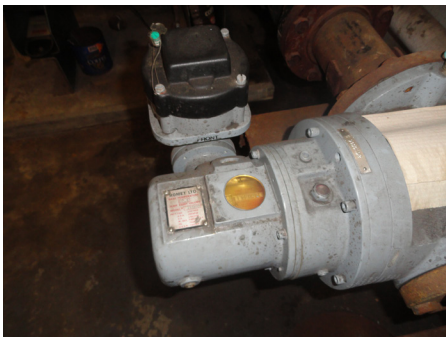
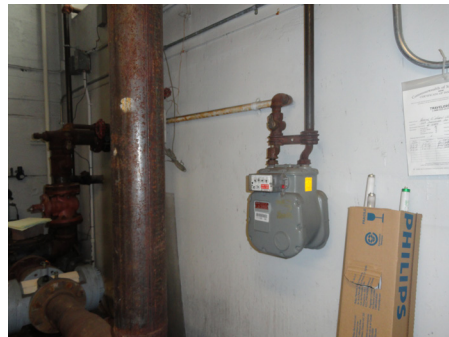
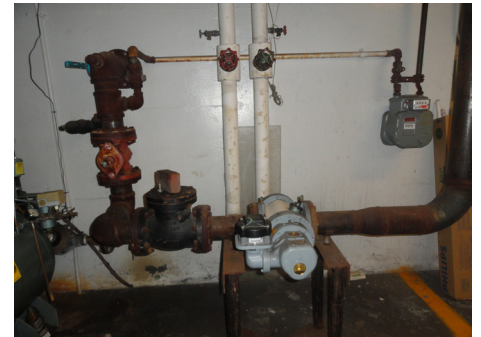
*Photo 7: Gas meters*

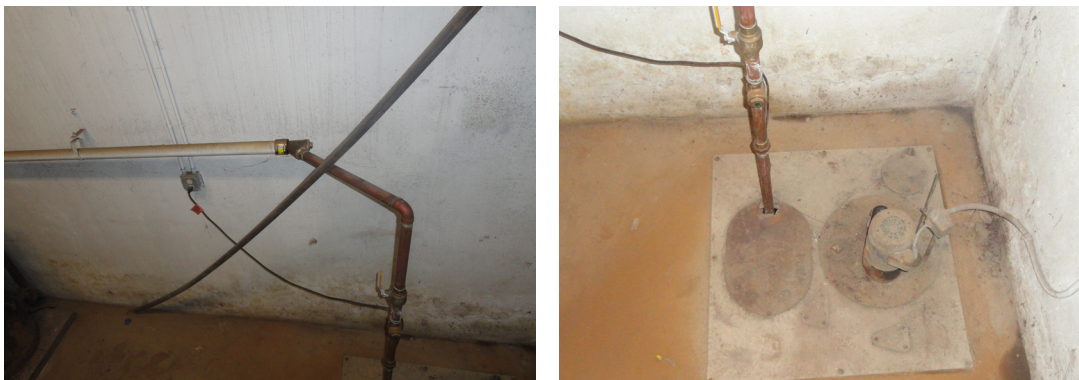
The existing sewage ejector in a pit is original and in fair to poor condition (see photo 9).

Photo 9: Existing sewage ejector

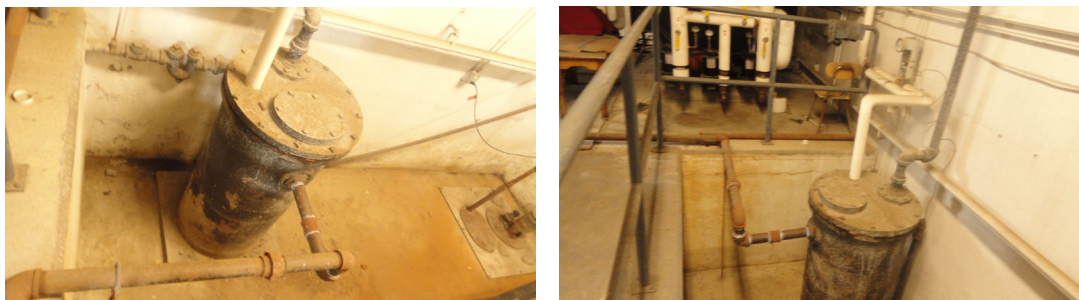
The existing tank receiving condensate from boilers is original and in fair to poor condition (see photo 10).

Photo 10: Existing tank receiving condensate

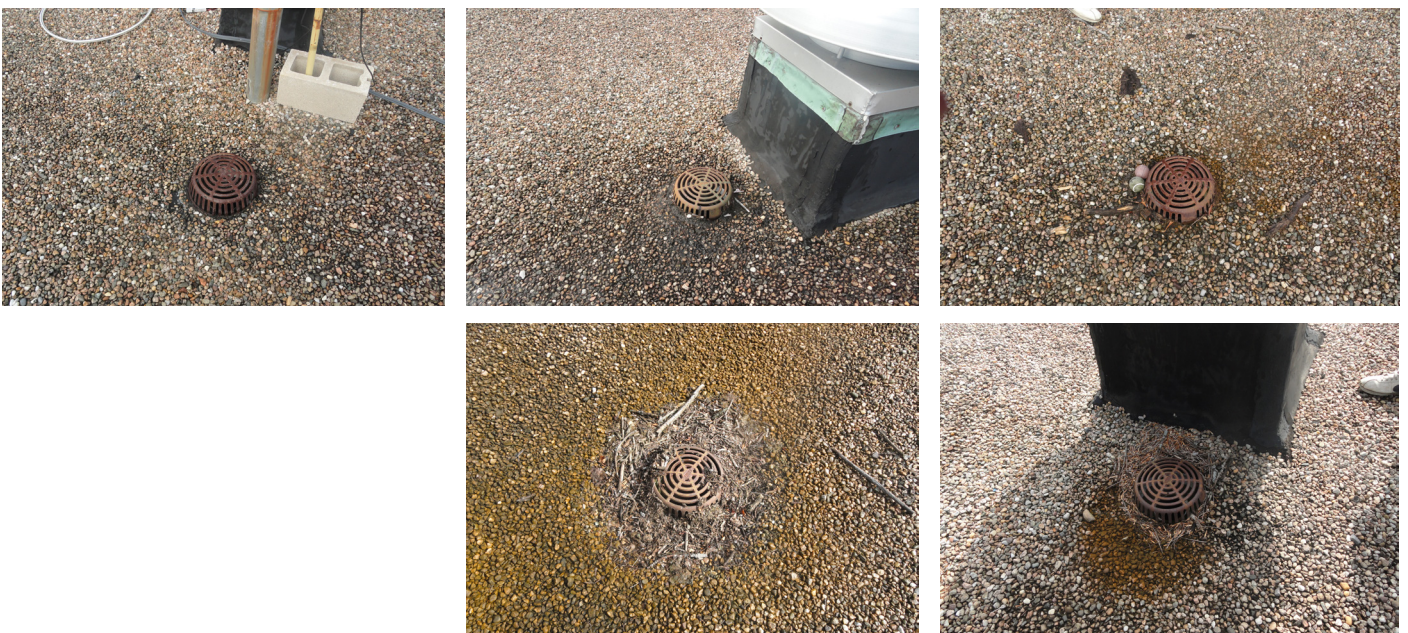
All roof drains and domes are original and in poor condition (see photo 13).

Photo 13: Roof drains and domes

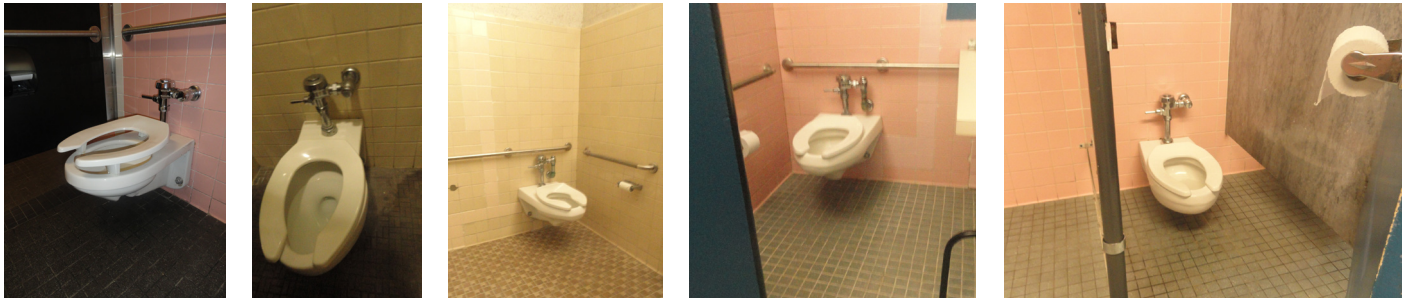
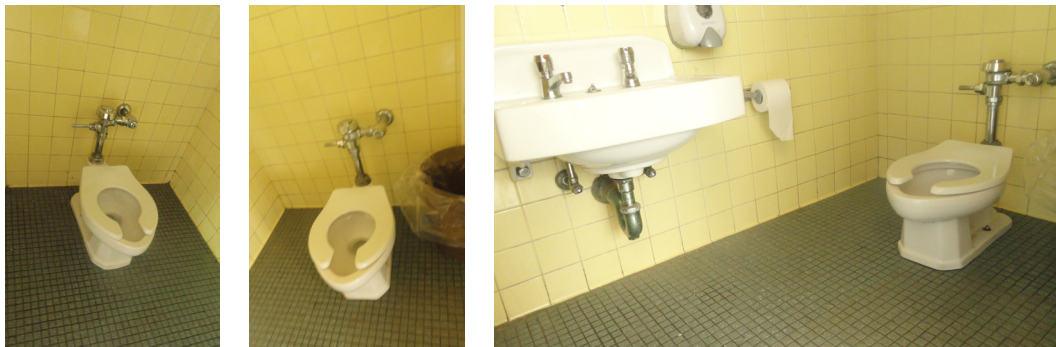
*Photo 14: Different types of installed water closets*

Some water closets are wall mounted with manual flush valves, and others are floor mounted with manual flush valves, generally in fair condition, and non-ADA compliant in some locations (see photo 14).

*Wall-mounted water closets with manual flush valve*

*Floor-mounted water closets with manual flush valve*

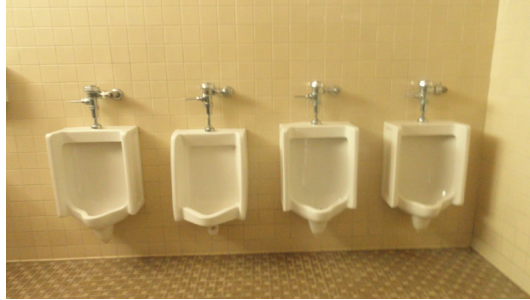
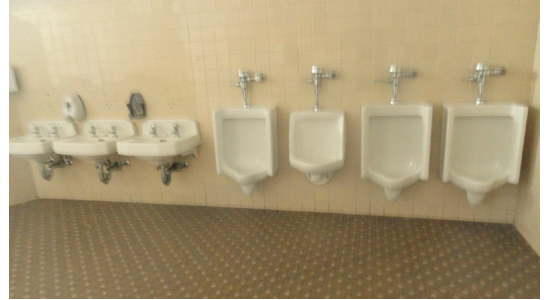
Urinals are wall mounted with manual flush valves, generally in fair condition (see photo 15).

Photo 15: Urinals

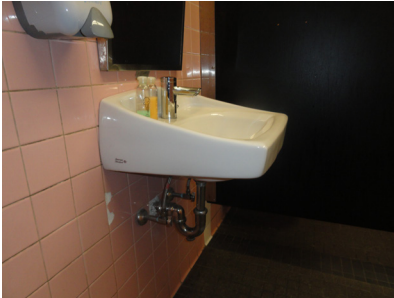
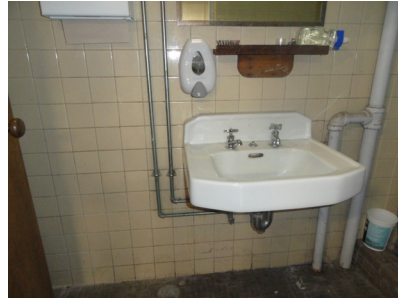
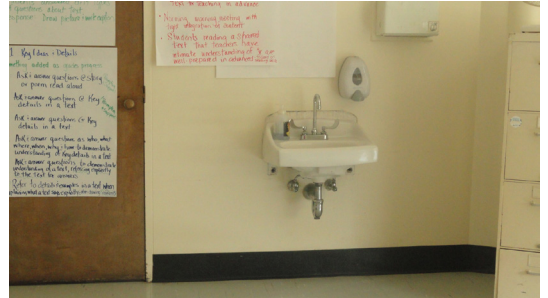
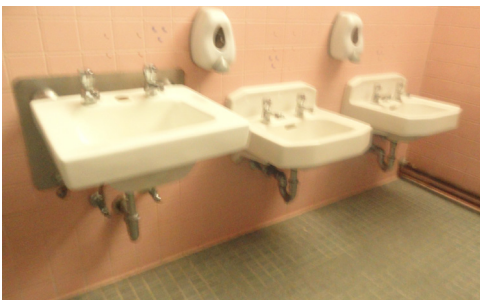
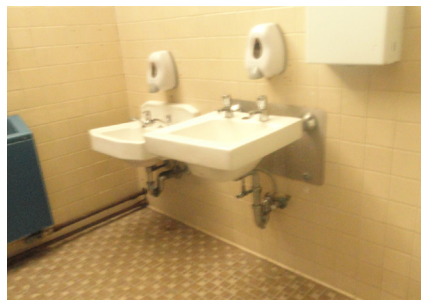
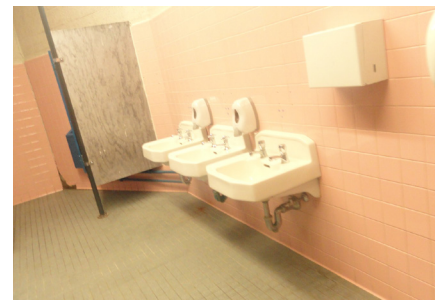
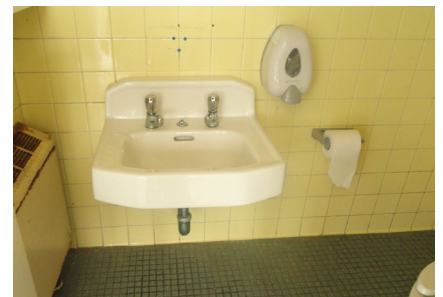
Lavatories are wall hung with battery powered or self-closing push-down faucets or lever handles, generally in fair condition. Some of the lavatories are non-ADA compliant. Pipe insulation is not installed in some locations and others are in poor condition (see photo 16).

Photo 16: Non-ADA, ADA compliant lavatories and without pipe insulation

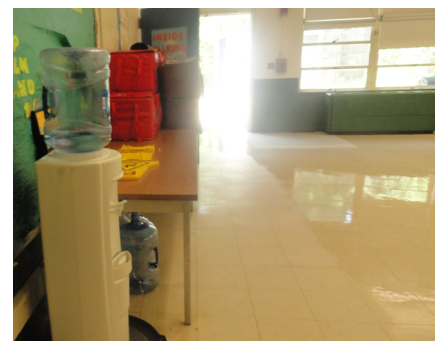
No bi-level electric water coolers are installed in the facility. Water dispensers are used in the entire facility (see photo 17). Existing drinking fountains in the classrooms were removed but the capped sanitary and cold water piping in wall are exposed in most locations (see photo 18).

Photo 17: Water dispensers in lieu of bi-level water coolers

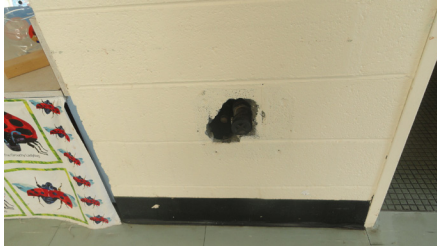
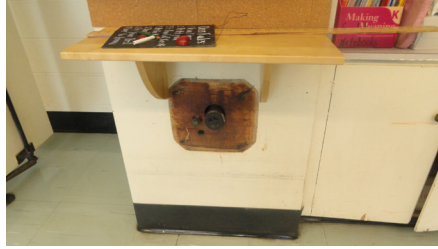
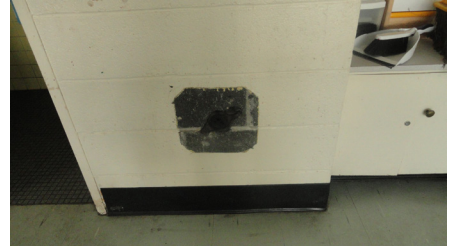
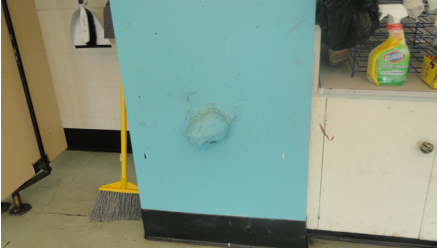
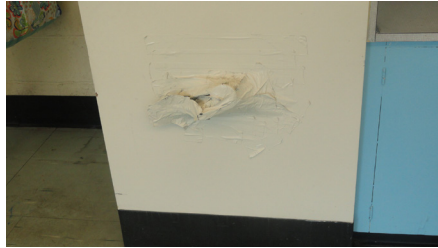
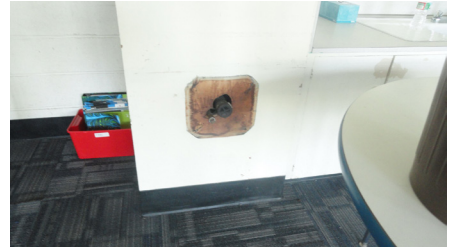
Photo 18: Exposed piping in wall

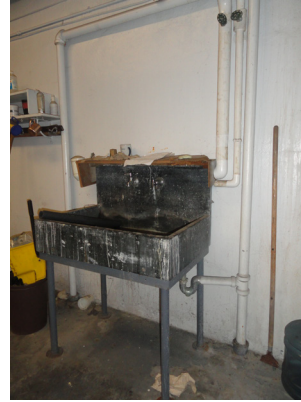
The existing service sink in the boiler room is in poor condition and has a leaking faucet (see photo 20).

*Photo 20: Service sink in the boiler room*

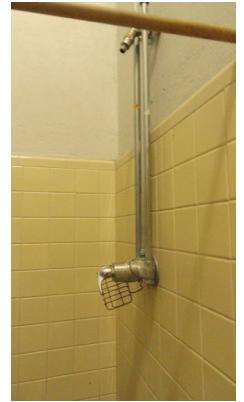
The shower in the boiler room has an outdated shower valve and is in poor condition (see photo 21).

*Photo 21: Outdated shower valve*

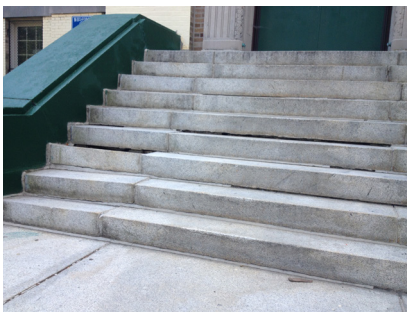
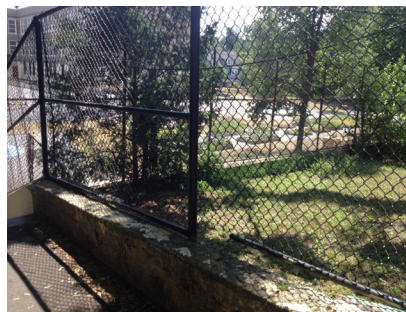
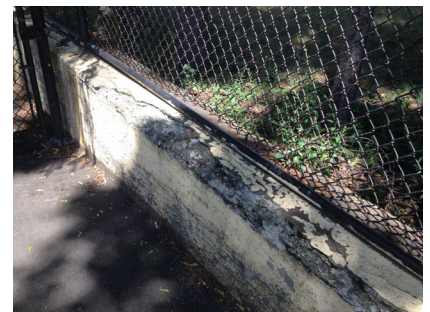
The main entrance for the school is on the southern side facing Croftland Avenue. The entrance is at the top of a large flight of steps with no nearby accessible route. The stairs are otherwise in fair to good condition. The iron fencing along the sidewalk is in good condition.

The walkway along the east side is in fair condition. The stairs connecting to Croftland Avenue are in poor condition.

- Repair west stairs.
- Repair/reconstruct Fuller Street walkway walls and fencing.
- TV sewer and drain systems to assess condition.

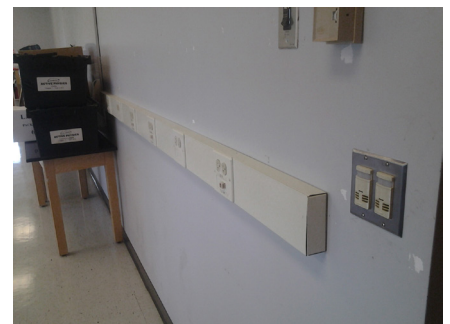
The surface mounted panelboards installed in classrooms/labs appear to be newer, in good and operational condition. These panels associate with the newer surface-mounted raceways added throughout the building (photo 4).

*Photo 4: Example of newer panelboards and newer raceways*

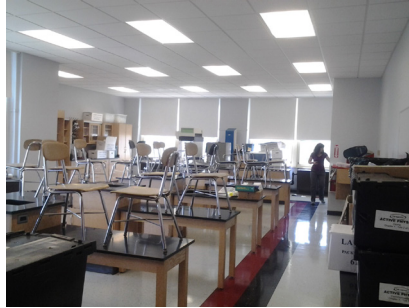
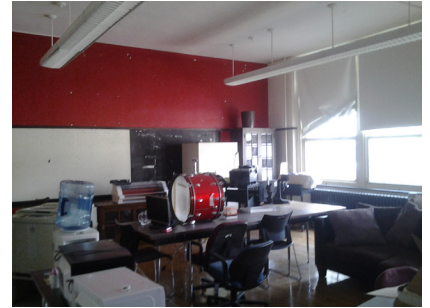
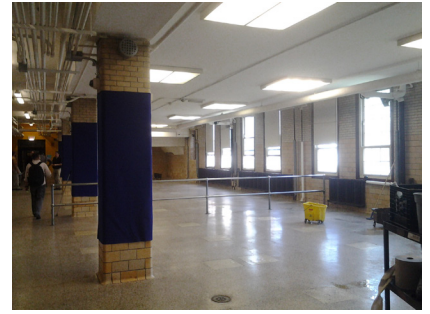
The lighting system was recently upgraded. New lighting fixtures were installed in administration area offices, science labs and classrooms, computer rooms, cafeteria, etc. (photo 7).

Photo 7: Examples of new lighting systems in classrooms, labs, cafeteria, etc.

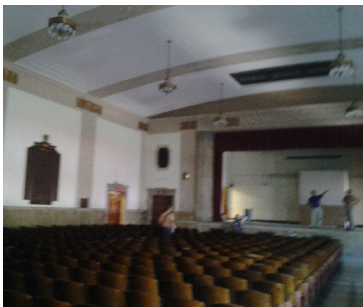
The corridor lighting system was upgraded, but not throughout the building. Auditorium lighting system consisting of decorative pendants is old and inefficient (photo 8).

Photo 8: Examples of old lighting systems

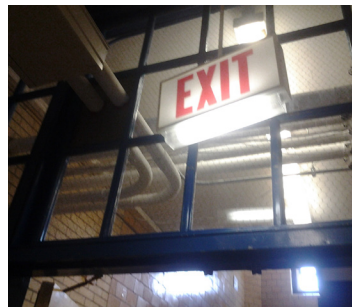
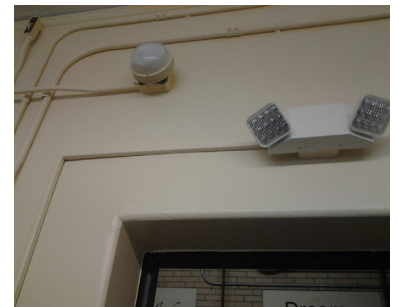
Photo 10: Egress emergency lighting

Emergency and egress lighting is implemented by use of battery packs/remote light heads (photo 10), electrical exist signs, and non-electrical exit signs (photo 11). Some exit signs were observed being not illuminated during site visit. Such arrangement is not in compliance with Building Code Chapter 27 requiring exit signs to be powered and illuminated at all times. It was also noticed that a few exit signs are not visible in corridors (blocked from view by columns or wall extensions).

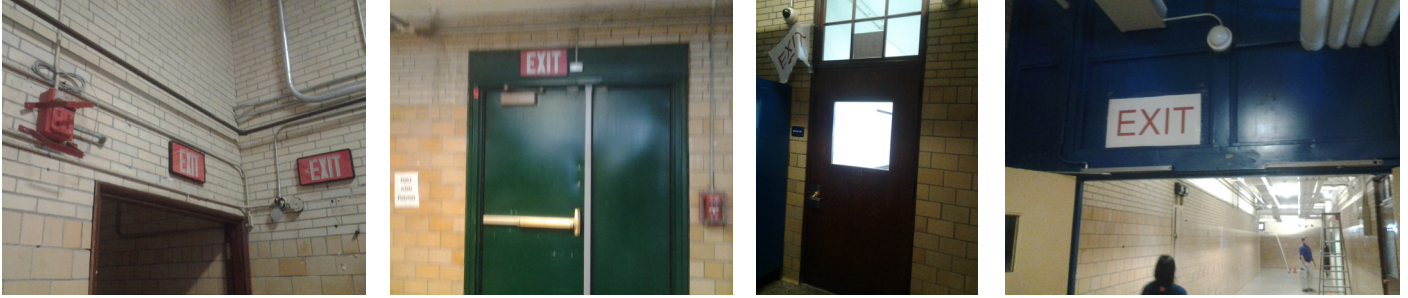
Photo 11: Egress exit signs

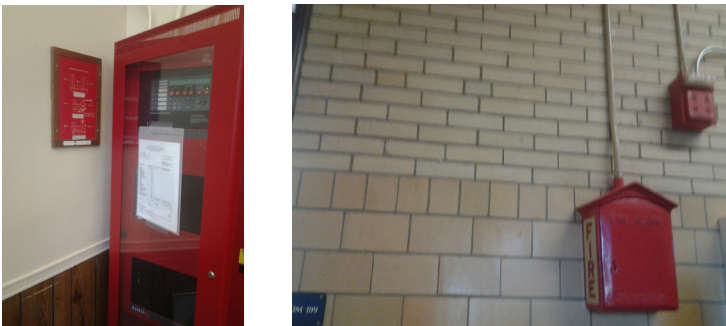
The existing fire alarm is manufactured by Simplex (photo 12).

Photo 12: Existing FACP and master box

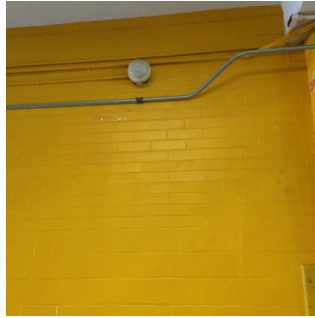
Motion sensors are distributed in corridors on the first floor to detect intrusion. Exterior doors are equipped with door contacts. A newer intrusion detection system has been installed to monitor doors.

Photo 1: Wall-mounted motion sensor

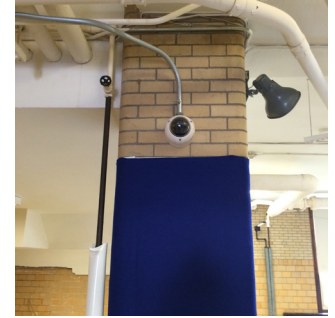
The school is equipped with a closed circuit television system. Cameras are distributed throughout corridors and around the exterior of the school. Coverage appears adequate.

Photo 3: Wall CCTV camera

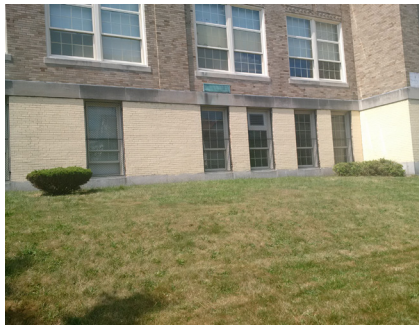
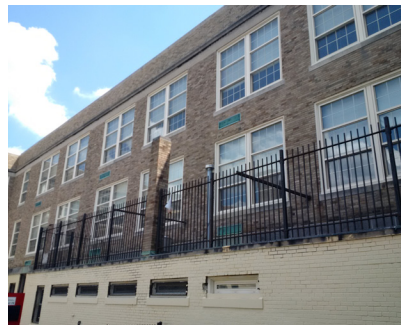
There are areas in back of the building where students or intruders could hide. The back of the school does not appear to be well lit. The sightlines on approach from the street are good. Exterior doors are not numbered. Room numbers are not posted on the building exterior. Plantings near the building are low or pruned and do not obscure views of the exterior.

Photo 4: and 5: Exterior views

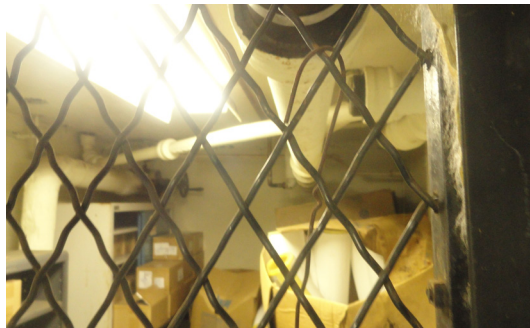
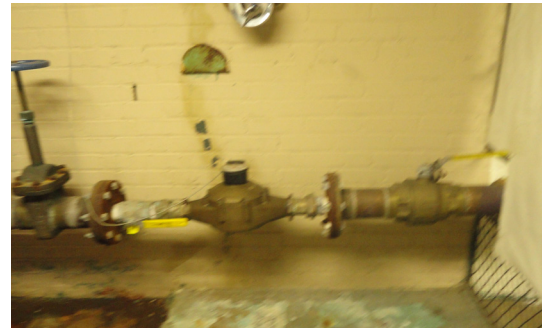
Domestic cold water for the facility is fed from a single water service; a 4-inch main entering the building in the boiler room. The water meter is in fair condition (see photo 1). All piping, valves and risers appear to be original, in fair to poor condition, and has outlived/exceeded its useful life. Domestic cold water piping is not expected to last a many more years without exhibiting widespread problems and possible failure. Some pipes are not insulated (see photo 2). One of the cold water risers is leaking (see photo 3).

*Photo 1: Domestic water service and water meter*

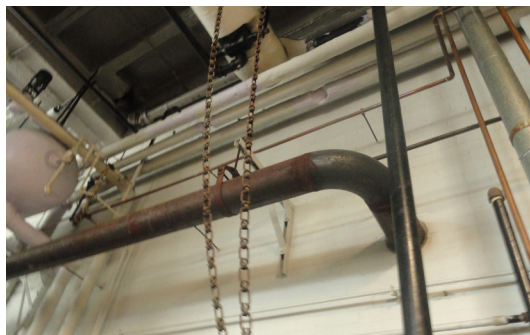
*Photo 2: Uninsulated Pipes*

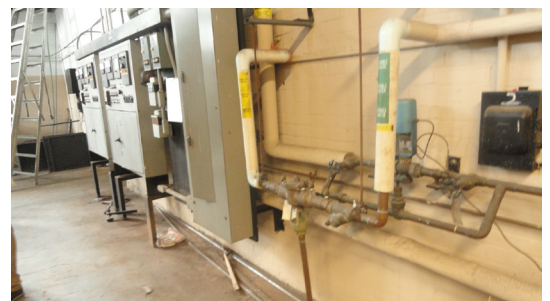
There is an existing backflow preventer in the boiler room for HVAC make-up, non-potable cold water system (see photo 4).

*Photo 4: RPBP for HVAC make-up*

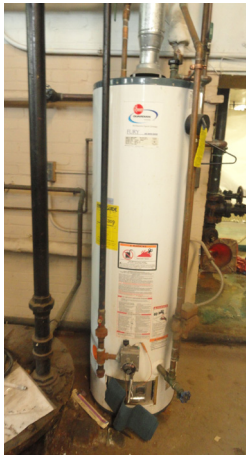
One gas-fired water heater, manufactured in 2011, is located in the boiler room and appears to be in good condition (see photo 5). The other gas-fired water heater, manufactured in 2013, is located and serves the kitchen, appears to be in good condition (see photo 6). All piping and valves appear to be original, in fair to poor condition, and have outlived/exceeded their useful life. Domestic hot water piping is not expected to last many more years without exhibiting widespread problems and possible failure. Some pipes are not insulated and there are two types of insulation, black and white. Hot water is circulated from hot water distribution loops by pumps in the boiler room and in the kitchen.

Photo 5: Gas-fired water heater in the boiler room

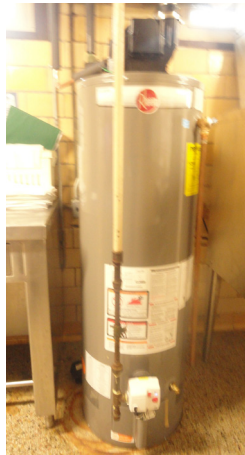
Photo 6: Gas-fired water heater in the kitchen

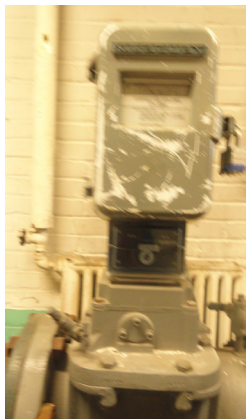
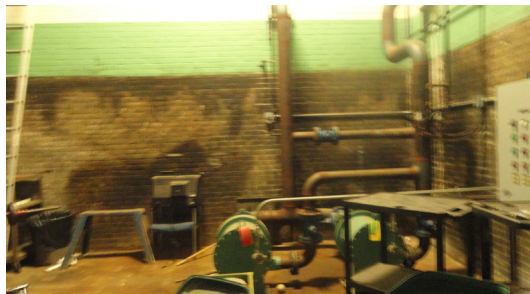
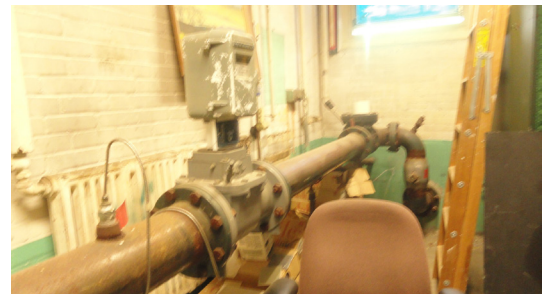
The existing natural gas system enters the building through the boiler room via a 6-inch gas main (see photo 7) and through the kitchen area (see photo 8). The existing gas system includes a gas meter, gas boosters, valves, and gas regulators. Gas is distributed throughout for the kitchen equipment, water heaters and gas boilers and laboratory classroom gas turrets. All piping and valves appear to be original, in fair to poor condition, and has outlived/exceeded its useful life and is not expected to last many more years without exhibiting widespread problems and possible failure.

Photo 7: Gas service, gas meter and piping in the boiler room

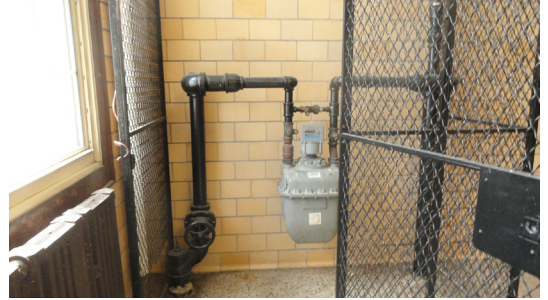
Photo 8: Gas service, gas meter and piping in the kitchen area

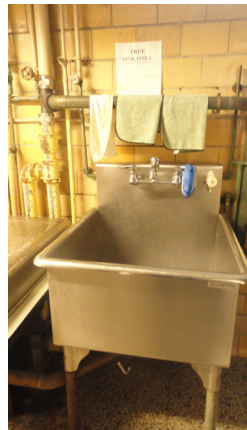
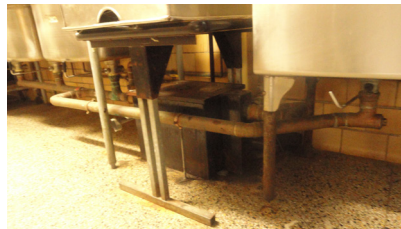
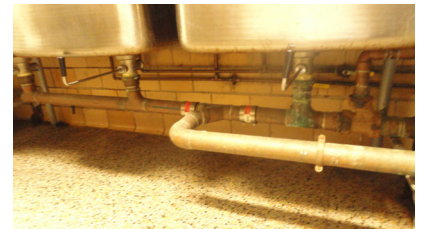
The kitchen's triple pot sink and prep sink are provided with above slab grease trap. Piping installation at triple pot sink is not code compliant (see photo 9). The air intake is not terminating above fixture's flood rim (see photo 10).

Photo 9: Waste piping installation at triple pot sink and prep sink

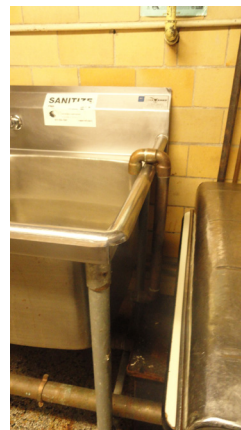
Photo 10: Air intake at triple pot sink

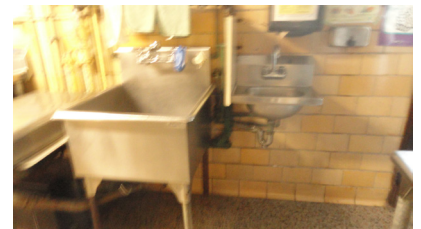
The hand sink is not ADA compliant and the piping is not insulated (see photo 11).

Photo 11: Hand sink
