10 Year Facility Master Plan  
3 School Pilot Study for:

## *Boston Public Schools*

# *Henderson Lower School Report*

### **Evaluation of Existing Conditions: Henderson Lower School**

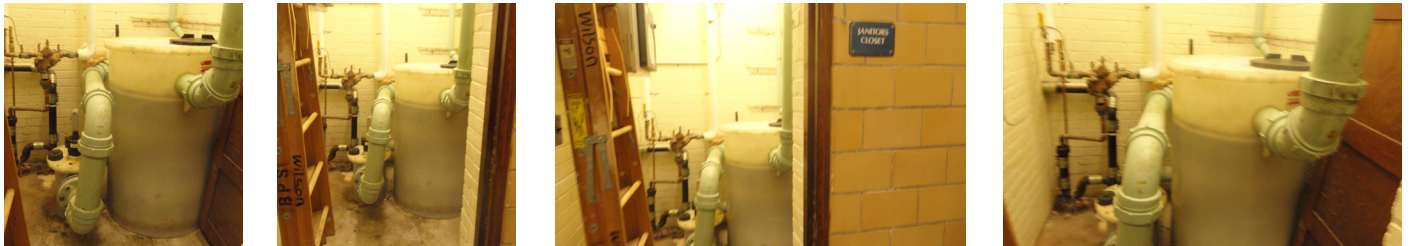
Acid neutralization tanks were installed in the first floor janitor's closet to collect laboratory waste (see photo 12).

Photo 12: Acid neutralization tanks

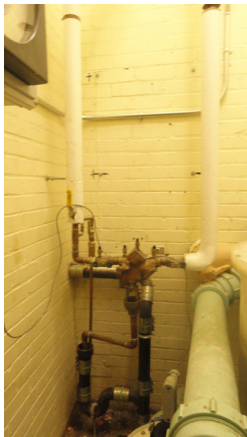
The non-potable water system includes only one backflow preventer. There should be one for non-potable cold water and one for non-potable hot water (see photo 13).

Photo 13: Backflow preventer for non-potable water system

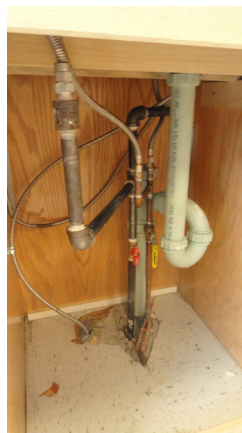
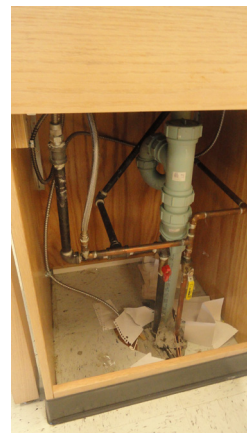
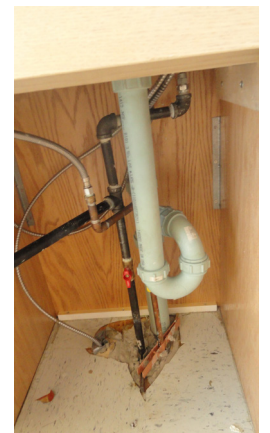
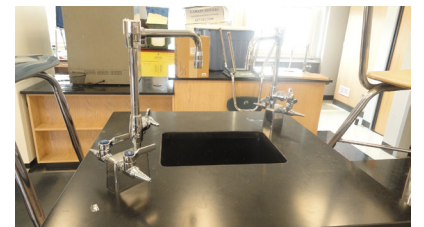
Only one water supply is provided for the laboratory faucets (see photo 14).

Photo 14: Water supply for the laboratory faucets

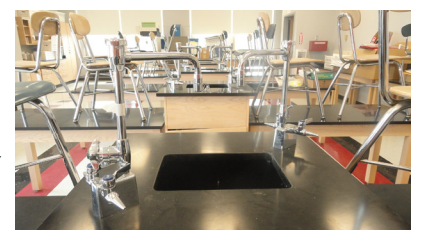
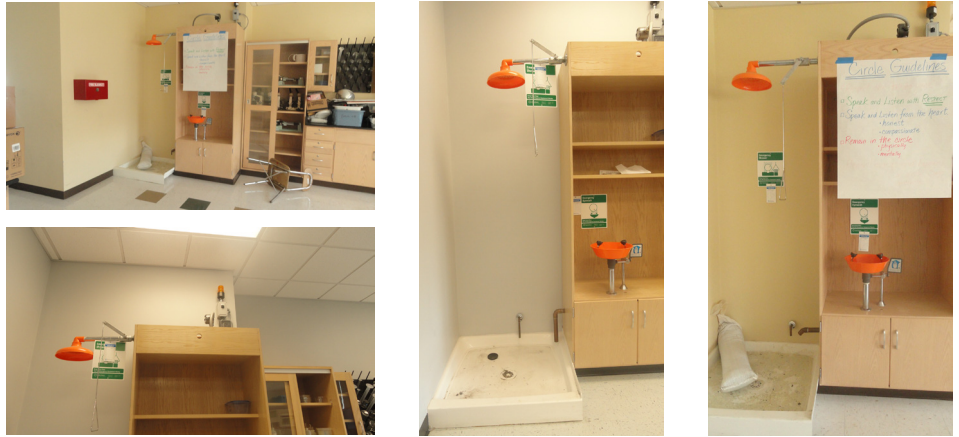
The existing emergency shower/eyewash installed in the science lab is non-ADA compliant (see photo 15).

Photo 15: Non-ADA compliant emergency shower/eyewash

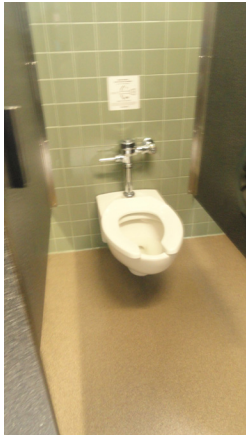
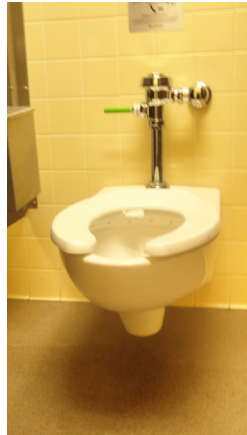
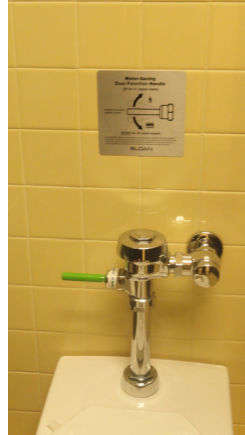
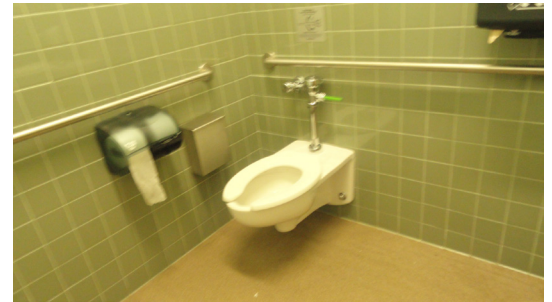
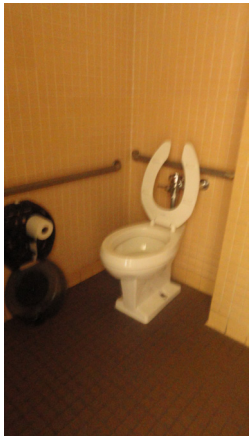
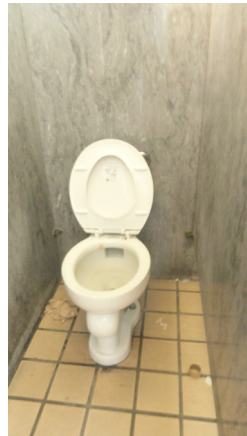
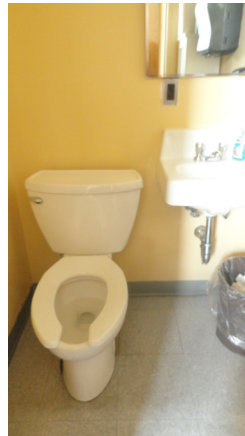
Some water closets are wall-mounted with manual flush valves, some have dual flush and others are floor-mounted, tank-type and some with manual flush valves. They are in fair condition (see photo 17).

*Photo 17: Different types of installed water closets*

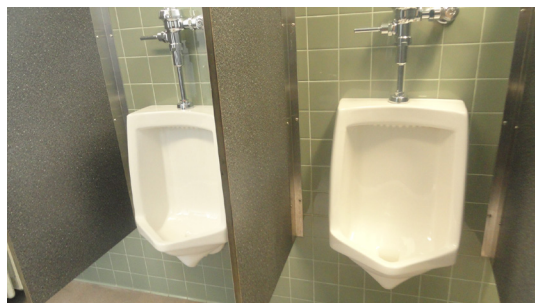
Urinals are wall-mounted with manual flush valves, generally in fair condition (see photo 18).

*Photo 18: Urinals*

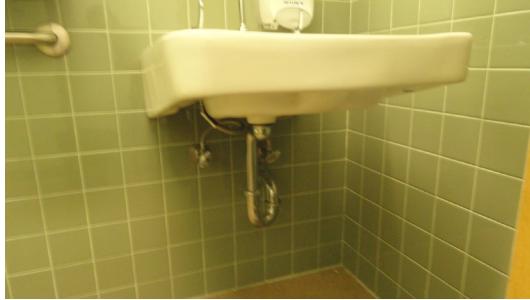
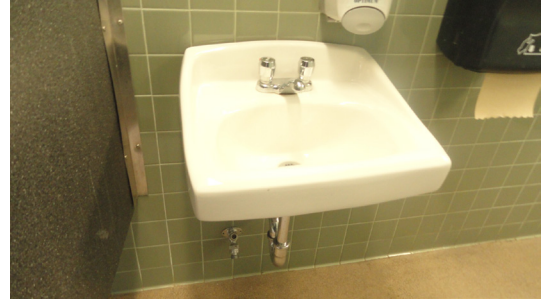
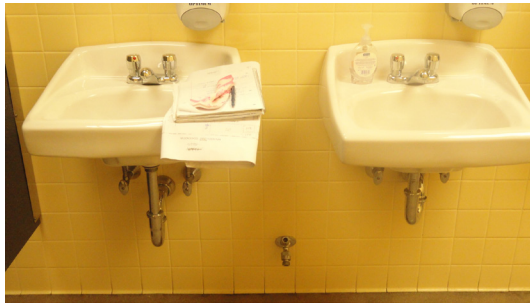
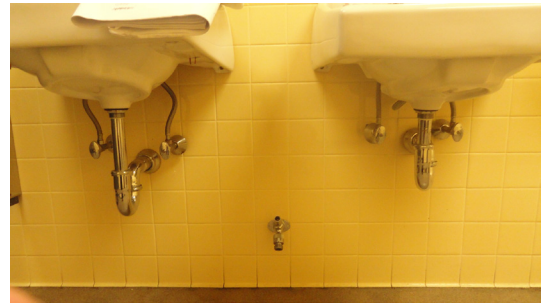
Lavatories are wall hung with self-closing push-down faucets or lever handles, generally in fair condition. Some of the lavatories are free-standing and non-ADA compliant. Pipe insulation is not installed in some locations and others are in poor condition (see photo 19).

*Non-ADA Lavatories and without pipe insulation*

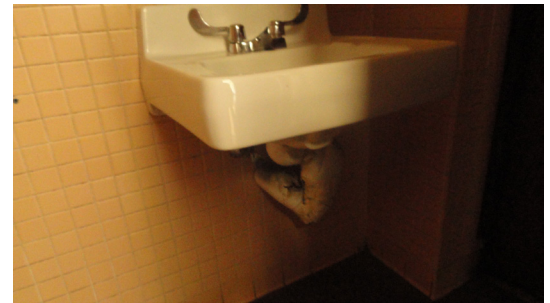
*Lavatory with poor pipe insulation*

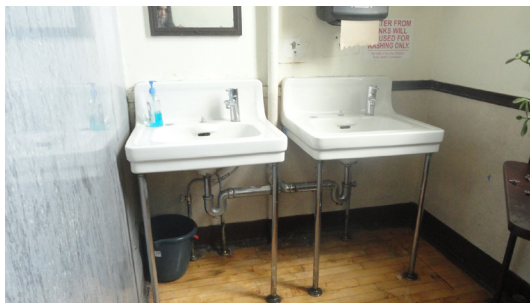
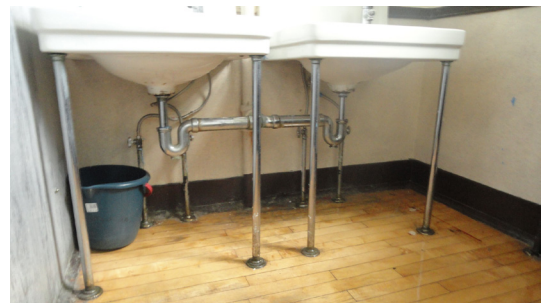
*Free-Standing non-ADA Lavatories*

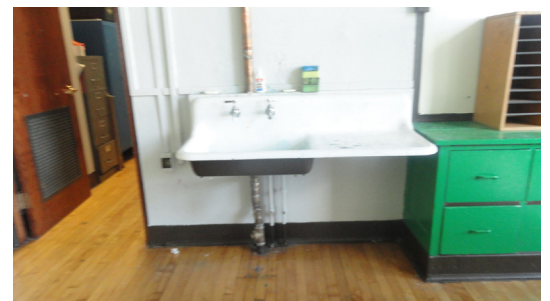
Some classrooms sinks are non-ADA compliant (see photo 20).

*Photo 20: Non-ADA classroom sink*
