At a Glance: East Boston High

86 White St East Boston, MA 02128

Evaluation of Existing Conditions: East Boston High School

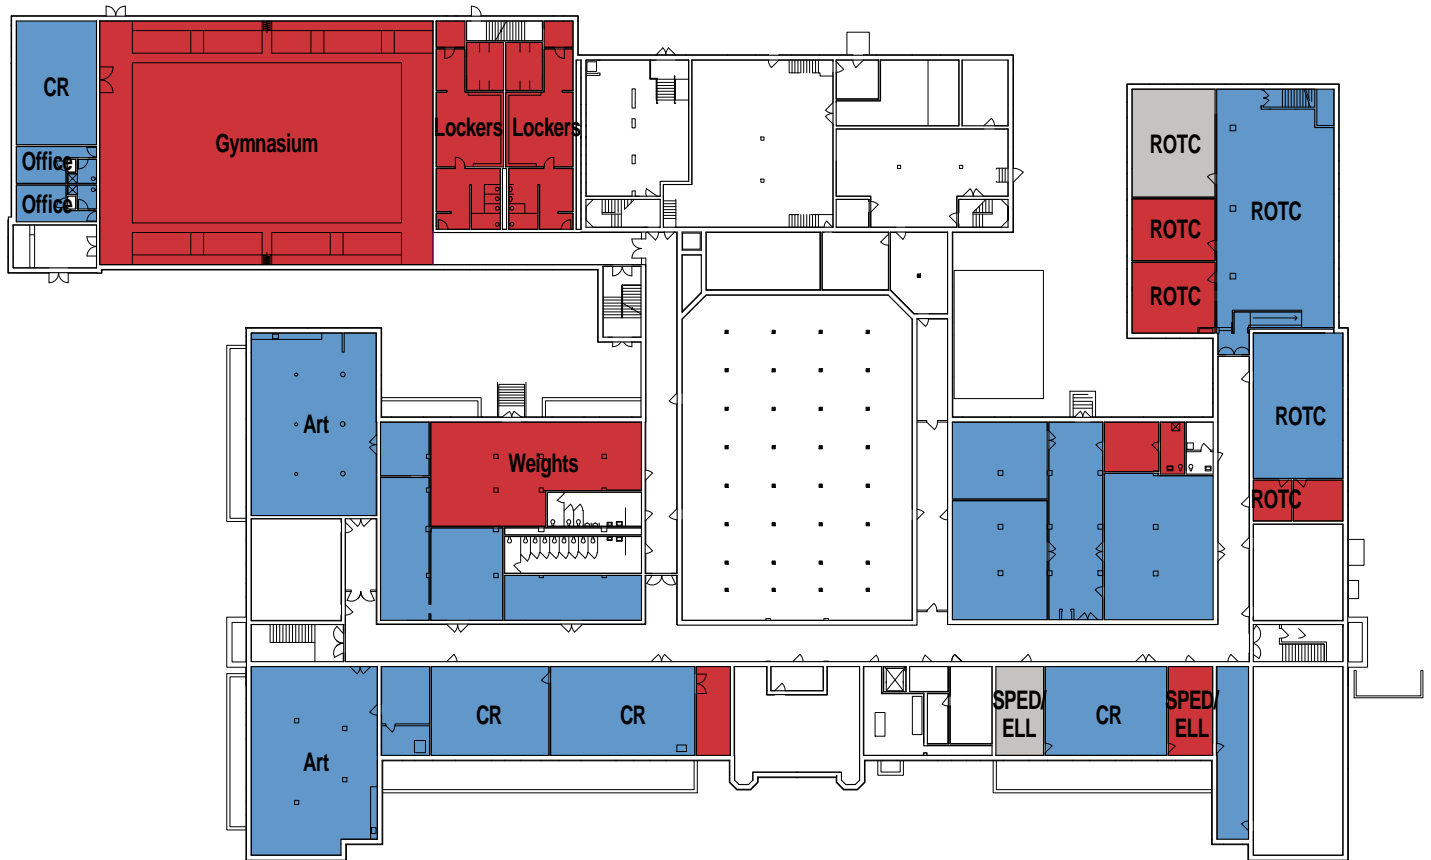
MSBA DEFICIENCY PLAN

- NSF 10% GREATER THAN MSBA GUIDELINES
- NSF AT LEAST 20% LESS THAN MSBA GUIDELINES
- NSF MEETS MSBA GUIDELINES (-20% TO +10%)

Some core program spaces are undersized or missing from the building
