At a Glance: Ellis, David A. Elementary

302 Walnut Ave Roxbury, MA 02119

Evaluation of Existing Conditions: David A. Ellis Elementary School

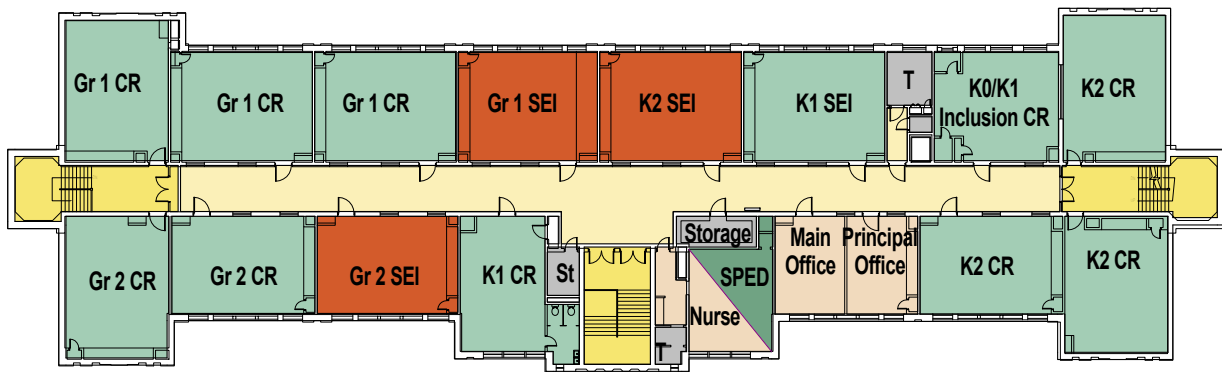
PROGRAM PLAN LEGEND

ADMINISTRATION / GUIDANCE / STUDENT SERVICES / NURSE	 CUSTODIAL / MAINTENANCE / STORAGE
 CAFETERIA & CIRCULATION	 ELL / SEI
 CLASSROOM & GENERAL EDUCATION SUPPORT	 SPECIAL EDUCATION
	 VERTICAL CIRCULATION

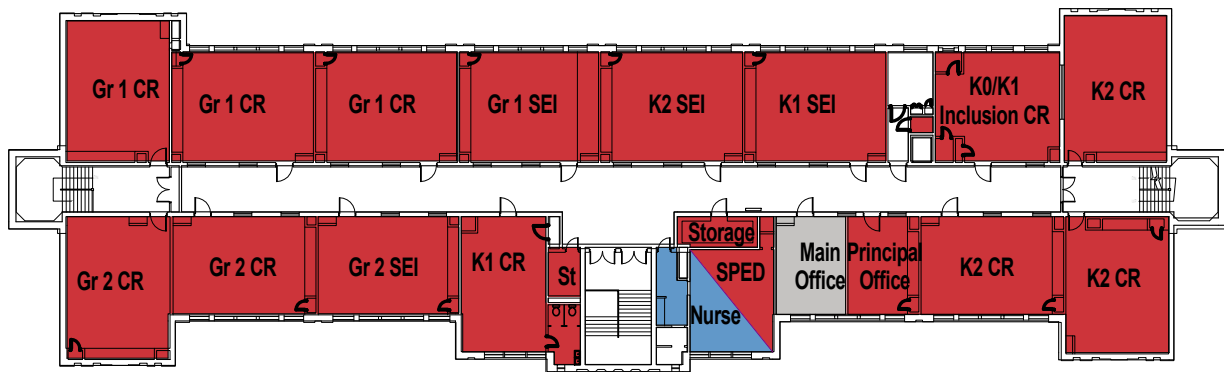
MSBA DEFICIENCY PLAN

- NSF 10% GREATER THAN MSBA GUIDELINES
- NSF AT LEAST 20% LESS THAN MSBA GUIDELINES
- NSF MEETS MSBA GUIDELINES (-20% TO +10%)

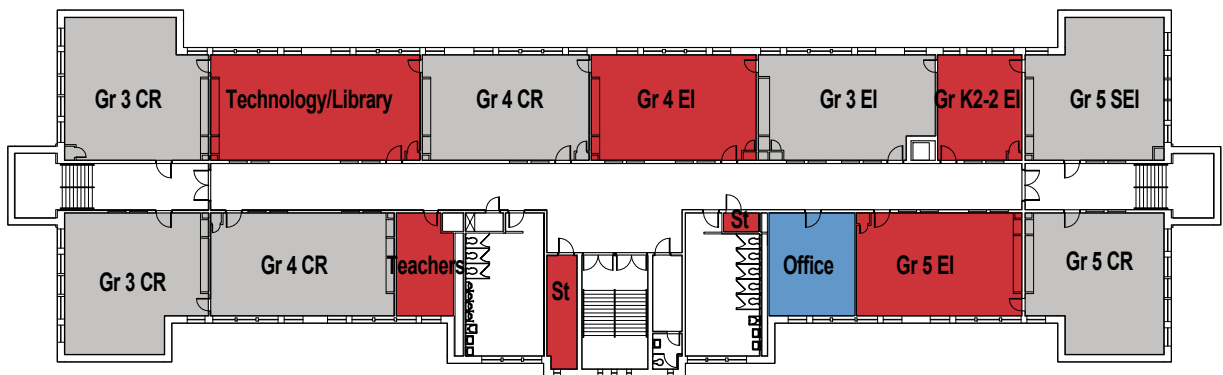
MSBA DEFICIENCY PLAN

- NSF 10% GREATER THAN MSBA GUIDELINES
- NSF AT LEAST 20% LESS THAN MSBA GUIDELINES
- NSF MEETS MSBA GUIDELINES (-20% TO +10%)
