At a Glance: Tynan, Joseph P. Elementary

650 E Fourth St South Boston, MA02127 **DOE Code:** 00350181

Evaluation of Existing Conditions: Tynan Elementary School

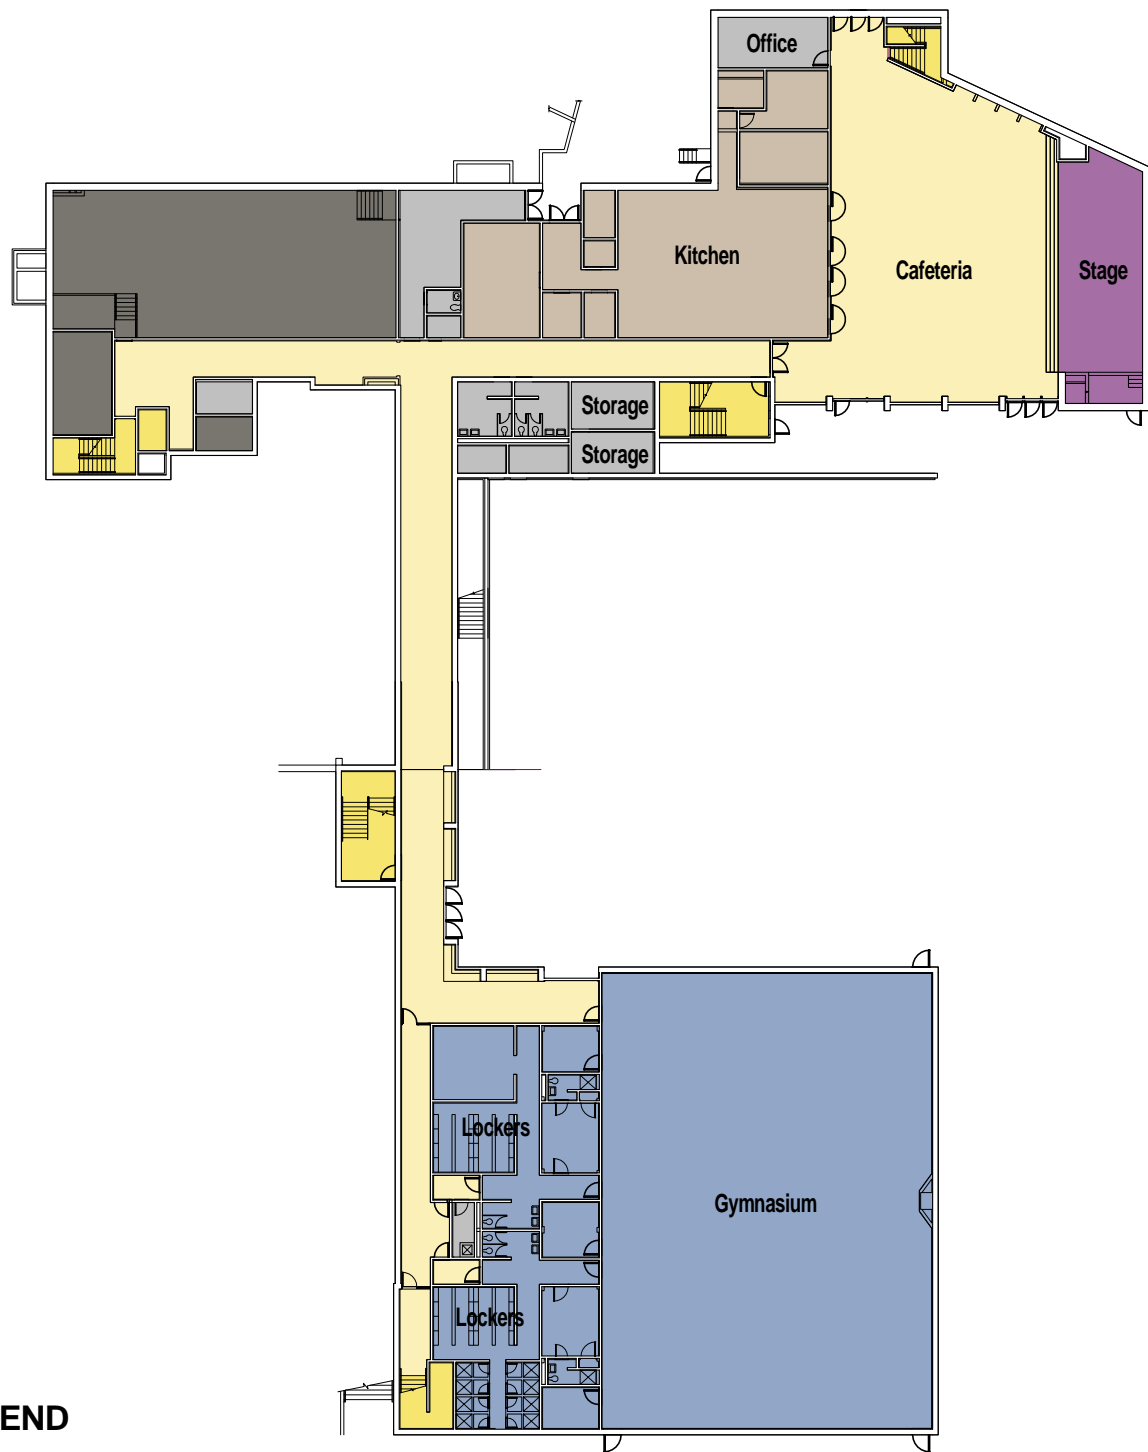
PROGRAM PLAN LEGEND

- AUDITORIUM / PERFORMING ARTS & DRAMA
- BUILDING EQUIPMENT
- CAFETERIA & CIRCULATION
- CUSTODIAL / MAINTENANCE / STORAGE

- KITCHEN / SERVERY
- PHYSICAL EDUCATION & SPORT SUPPORT
- VERTICAL CIRCULATION

The building currently supports large sub-separate program. Some core spaces are undersized or missing from the building.

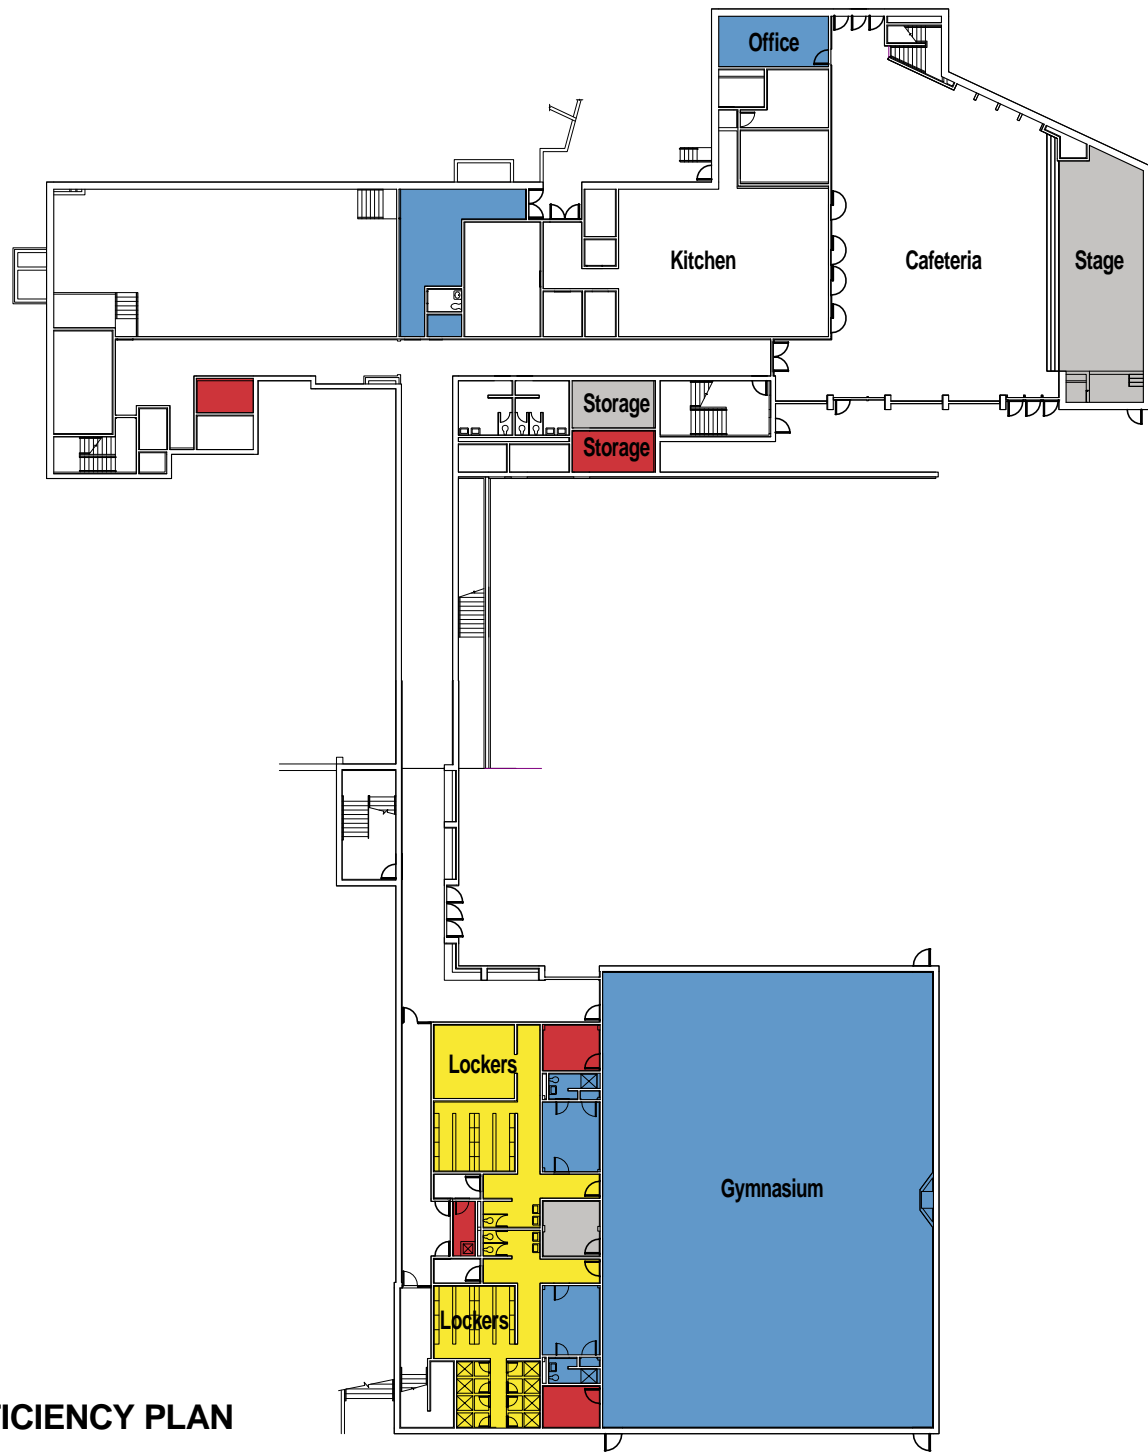
MSBA DEFICIENCY PLAN

- NOT INCLUDED IN A TYPICAL MSBA PROJECT
- NSF 10% GREATER THAN MSBA GUIDELINES
- NSF AT LEAST 20% LESS THAN MSBA GUIDELINES
- NSF MEETS MSBA GUIDELINES (-20% TO +10%)
